Over and Above Estimate

CSS #: 18868

Maximo Work Order No.: 8809

Site Name	US Army Reserve Center
Work Description	Misc. Repairs
Site Address	1821 Industry Drive Culpeper, VA 22701

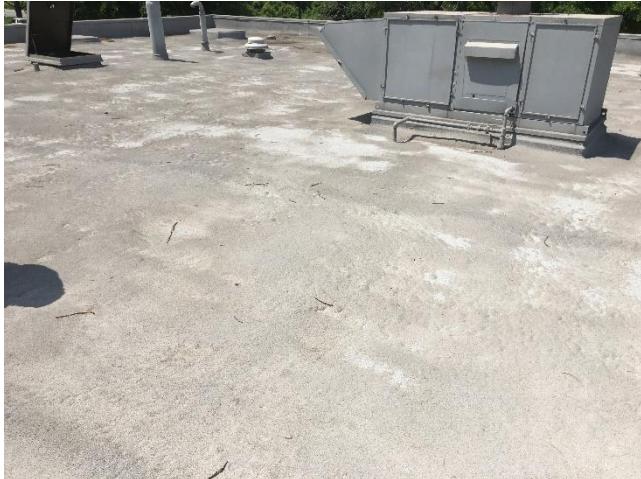
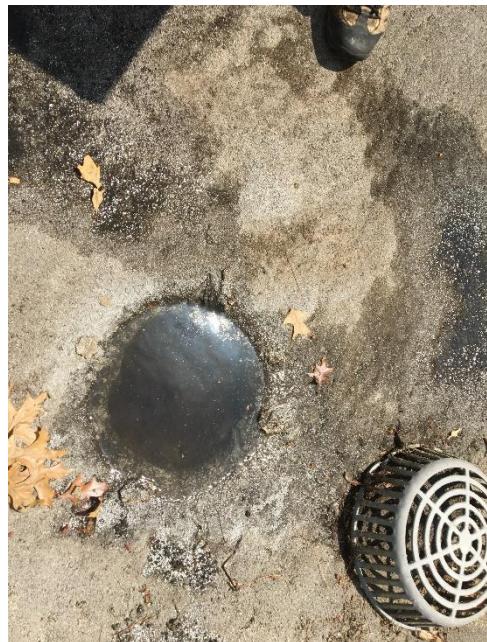
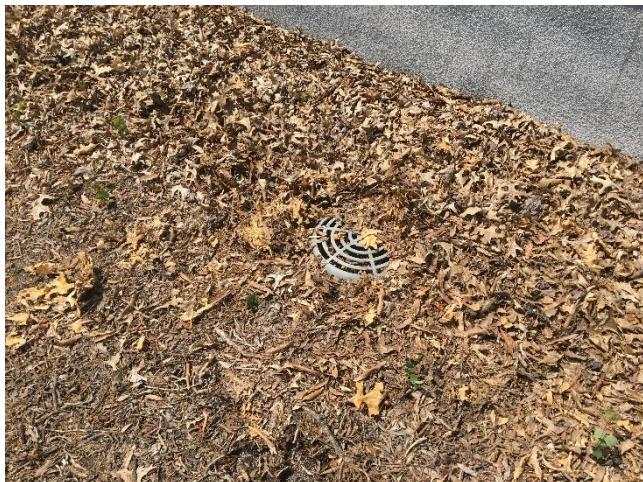
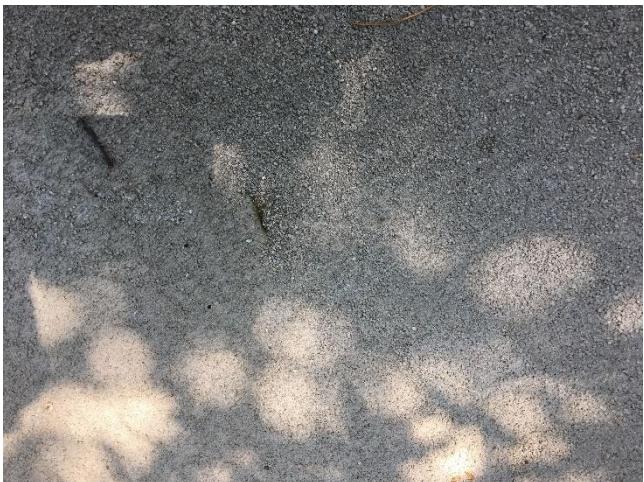
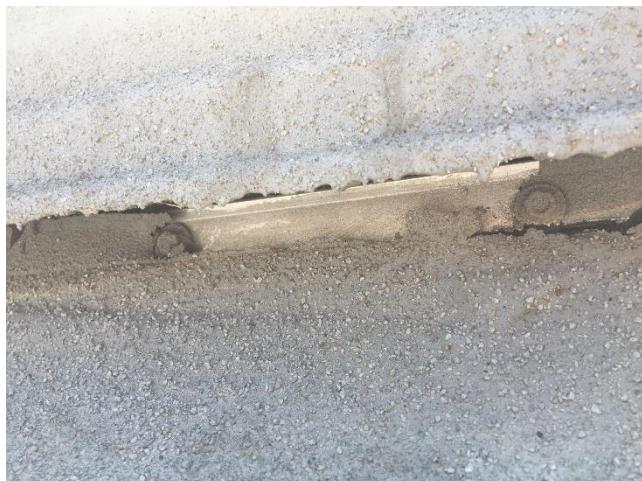
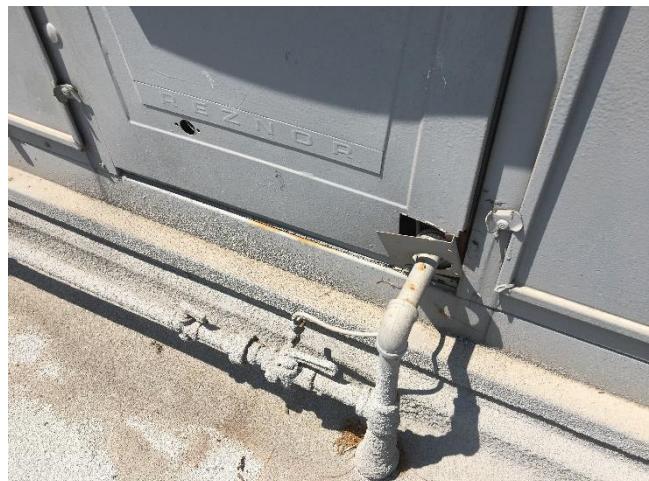
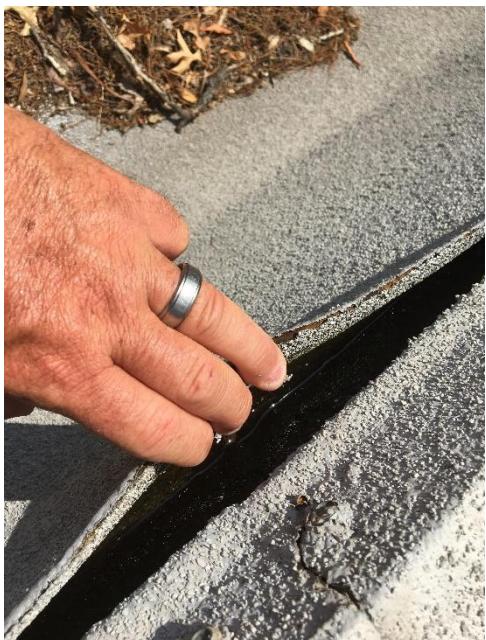
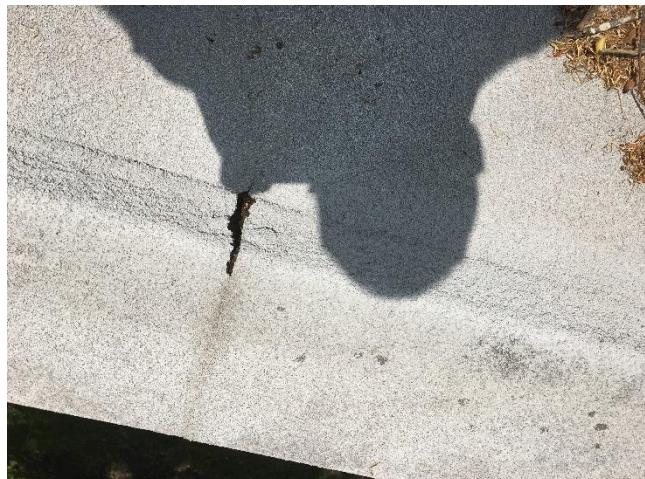
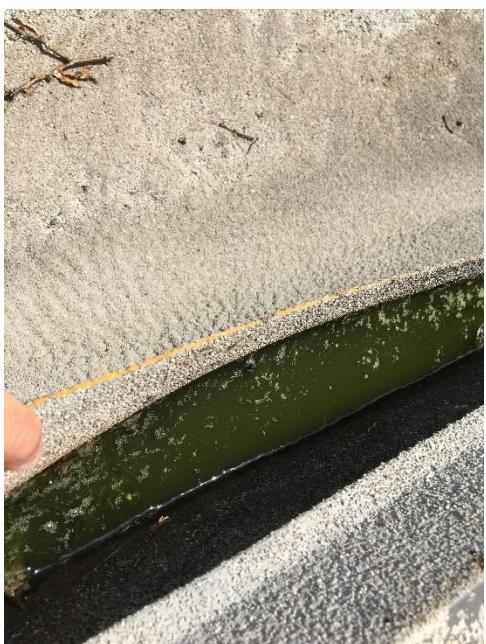
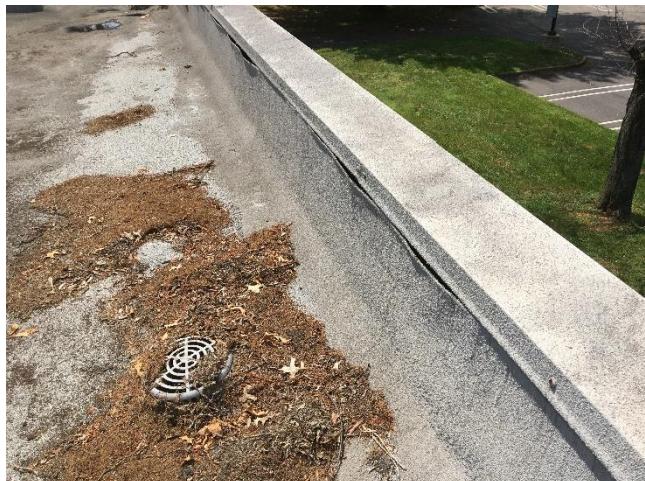
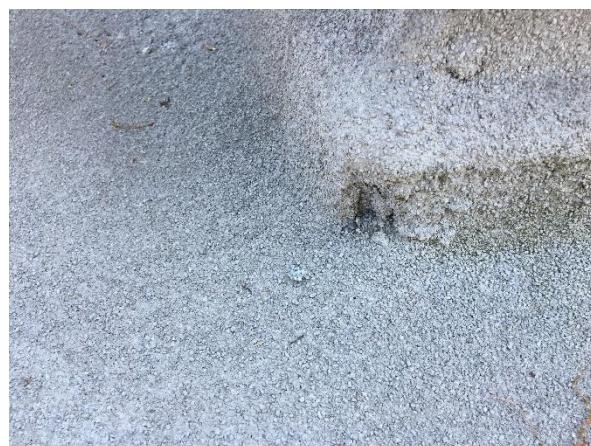
The existing roof is a granule surfaced spray-applied urethane foam roof installed directly over an (original?) gravel surfaced built-up roof system over a steel deck.

The leak was reported under and appears to drip through at a gas line penetration through the roof next to an abandoned mechanical unit. The penetration may not be flashed watertight and there is some reason to believe that the old RTU is taking in water where the panels have a hole or are ill-fitted.

However, there are several other defects in the roof including the following:

1. A large area adjacent to the bounded mechanical unit, approximately 16' x 25', where water has apparently collected between the foam roof and the gravel built-up roof. This may or may not be contributing to the leak. It may also be a result of the water getting into the unit.
2. Many coping joints where there is a split in the foam and noticeable moisture in the split.
3. Approximately 100 feet of wall where the original roof's base flashings are pulling out from under the cooping. Water was found behind these flashings.
4. Numerous small splits in the surface of the foam roof.
5. All debris needs to be cleaned from the roof and from around the drains.

In general, the appearance of the foam roof is better than what we often see for this roof type.

We would also suggest that the mechanical unit should be inspected or water leaks, whereas this may be contributing to the problem.

We propose to address items 2, 3, 4 and 5 above. Item 1 is not included.

When these items are done, we cannot be sure that these will resolve the leaks. All we are doing is addressing specific defects.
