## Over and Above Estimate

**Original Description:** Water leak from ceiling or pipe in ceiling.

US Army Reserve Center  
1821 Industry Drive  
Culpeper, VA 22701

# PROJECT PROPOSAL

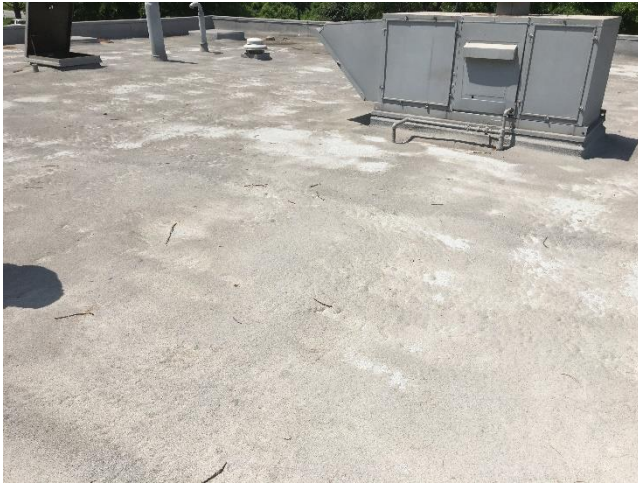
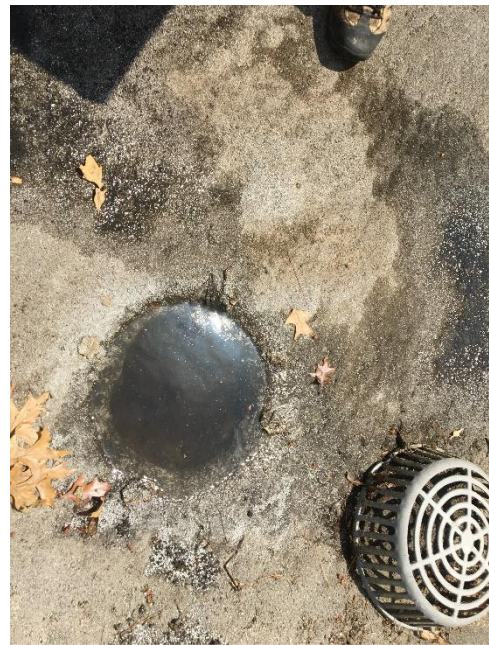
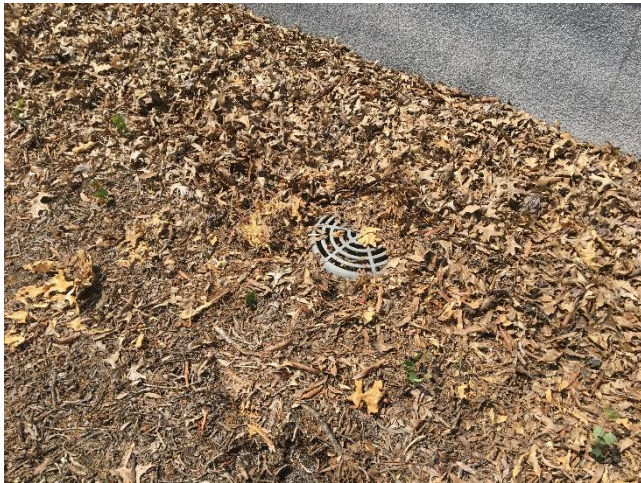
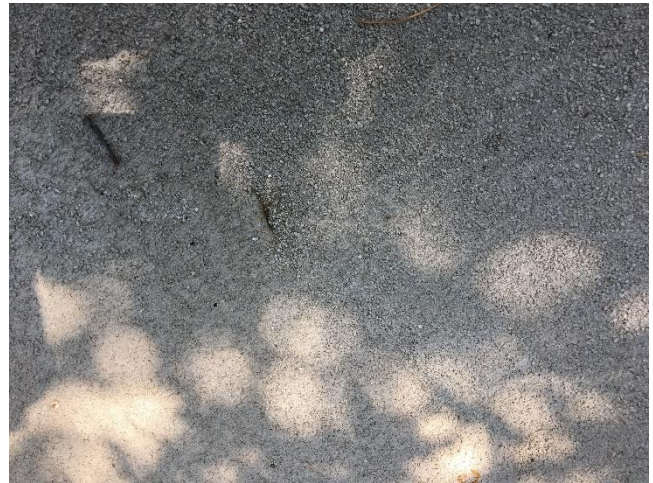
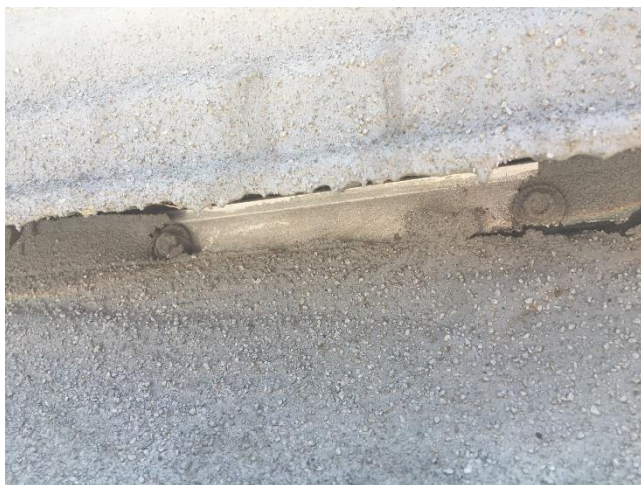
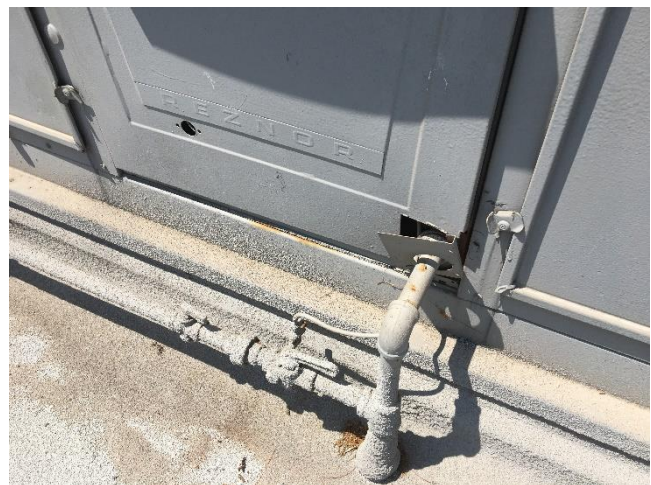
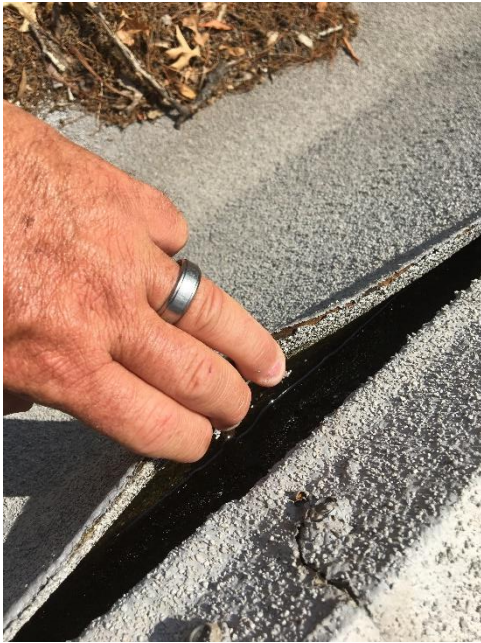
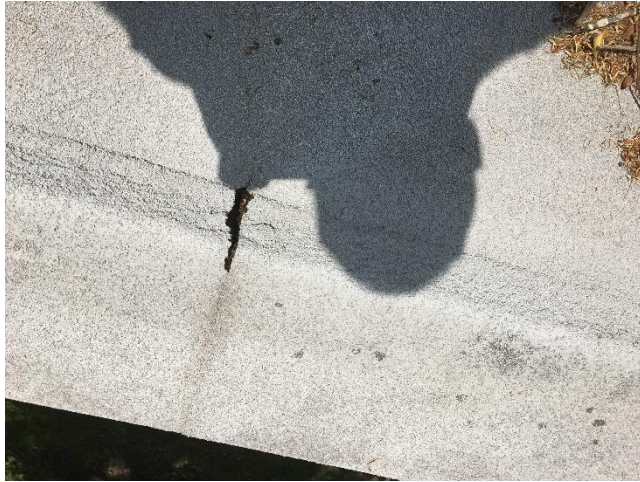
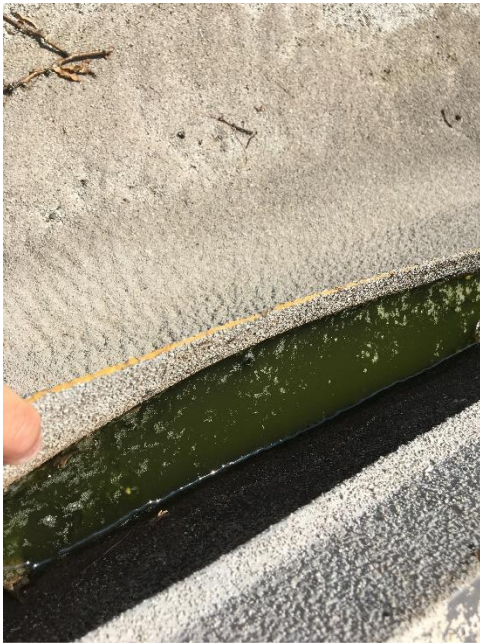
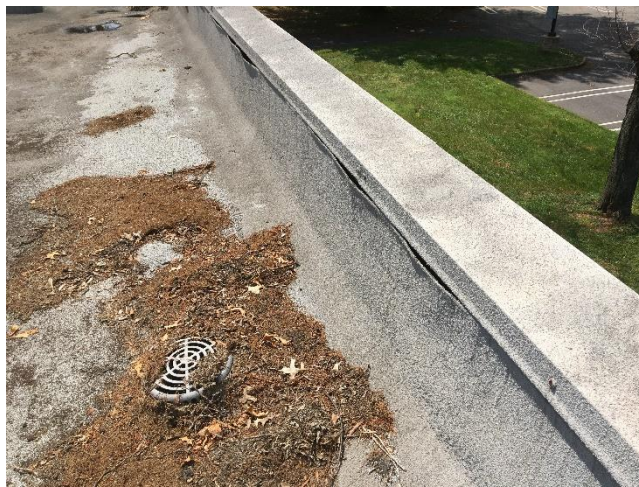
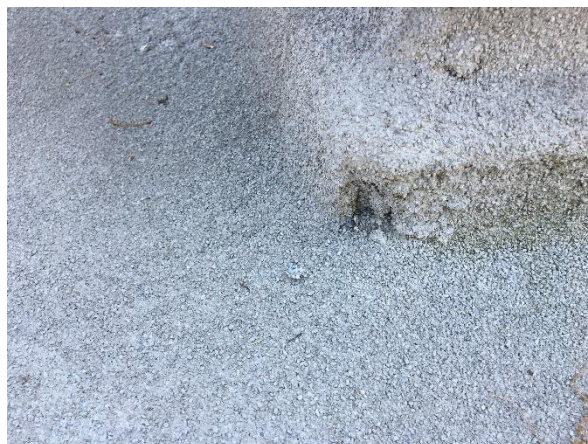
The existing roof is a granule surfaced spray-applied urethane foam roof installed directly over an (original?) gravel surfaced built-up roof system over a steel deck.

The leak was reported under and appears to drip through at a gas line penetration through the roof next to an abandoned mechanical unit. The penetration may not be flashed watertight and there is some reason to believe that the old RTU is taking in water where the panels have a hole or are ill-fitted.

1. A large area adjacent to the abandoned mechanical unit, approximately 16' x 25', where water has apparently collected between the foam roof and the gravel built-up roof. This may or may not be contributing to the leak. It may also be a result of the water getting into the unit.
2. Many coping joints where there is a split in the foam and noticeable moisture in the split.
3. Approximately 100 feet of wall where the original roof's base flashings are pulling out from under the coping. Water was found behind these flashings.
4. Numerous small splits in the surface of the foam roof.
5. All debris needs to be cleaned from the roof and from around the drains.

We propose to address items 2, 3, 4 and 5 above. Item 1 is not included.
