PREVENTATIVE MAINTENANCE PROGRAM CHECKLIST

VAULT DOOR

SITE AND BLDG #: NY013 BLDG1

LOCATION/RM #: VAULT WO# 21559 ASSET # 9247

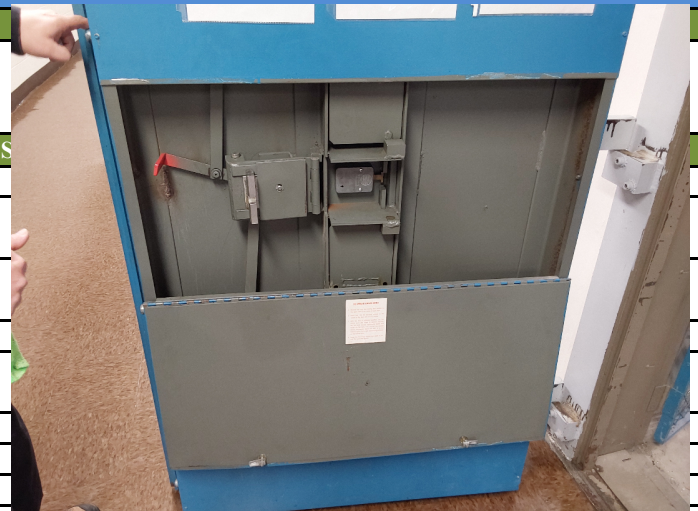
THE LOCKSMITH INFORMED ME THE DOOR IS NON COMPLIANT AND NEEDS TO BE REPLACED
 THE THRESHOLD IS WARPING AND GIVING THE DOOR A HARD TIME OPENING AND CLOSING the
 lock no longer meets ffl 2937 and the door has been drilled and repaired in non compliance to fed
 standard 809
