**PREVENTATIVE MAINTENANCE PROGRAM CHECKLIST**  
**VEHICLE EXHAUST REMOVAL**

SITE AND BLDG #: WV014-01

LOCATION/RM #: Motor Pool

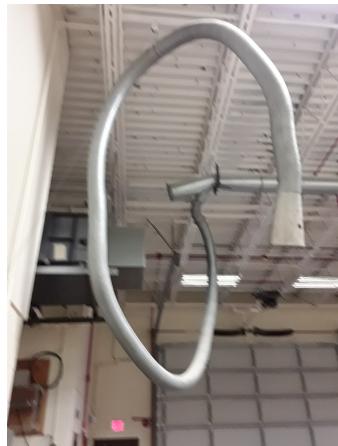
7	Visually inspect exhaust system tubing and/or duct work for any damage that could result in leaks.	✓		Ductwork Bent, causing kink
8	Repair as needed	✓

\* Ductwork bent, causing kink. Not flowing properly.

Corrective Action Required.

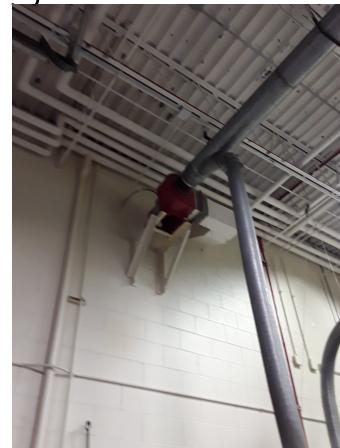
\* Exhaust hoses dangling, causing possible obstruction hazard. Should be upgraded to reel type storage.
