PREVENTATIVE MAINTENANCE PROGRAM CHECKLIST

EXHAUST FANS

SITE AND BLDG #: WV020-02

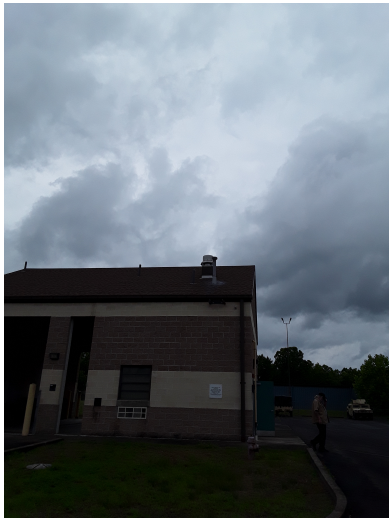
Note: Unable to access exhaust due to extreme roof pitch. Tested unit from ground for bearing noise and proper operation.
