CMI Management
Bowie Army Reserve Center
4600 Foxtail Place
White Plains MD 20695
(202) 437-5119

Report Number: **368091**

4600 Foxtail Place - HVAC

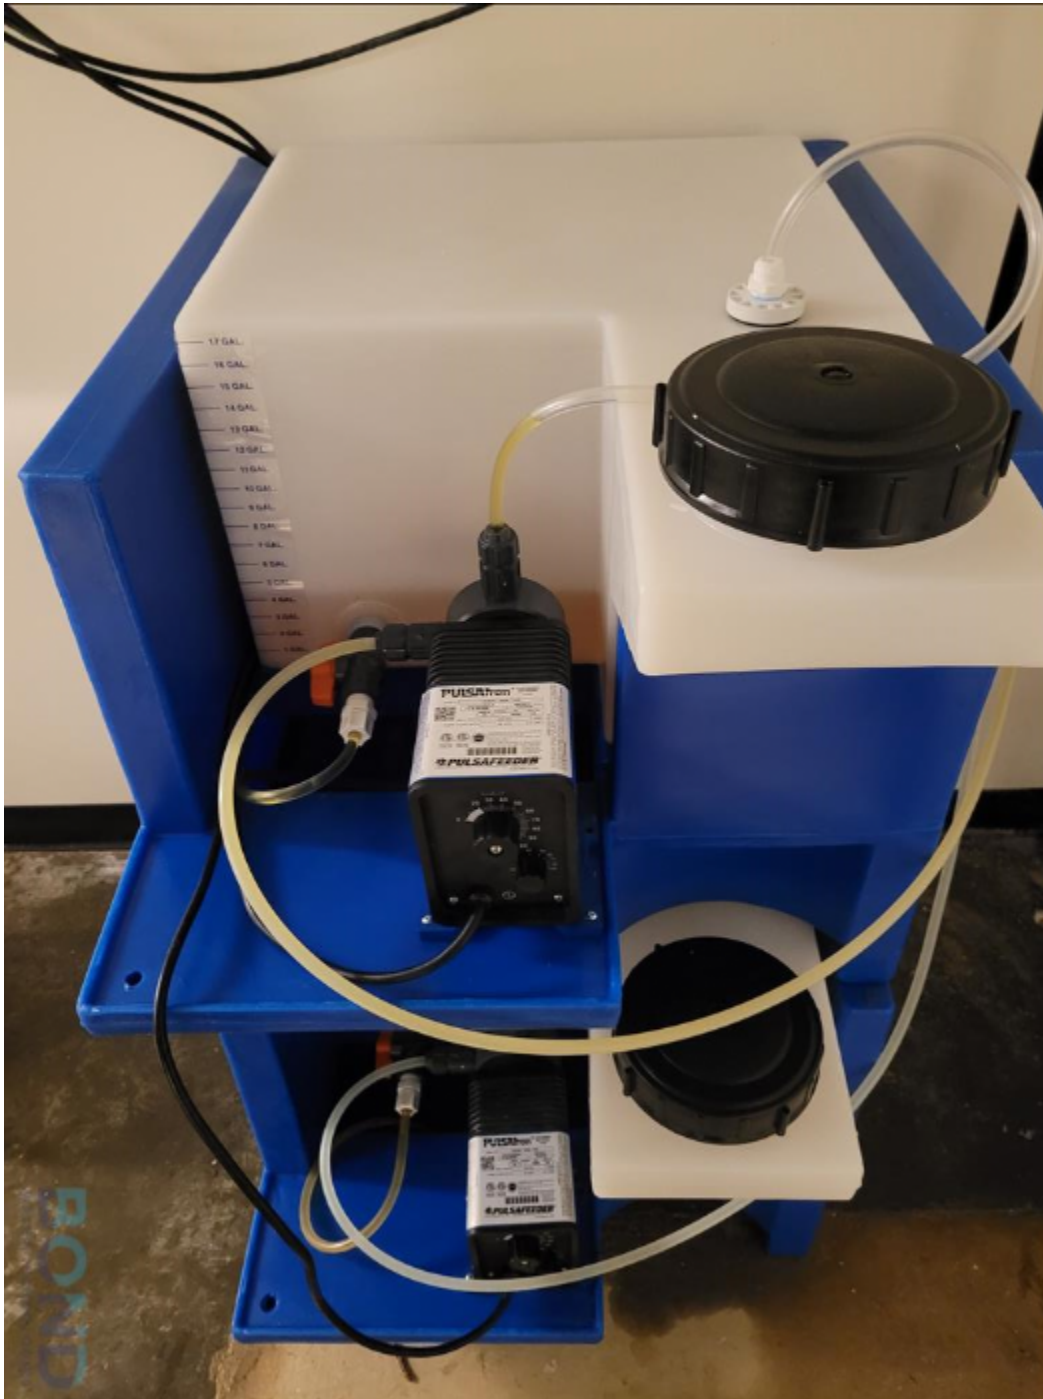
During this visit the containment tanks were cleaned and tubing was now securely run into the containment tanks.

On arrival I found that the cooling tower control was leaking on the exterior portions of the piping. The piping was wrapped in insulation and the extent of the break was unknown. Chemical testing found low levels in the cooling tower due to this water loss. All levels will rise and stabilize once the pipes have been repaired and the system is operating normally. Reviewed controller programming and filled chemical tanks as needed. It was later found that the heat tape had actually melted the PVC and all damage has been repaired.
