Additional Funding Request

WORK ESTIMATE

18085

8012

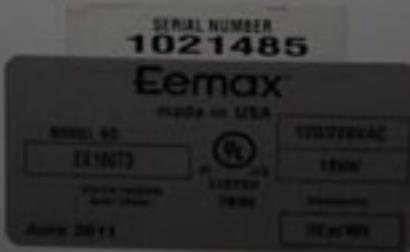
Labor and materials to install an access hatch in ceiling needed to access inop tankless water heater that requires troubleshooting. Upon troubleshooting, we will then know whether repair or replacement is necessary.
