Fratello & Amico, Inc.

**RE: WV020, Report of Oil Water Separator Cleaning and Preventative Maintenance Inspection, Jane Lew
USARC, 7605 US Route 19 North, Jane Lew, WV 26378**

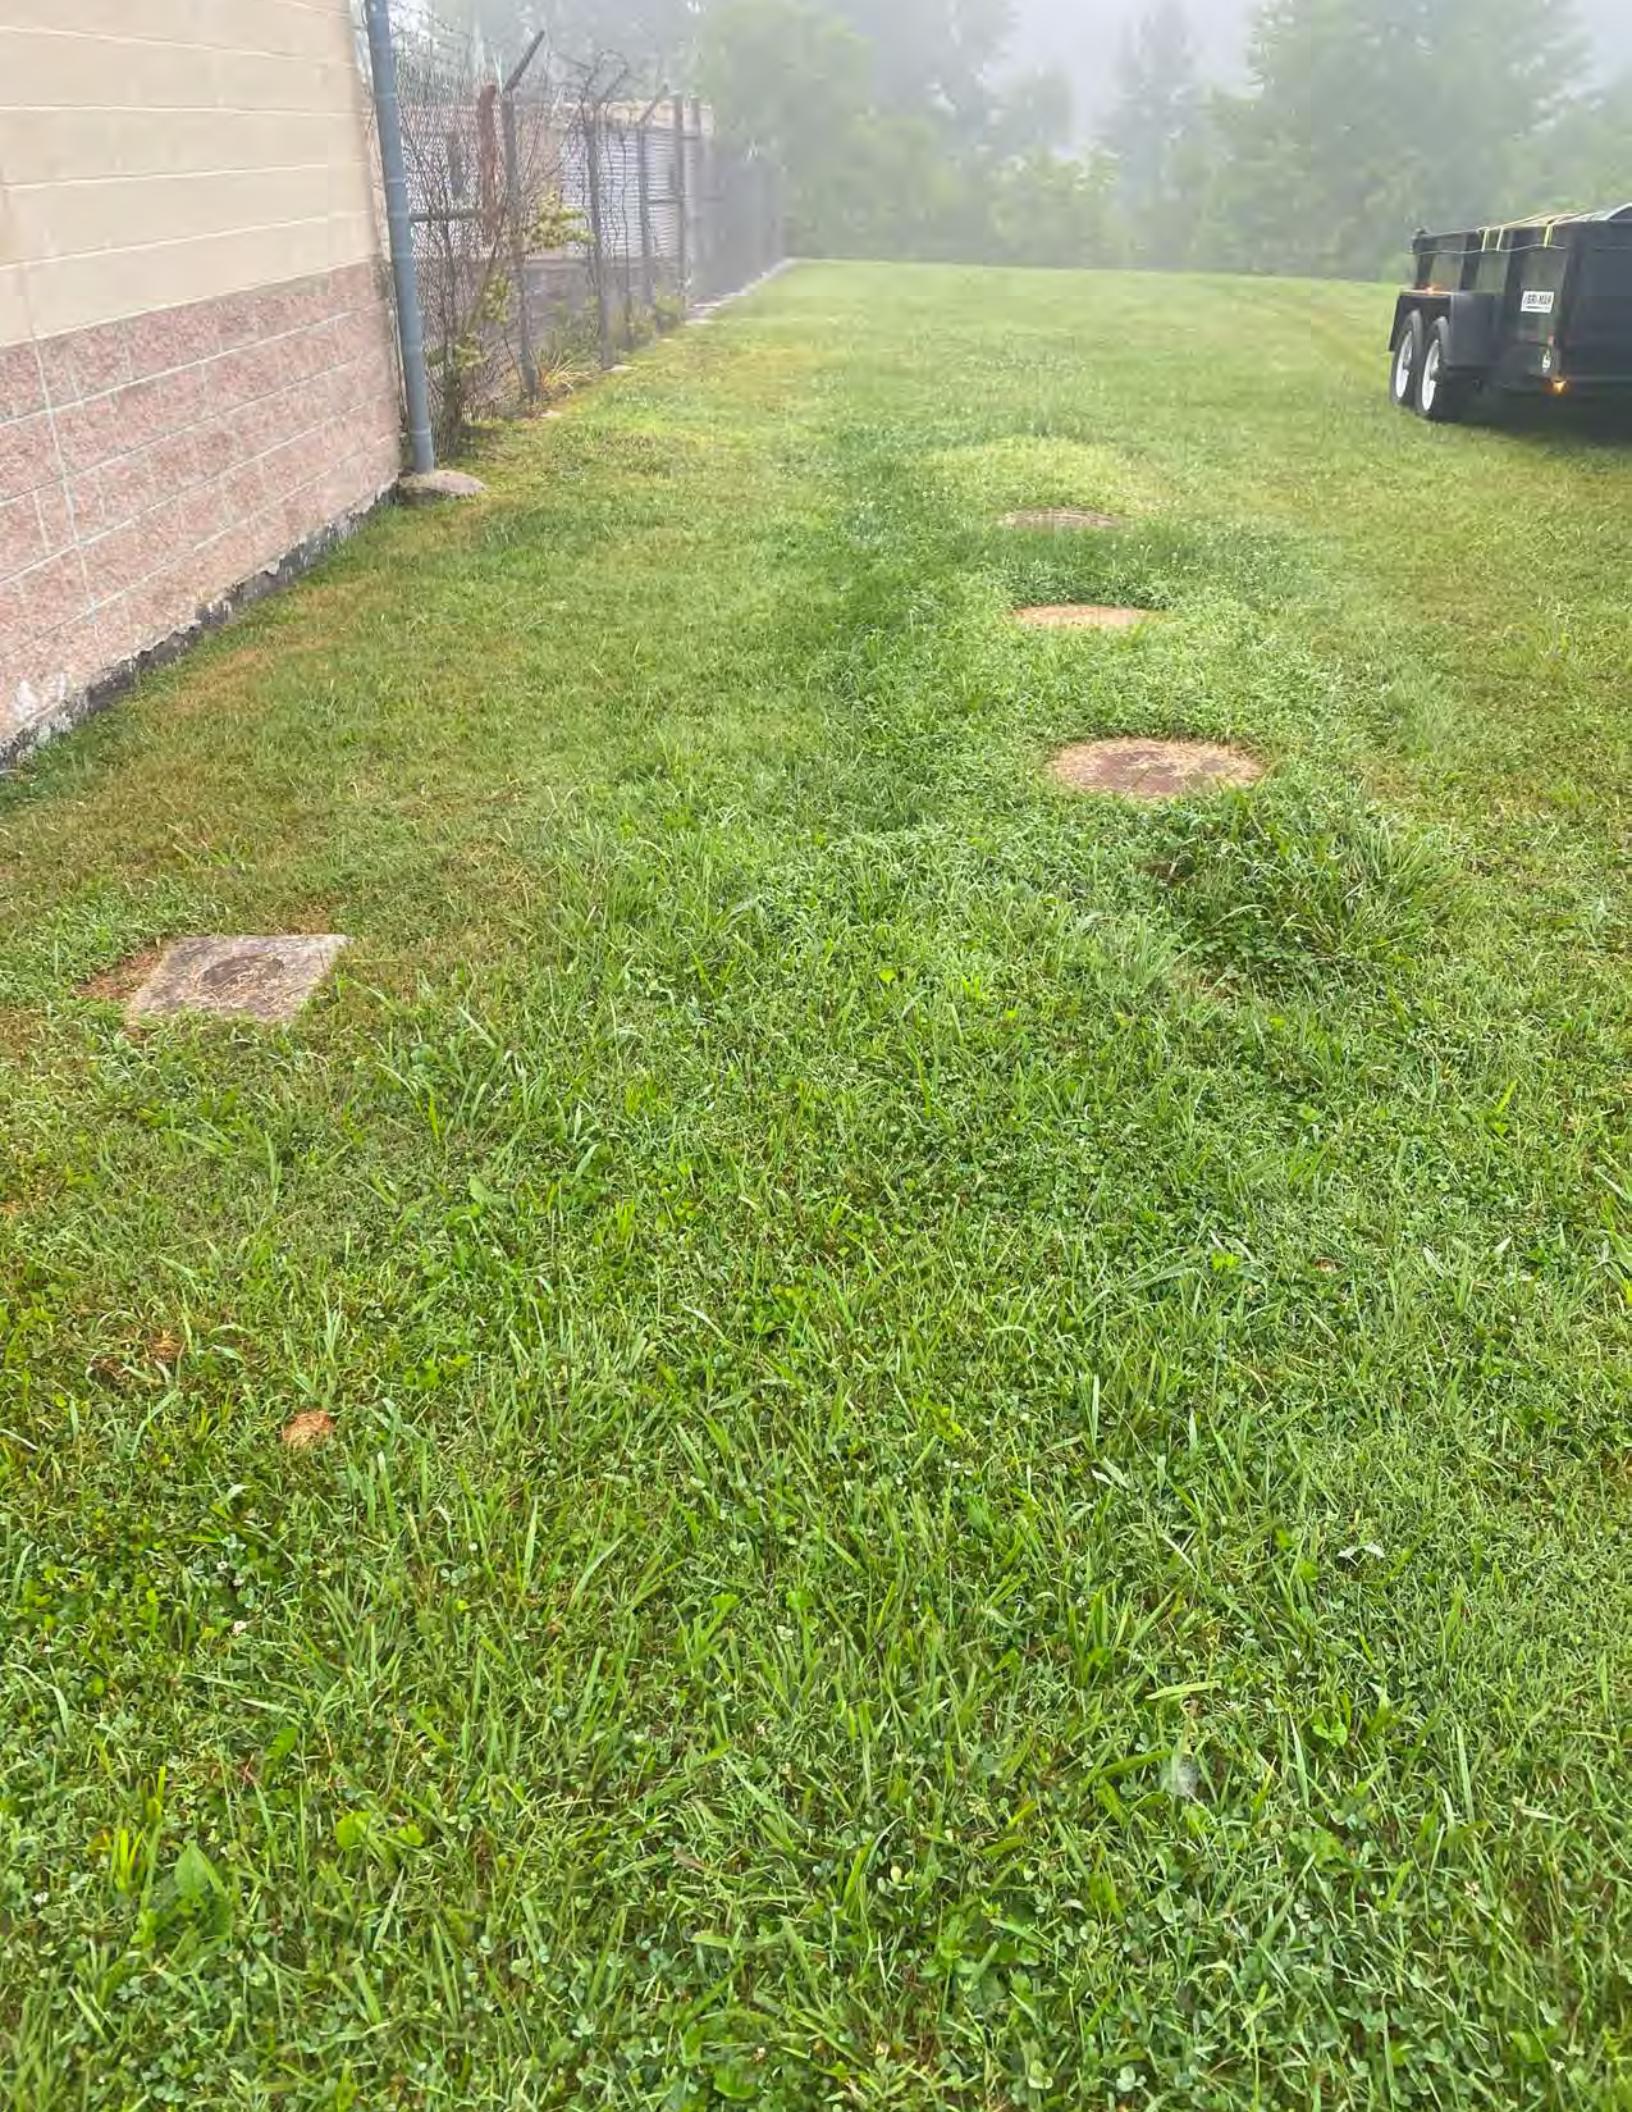
| 3 | OWS Area Prework |

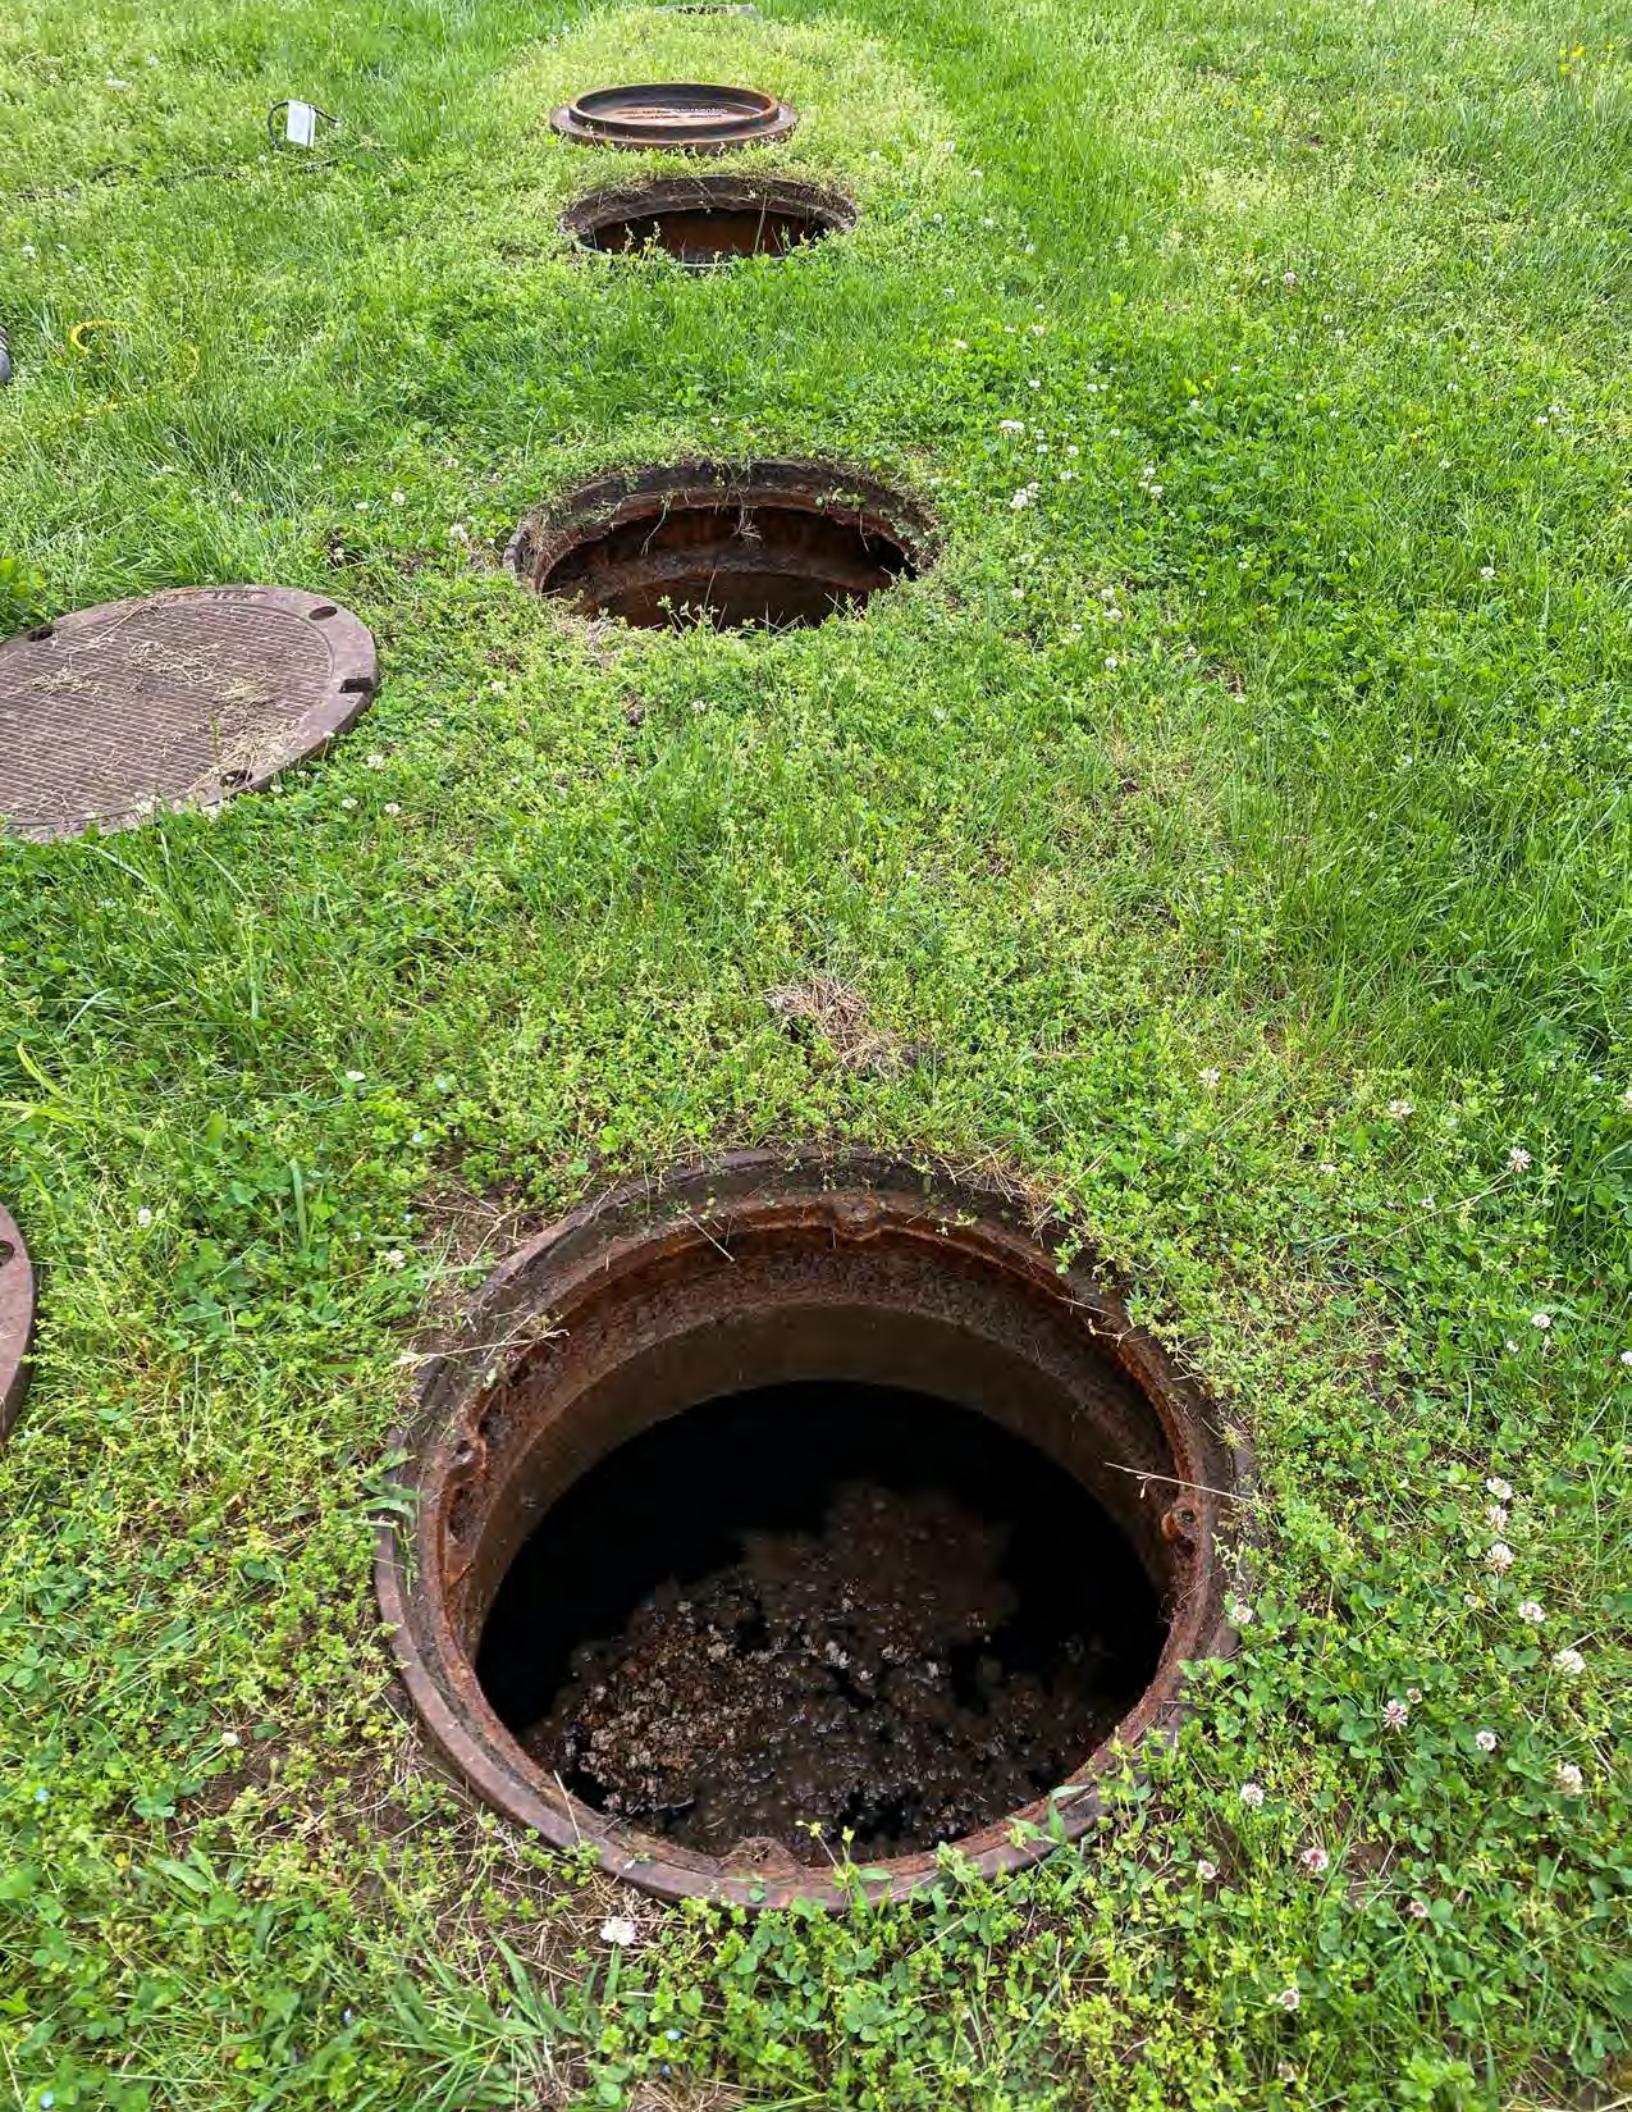
Site Service Performed: We mobilized to the facility on the afternoon of Wednesday, May 7, 2025. The three chambers of the system were accessed by the removal of three manhole covers, all were inspected and evaluated.

| 4 | OWS Covers Removed |

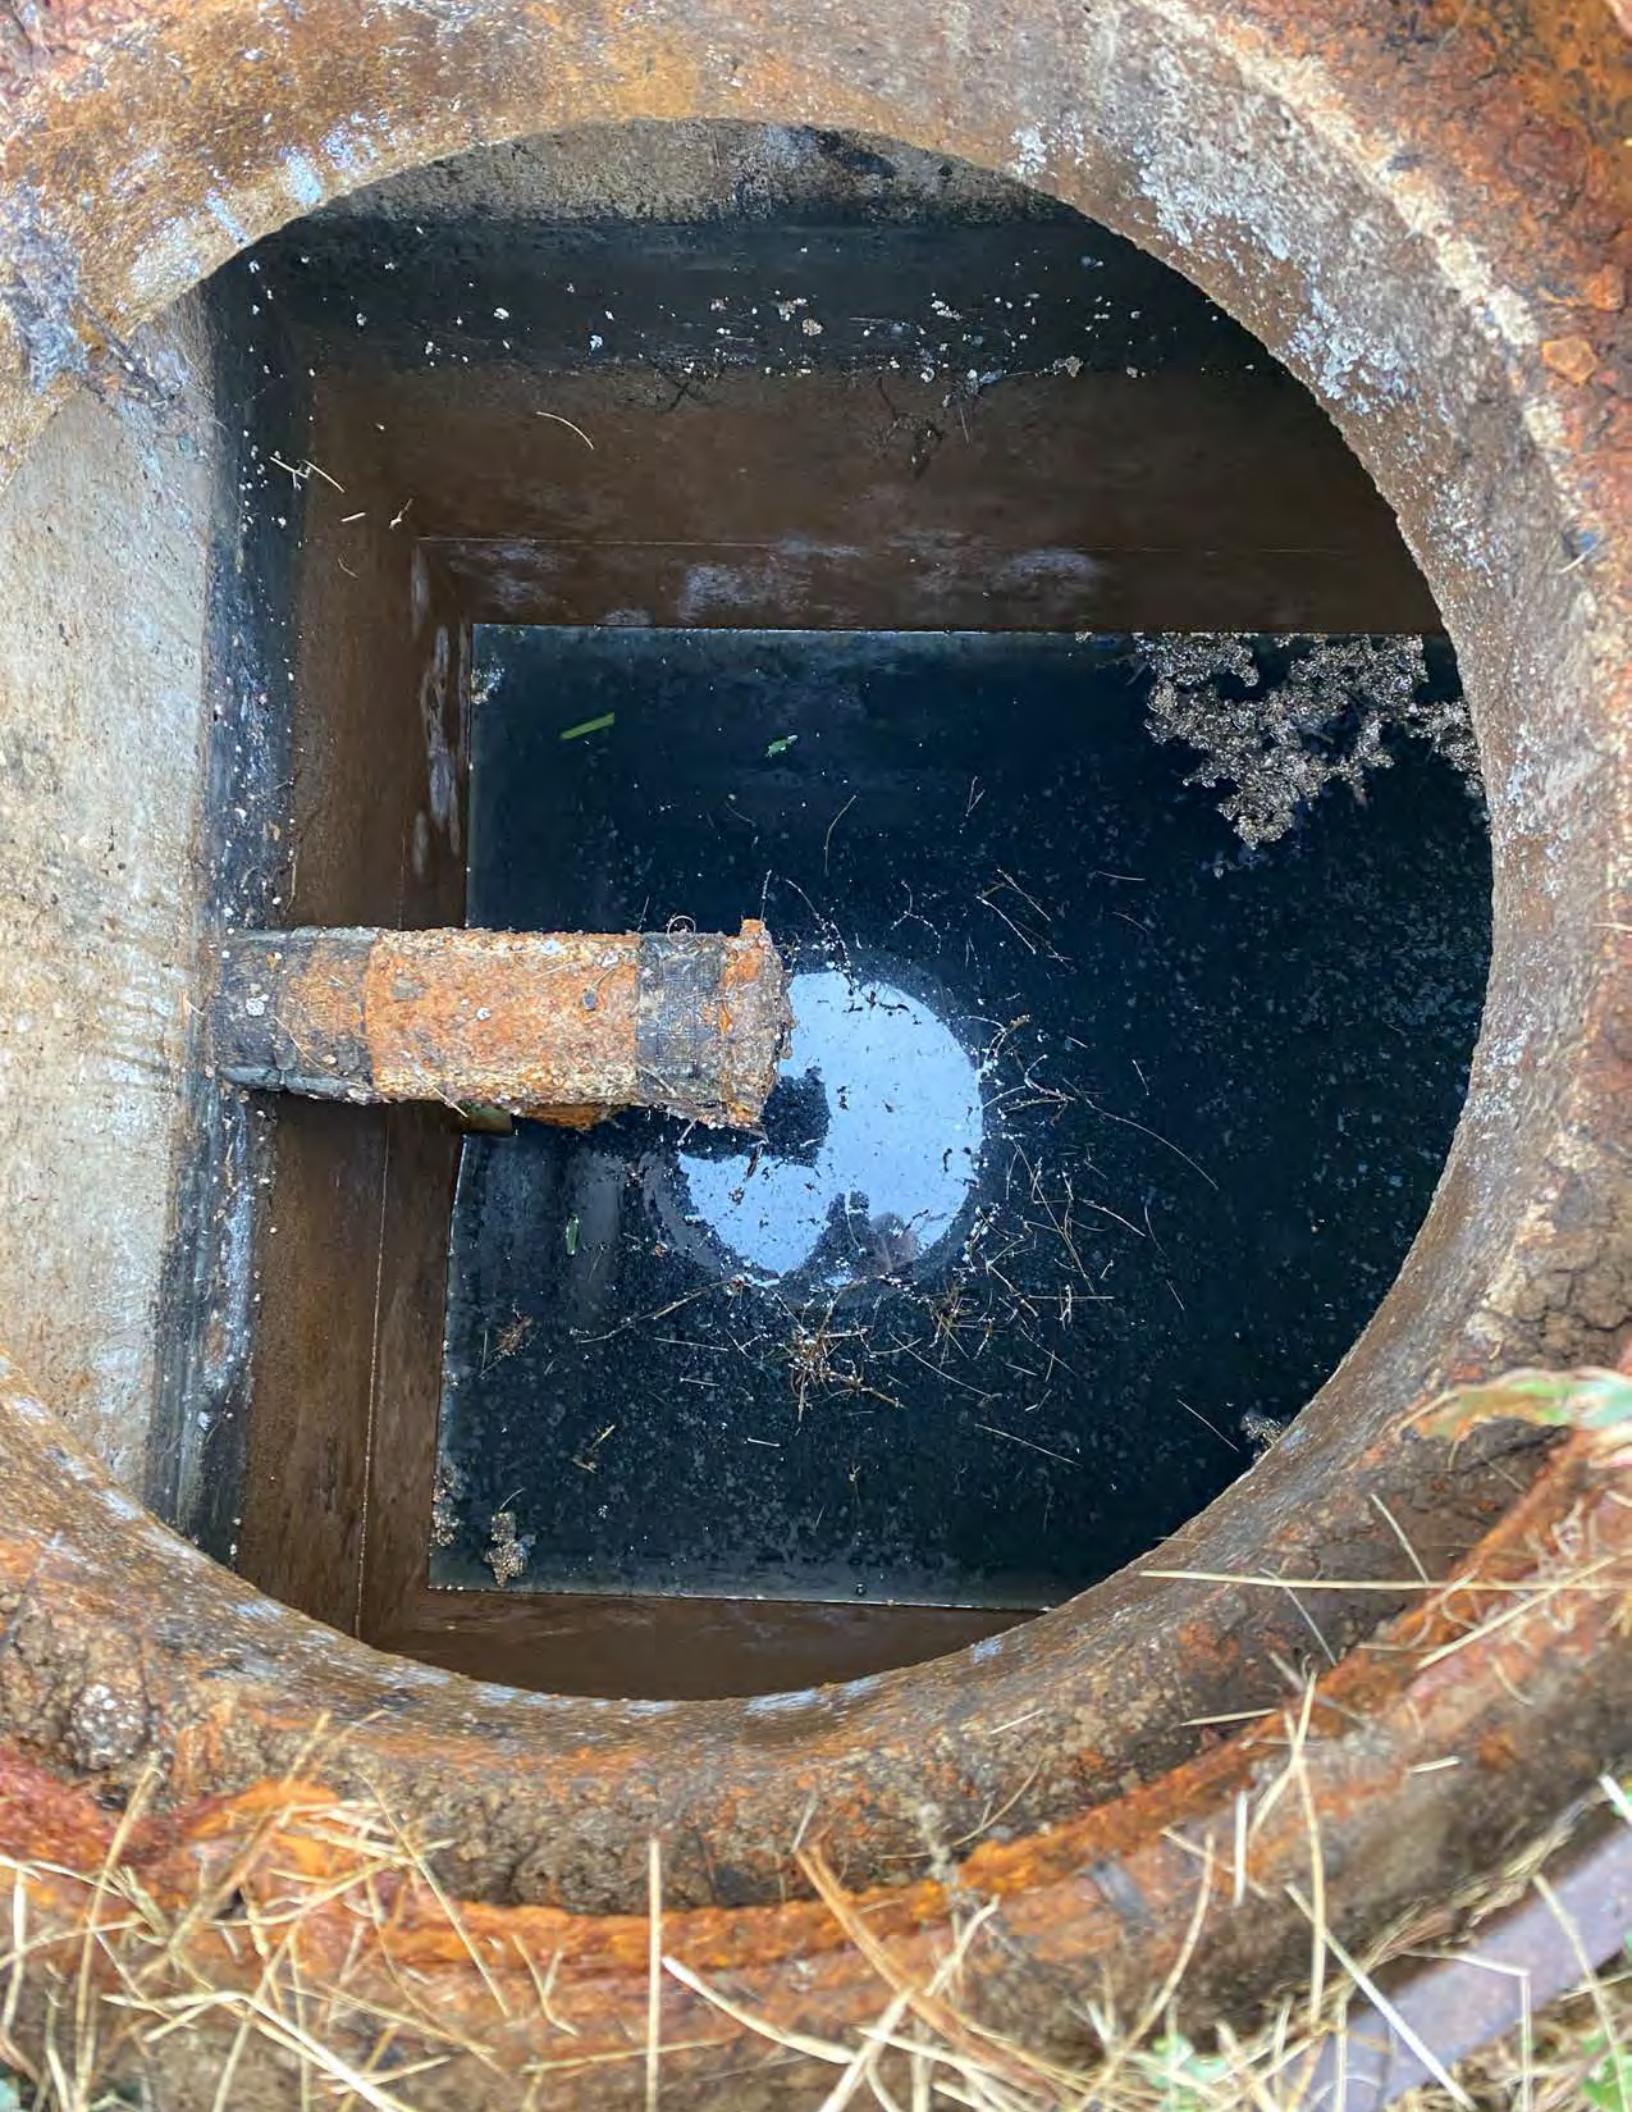
| 5 | Grit Interceptor Primary Chamber Prework |

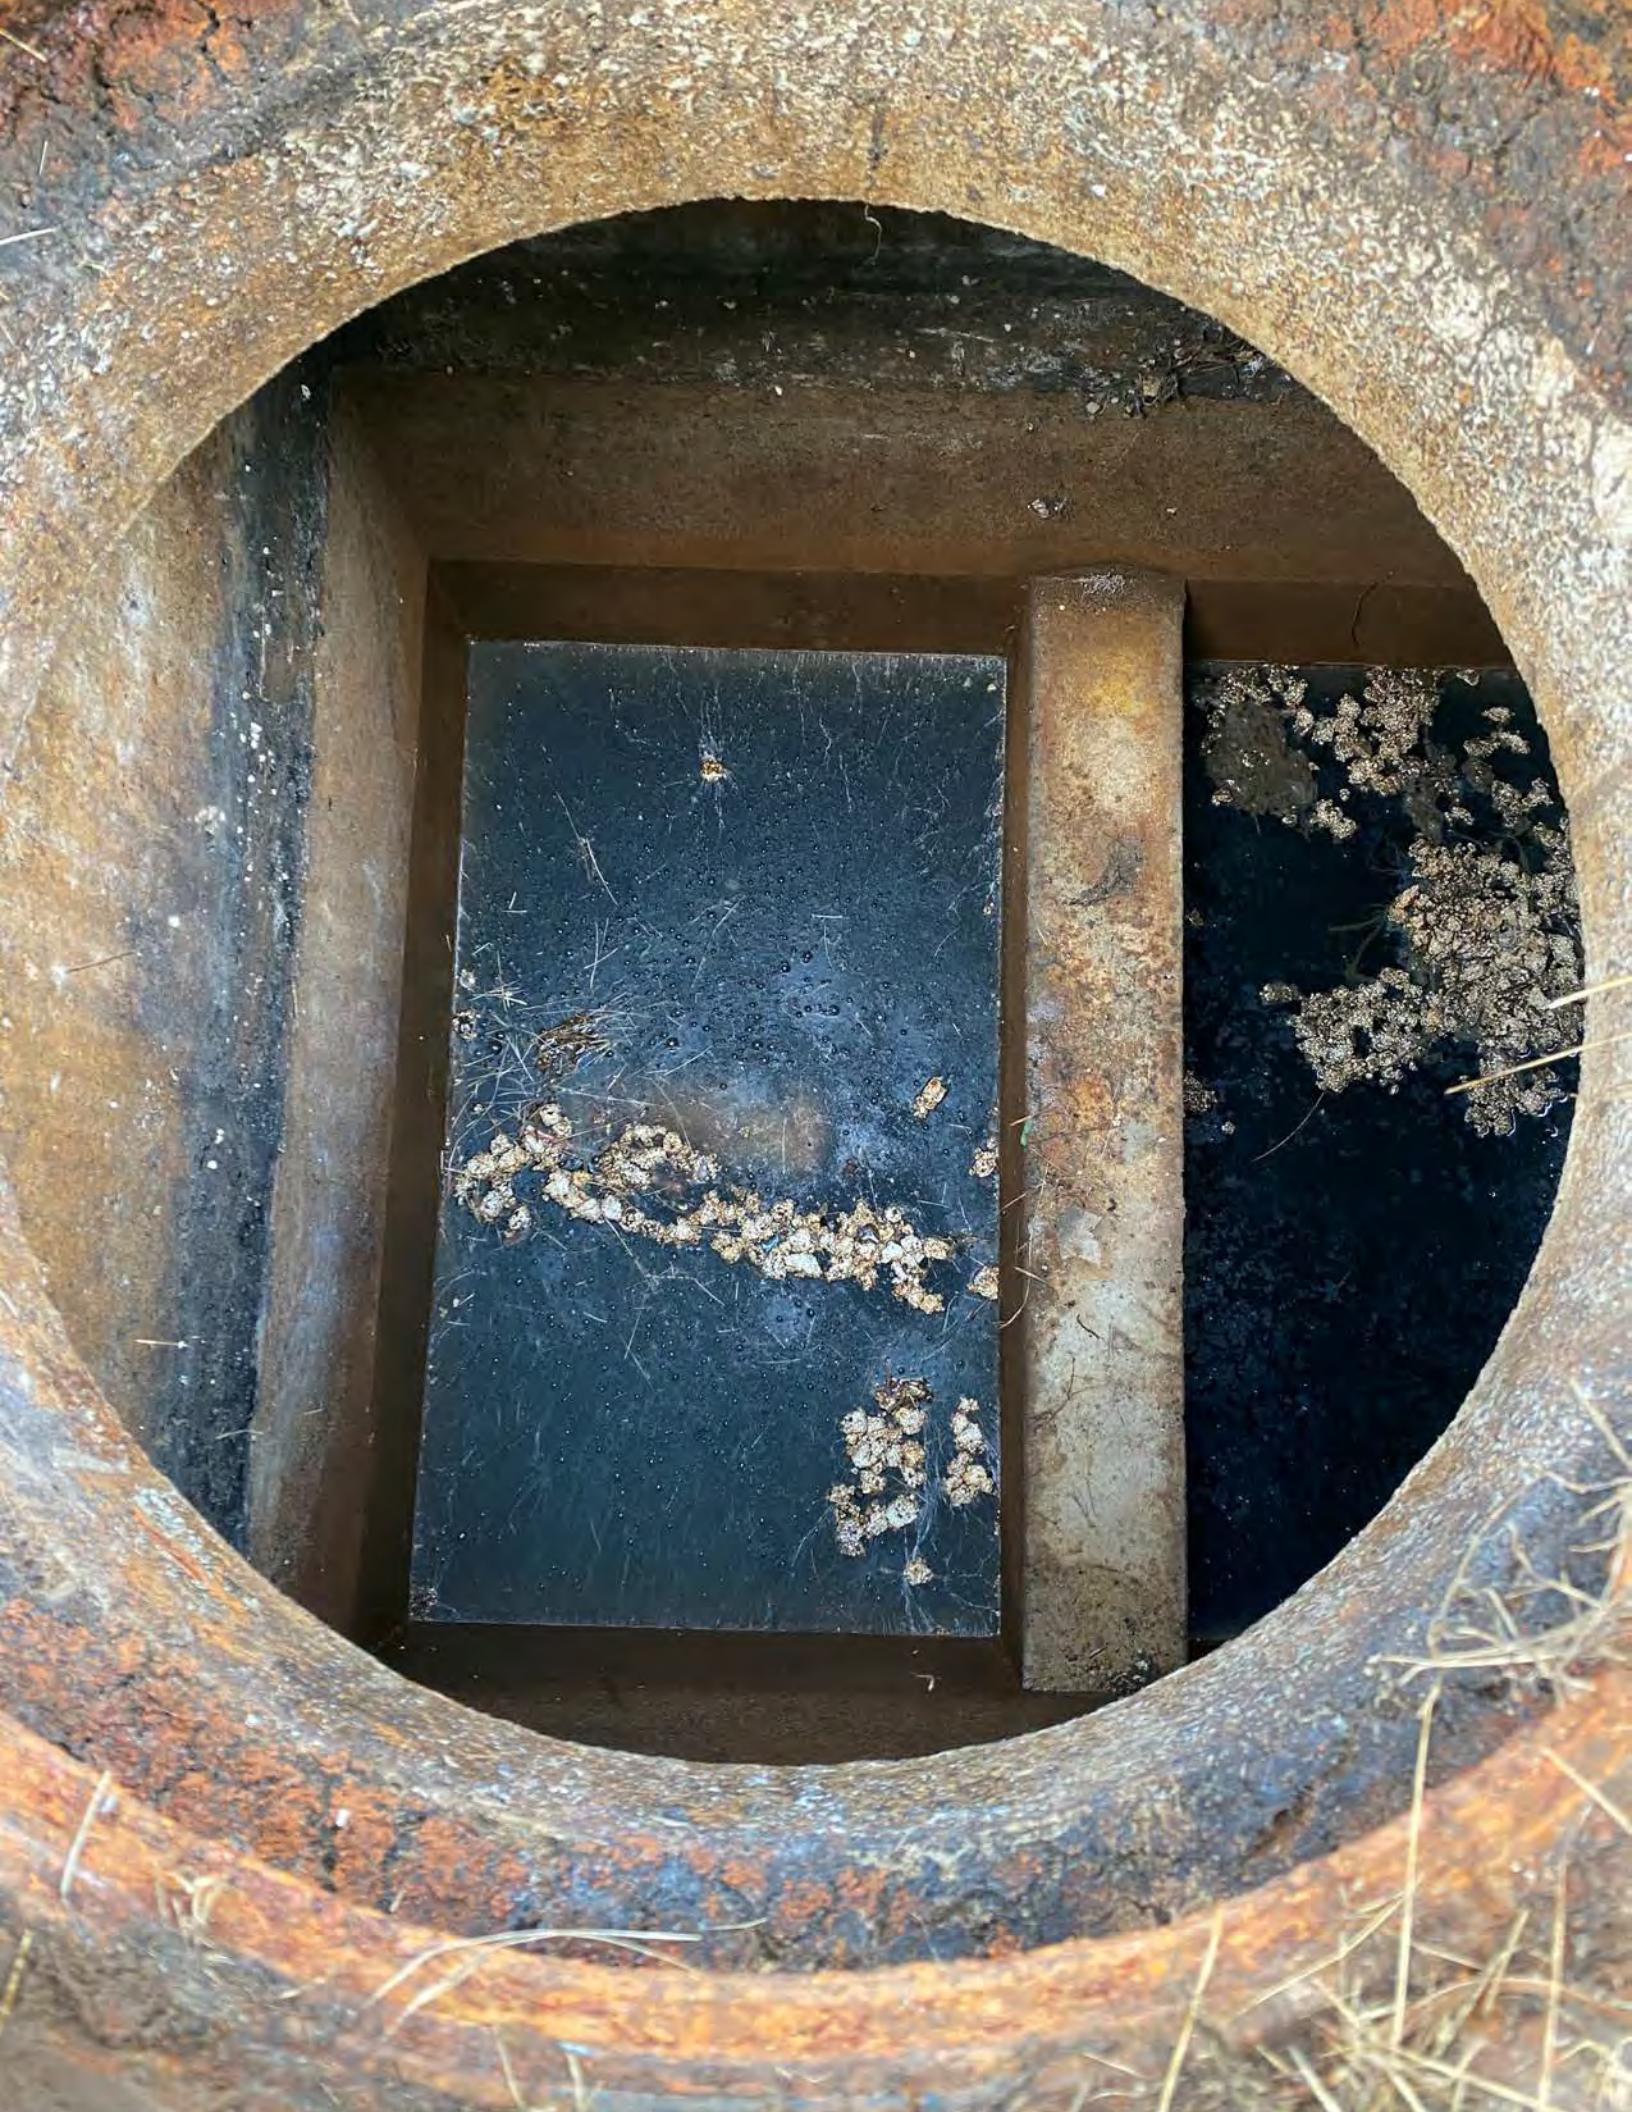
| 6 | Grit Interceptor Secondary Chamber Prework |

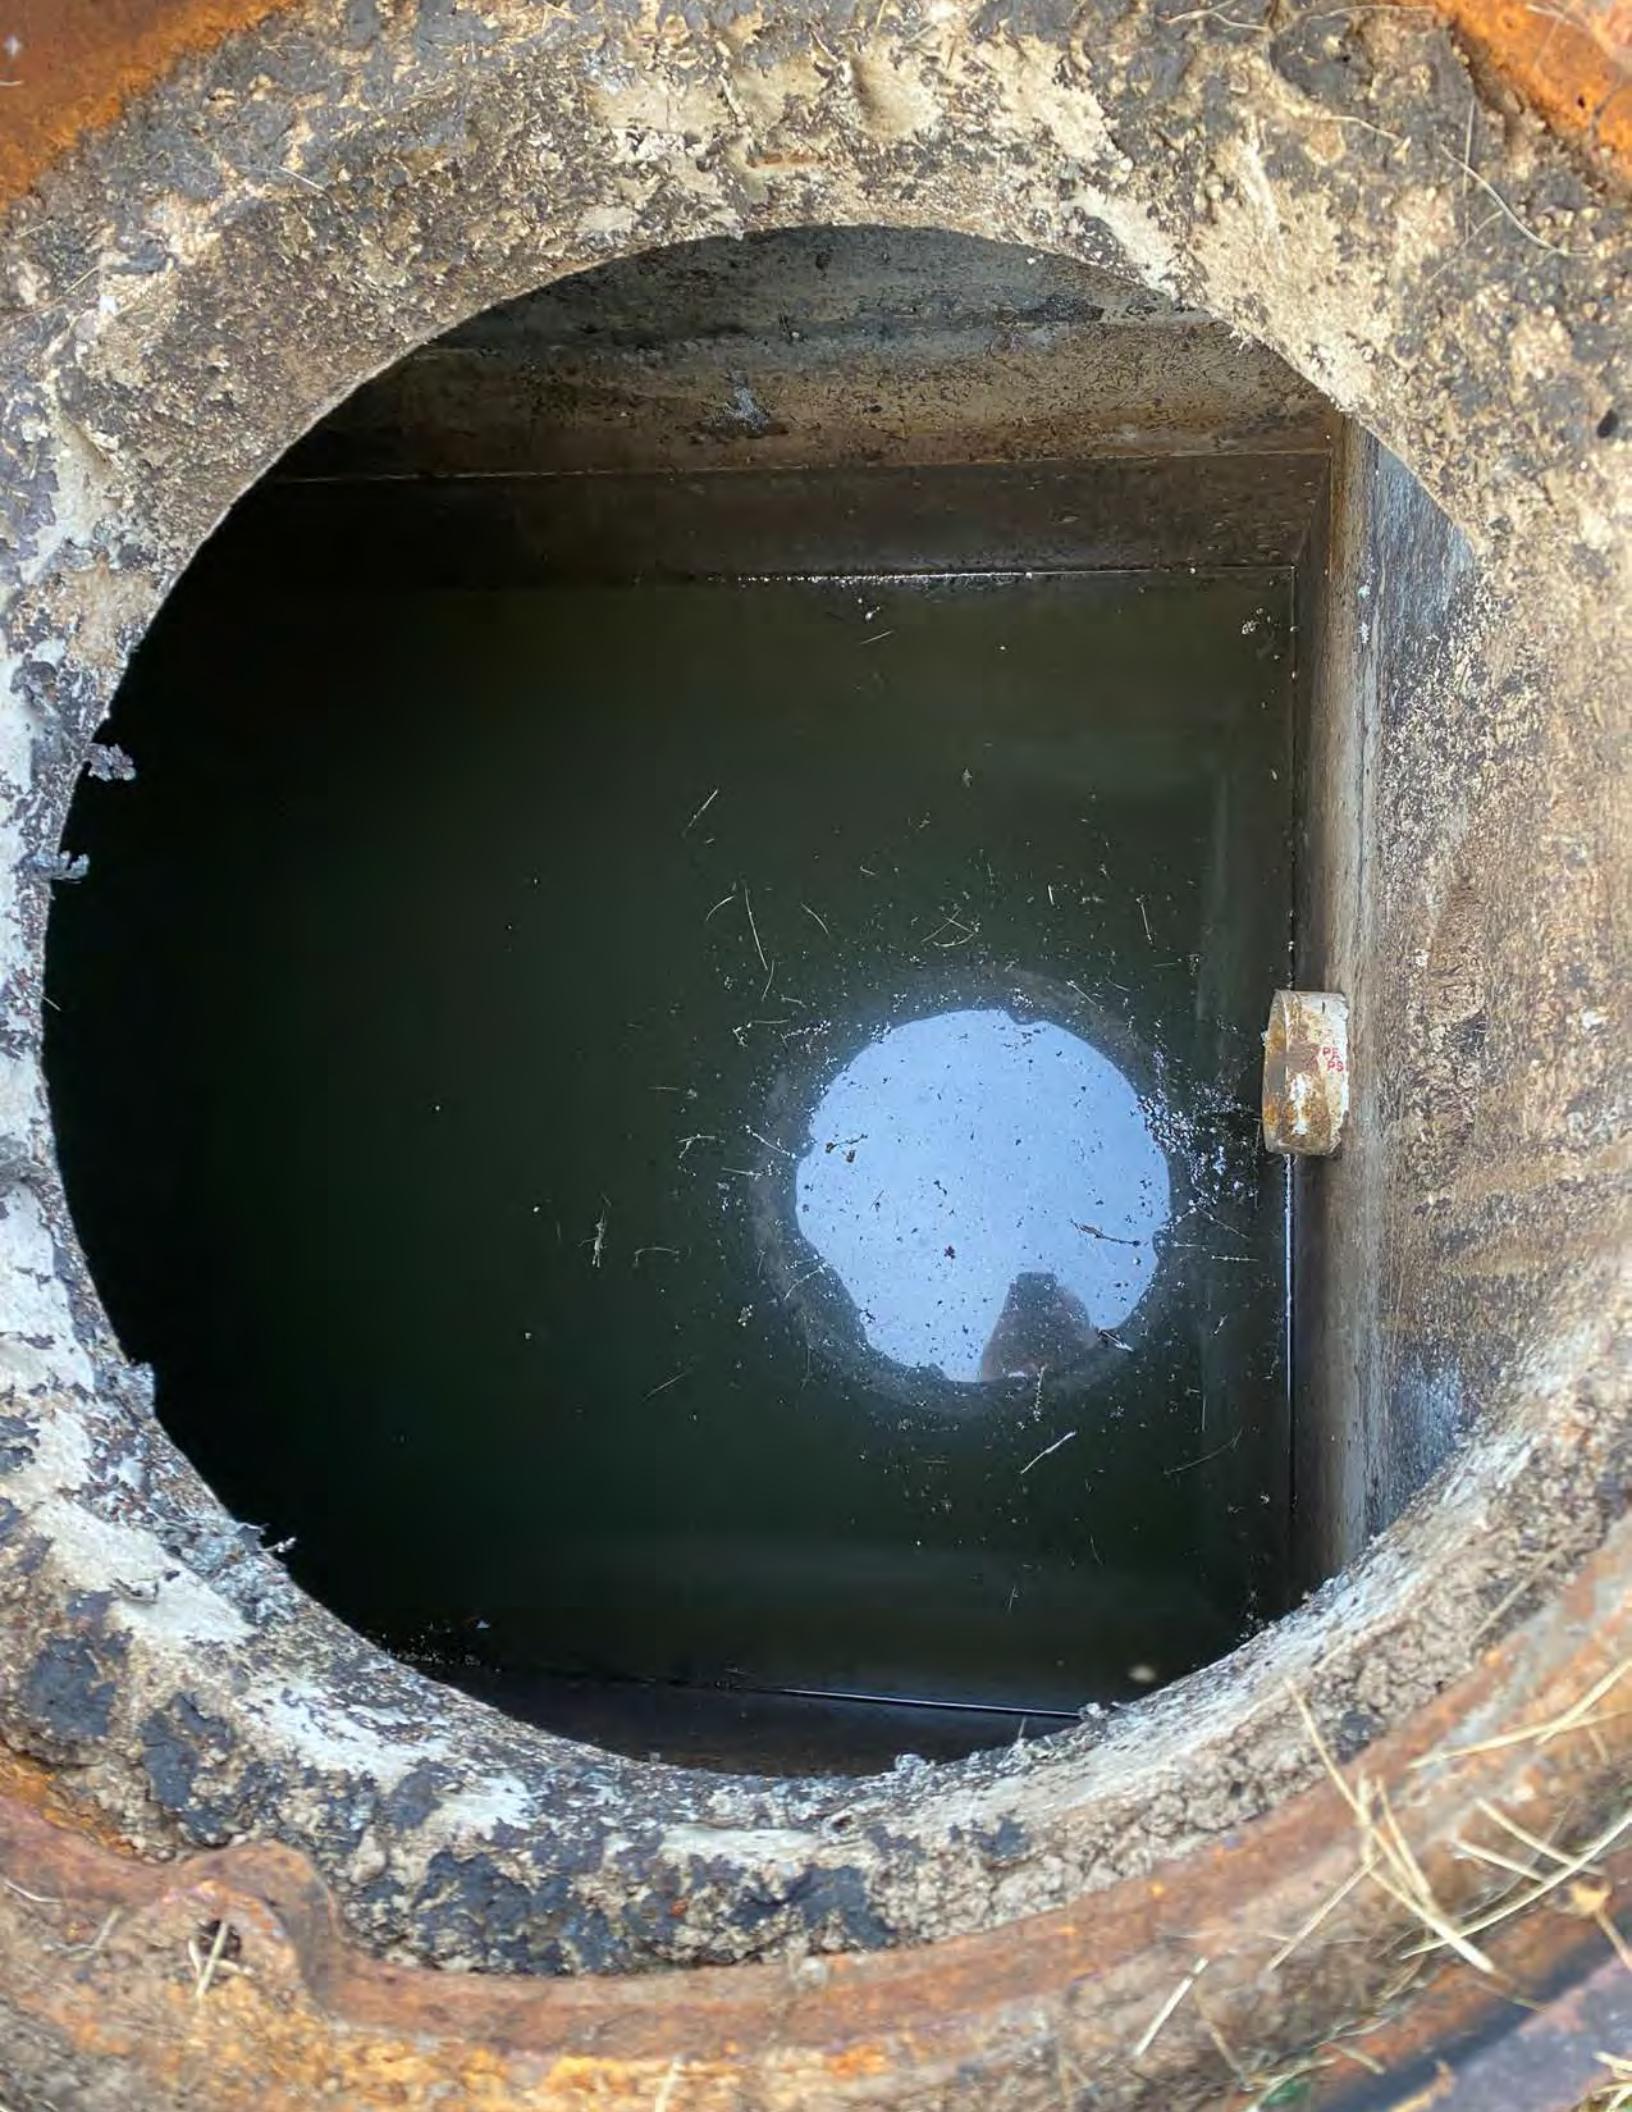
| 7 | Oil Water Separator (Tertiary) Chamber Prework |

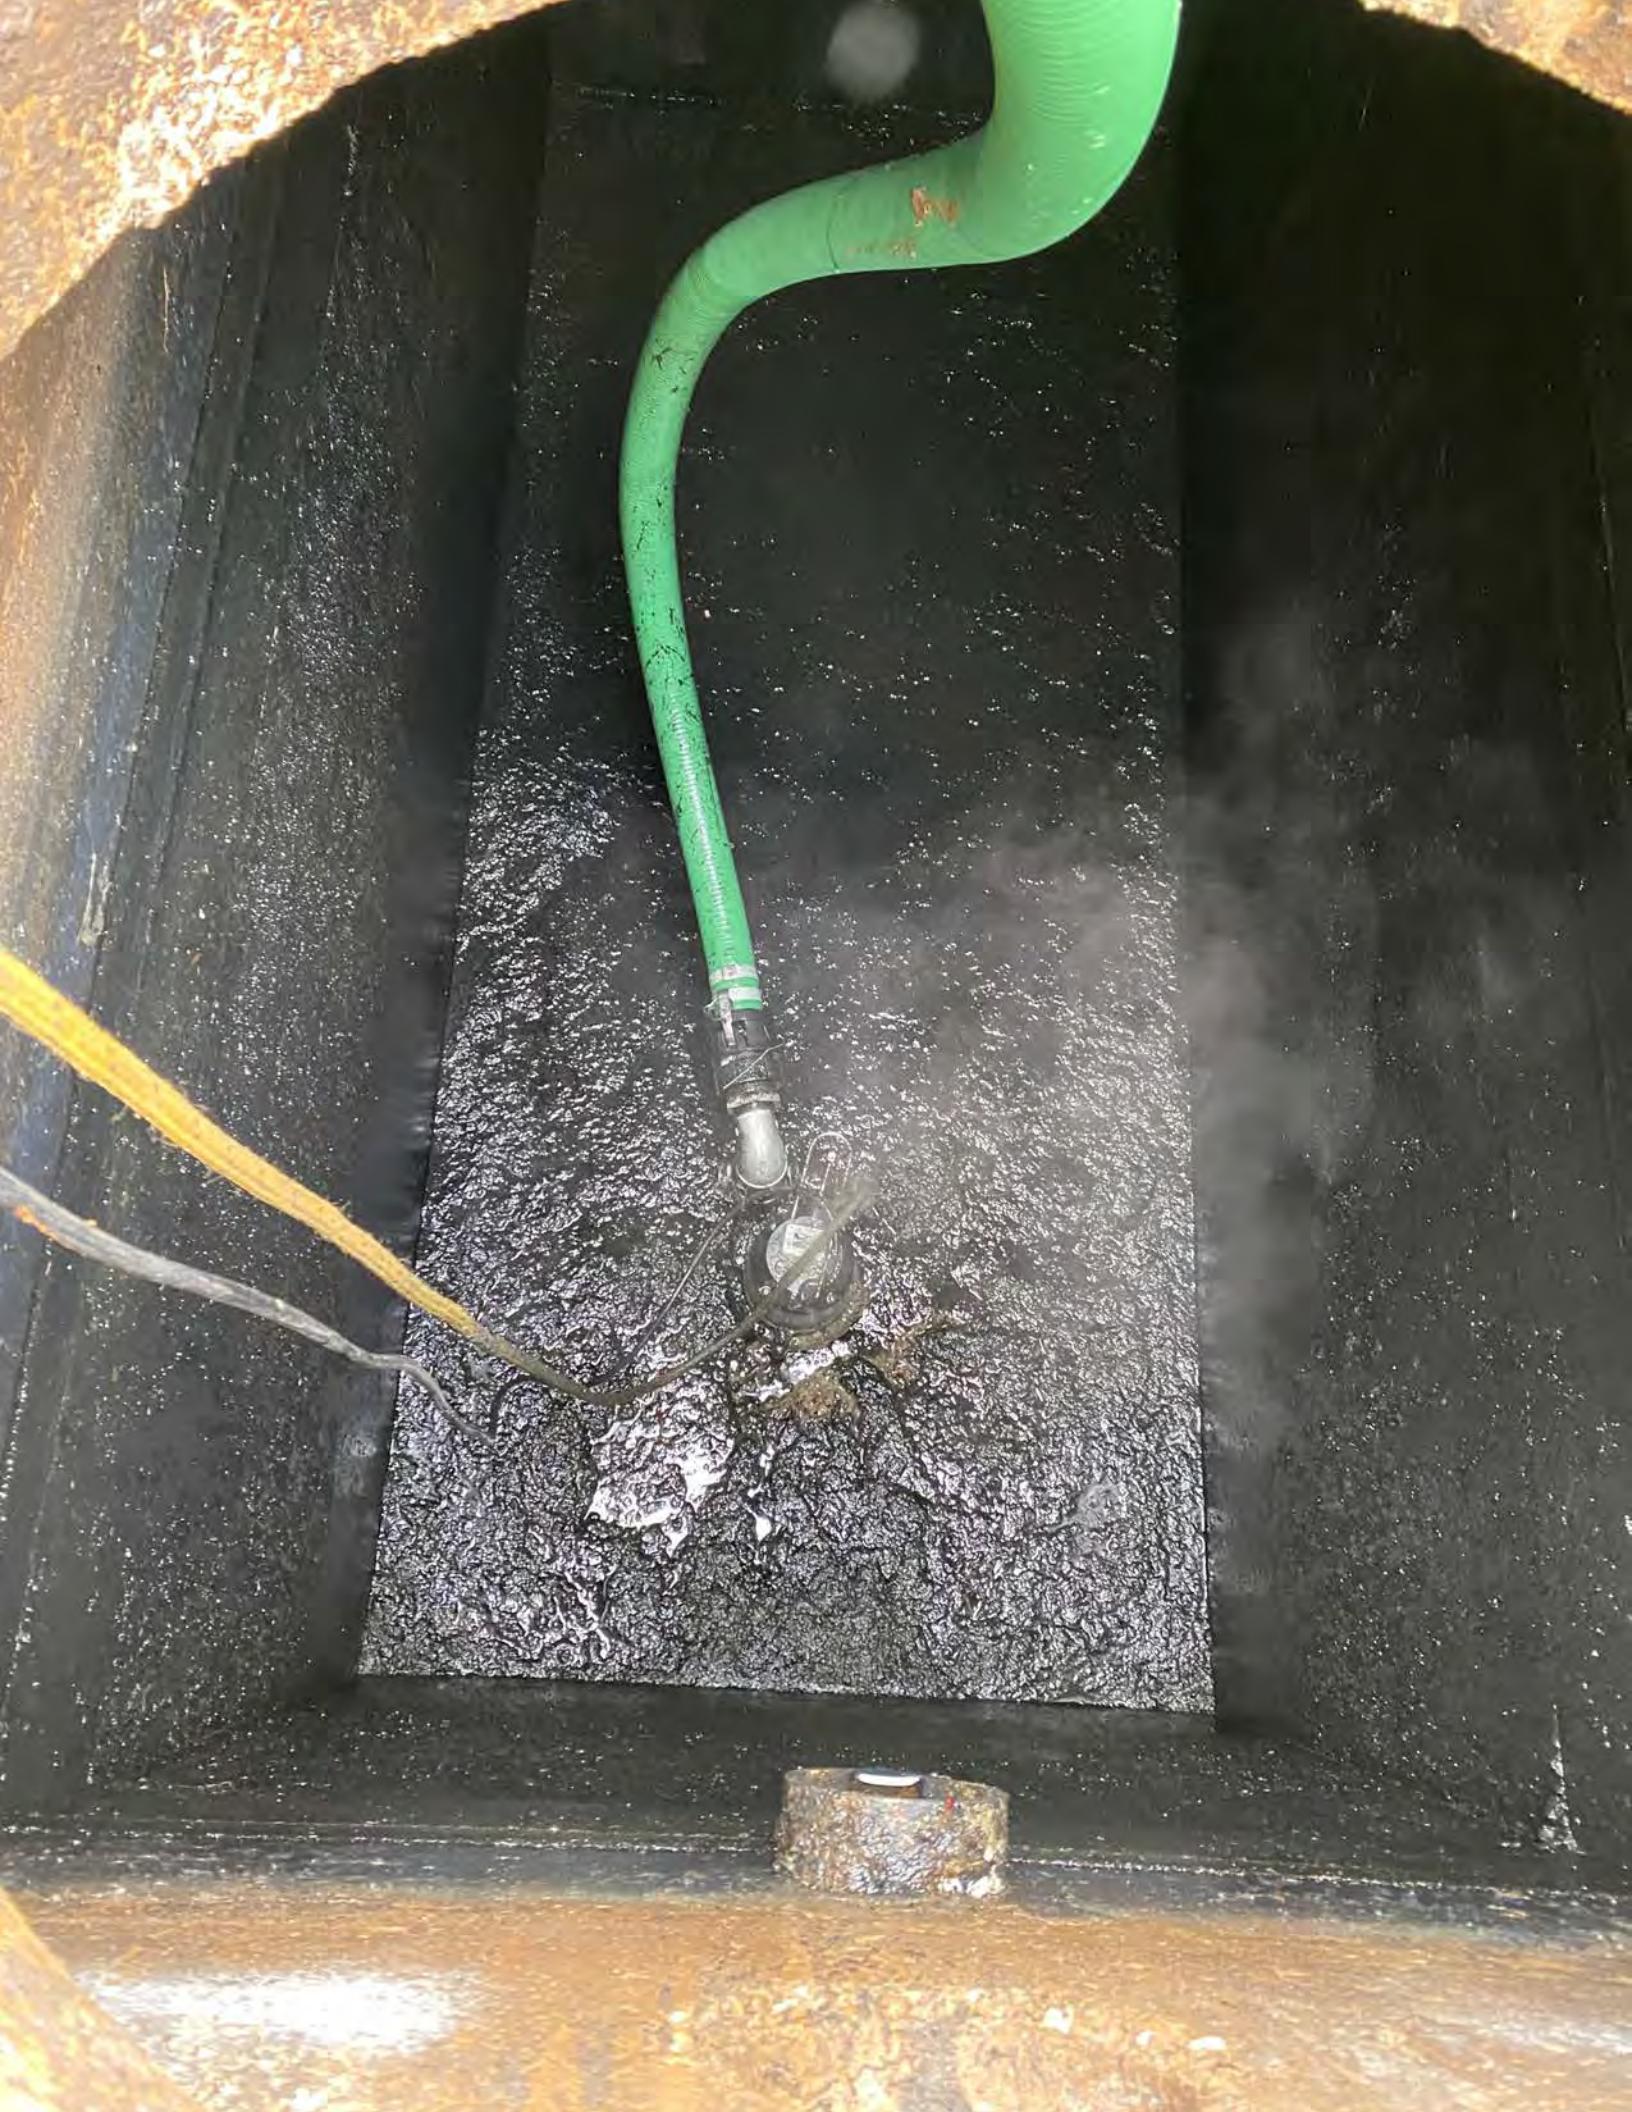
| 8 | Primary Chamber Dewatered |

We returned on Tuesday July, 8, 2025 to clean the GI and OWS. Surface oil was absorbed and removed from the GI. The water phase was processed through the unit and the bottom sludge was evacuated and containerized.
