Fratello & Amico, Inc.

**RE: WV020, Report of Oil Water Separator Cleaning and Preventative Maintenance Inspection, Jane Lew
USARC, 7605 US Route 19 North, Jane Lew, WV 26378**

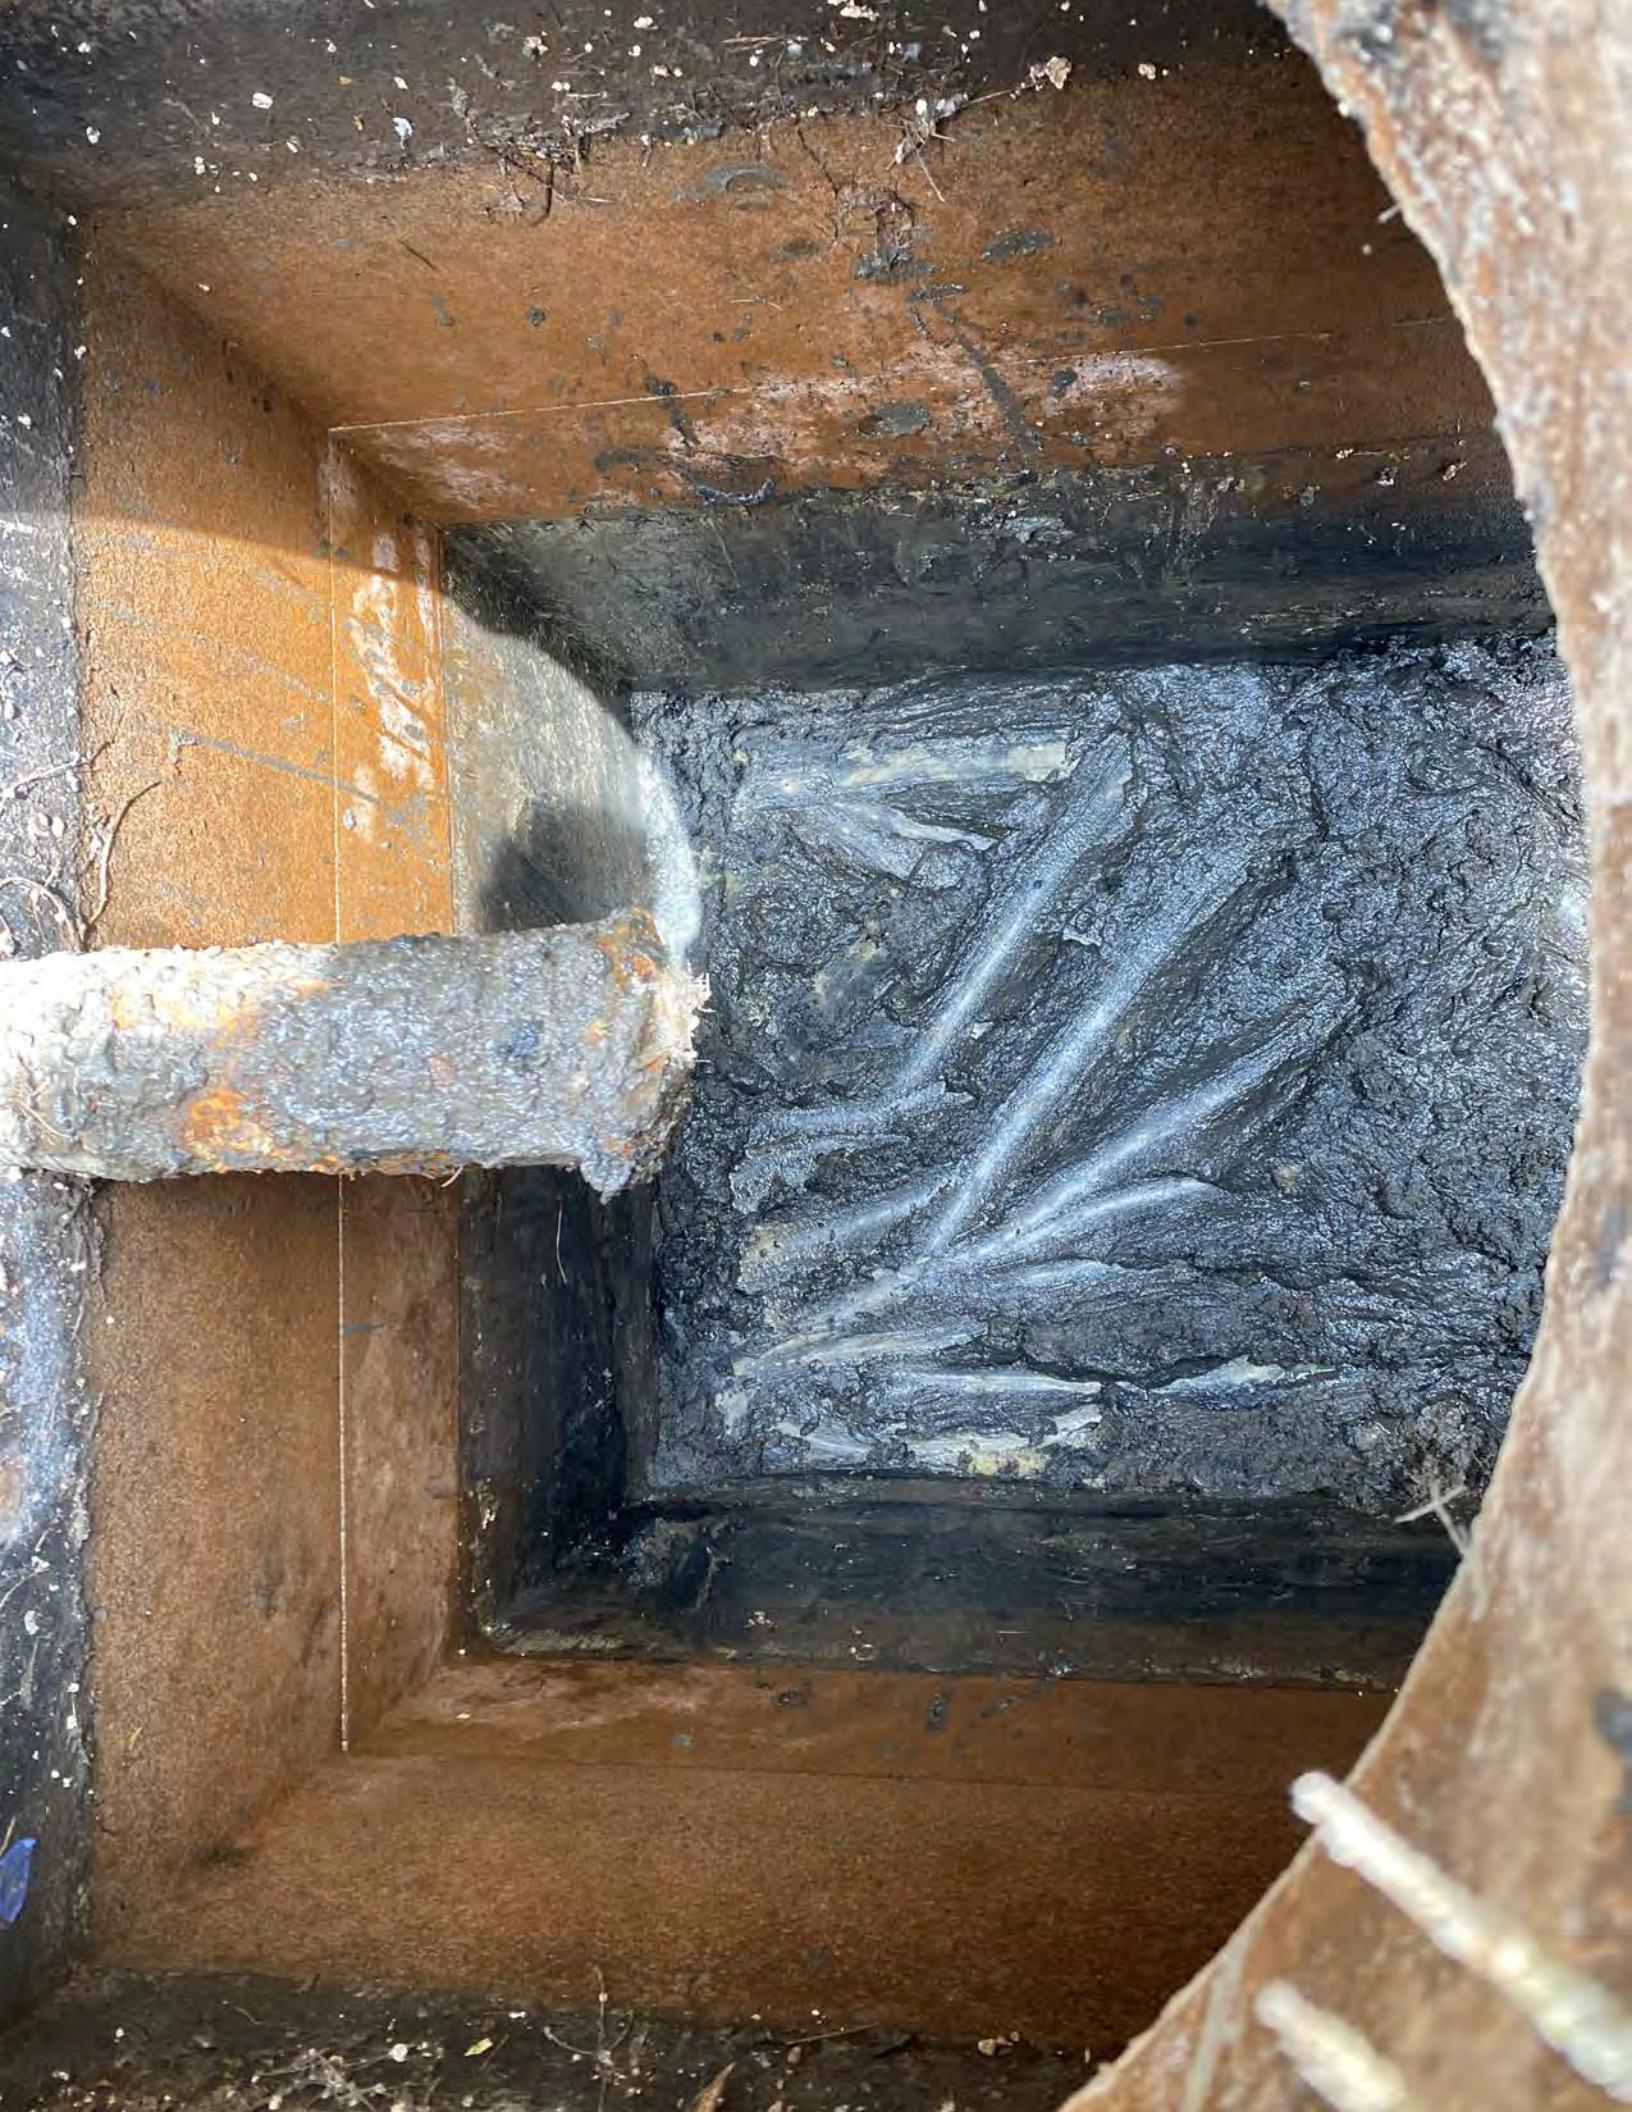
| 9 | Removing Bottom Sludge |

Next, we started on the OWS chamber and we pumped the water phase from the OWS side backwards into the GI chamber. The exposed bottom sludge was evacuated and containerized and then the OWS was refilled with fresh water. Three 55-gallon drums of OWS sludge were generated during the cleaning.
