## PREVENTATIVE MAINTENANCE PROGRAM CHECKLIST

### EXPANSION TANKS

SITE AND BLDG #: NY023-123

LOCATION/RM #: Boiler Room

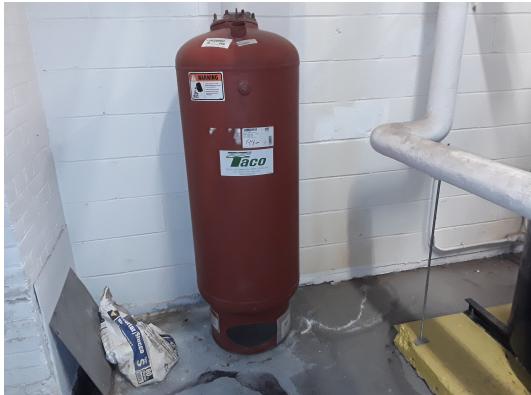
CM\* Asset # 190919-516 pressure is reading when the tank holds 125 psi, which is probably why the indoor AC-unit coil keeps splitting open, due to pressure build-up in the system.

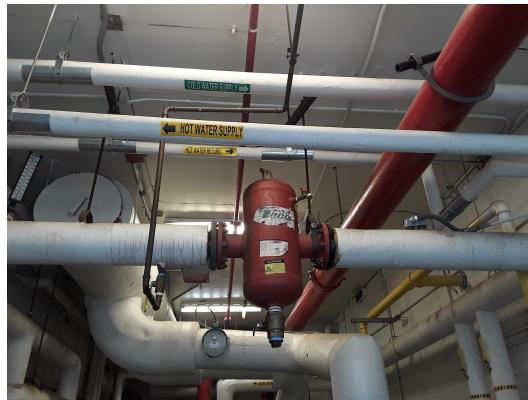
CM\* Asset # 190917-518 air vent is leaking water.
