Over and Above Estimate

CSS # 91038

Maximo Work Order No. 20216 **Asset#:**

Original Description: Fix boiler alarm 128

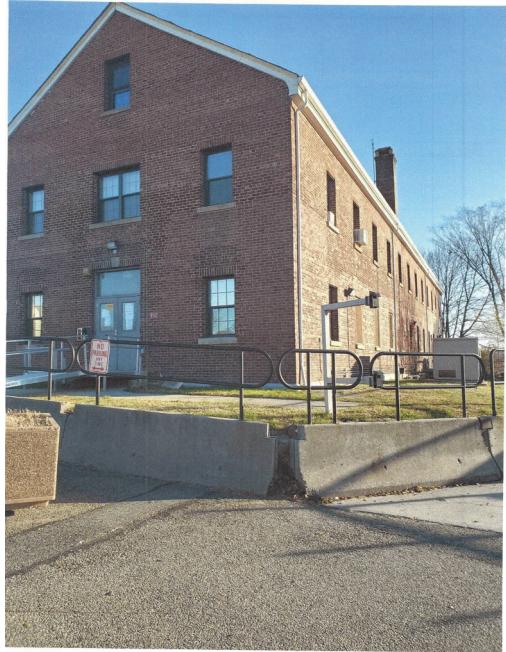
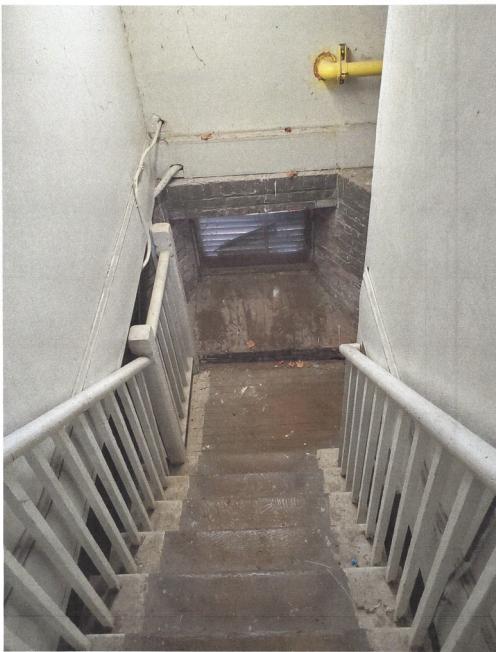
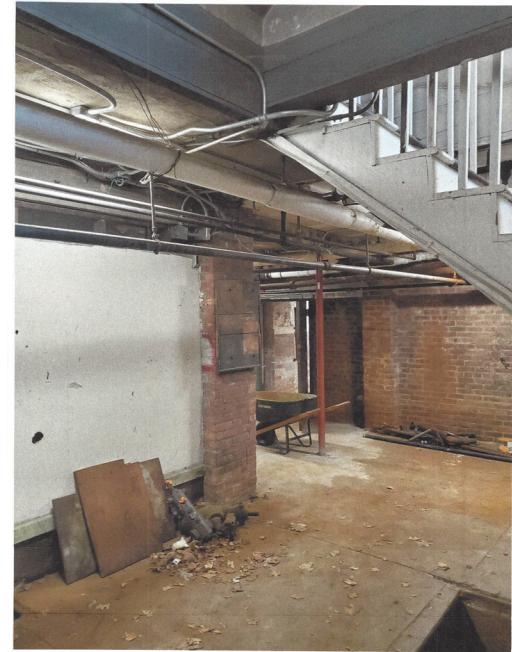
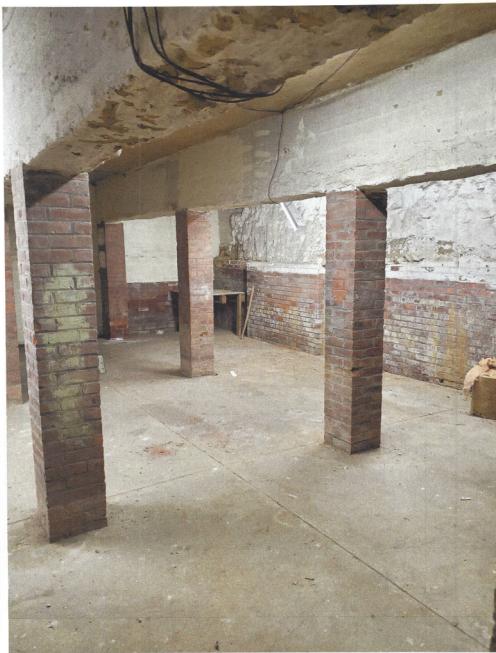
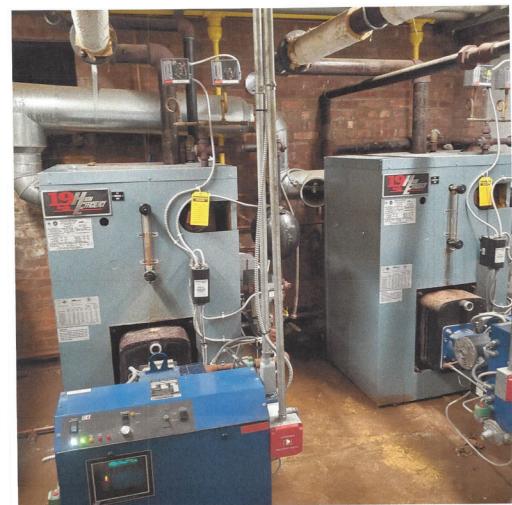
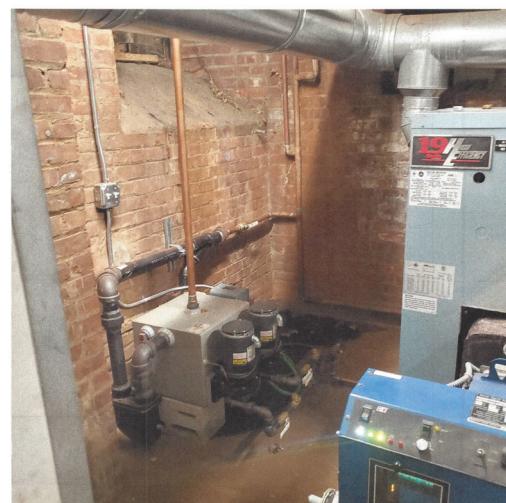
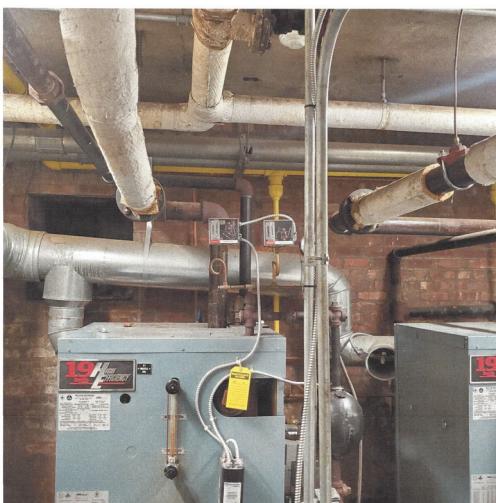
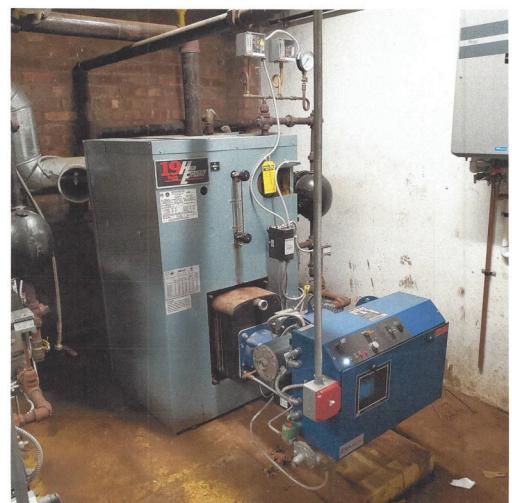
Description of Repairs: Boiler 1 is in alarm and not working. A complete diagnostic has been conducted on the entire boiler system. The poor pilot light ultraviolet scanner needs to clean and adjusted, the cad cell scanner and electrodes need to be cleaned, and replace Honeywell scanner C7027A.

| Qty. | Item# | Description | Unit Price | Line Total |
|---|---|--|---|---|
| | | <p>NY23 (BLDG 128)</p> <p>BOILER #1 IN ALARM AND NOT WORKING</p> <p>A COMPLETE DIAGNOSTIC HAS BEEN CONDUCTED OF THE ENTIRE BOILER SYSTEM OPERATION</p> <p>POOR PILOT LIGHT ULTRA VIOLET SCANNER NEEDS TO BE CLEANED AND ADJUSTED</p> <p>CAD CELL SCANNER AND ELECTRODES NEEDS TO BE CLEANED</p> <p>REPLACE THE HONEYWELL SCANNER #C7027A</p> | | |
