# Microbial Clearance Report

Amherst United States Army Reserve Center  
Basement Class Rooms 21, 22 & 23  
100 North Forest Road  
Amherst, NY 14221

**Project ID:** 24-0909MN-A

**Re: Mold Clearance Report**  
**Amherst United States Army Reserve Center**  
**Basement Class Rooms 21, 22, 23**  
**100 North Forest Road, Amherst, NY 14221**  
**AMD Project ID: 24-0909MN-A**

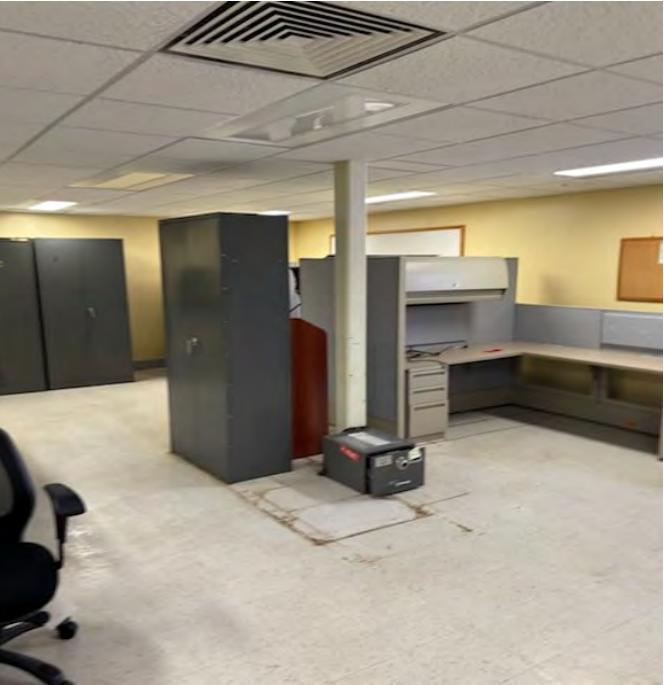
<p><b>Observation:</b></p> <p>Overall existing conditions of the interior mold remediation locations as of 01/21/2025.</p>

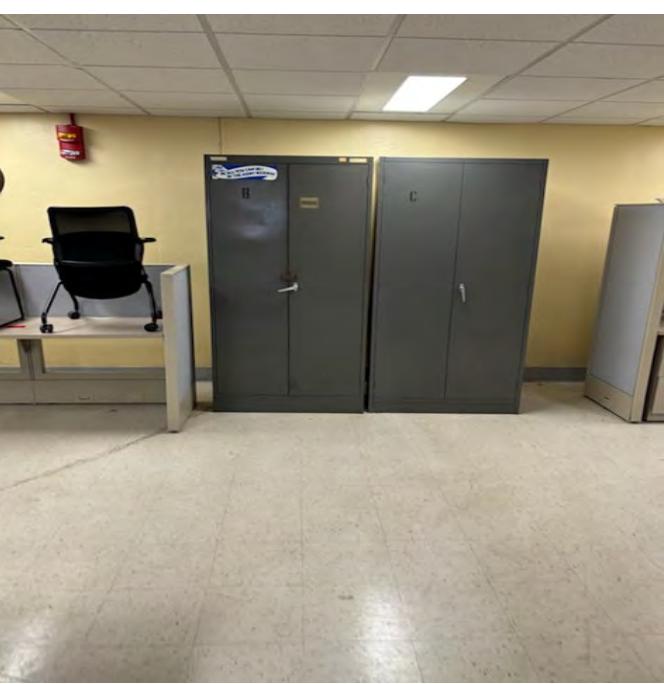
<p><b>Observation:</b></p> <p>Overall existing conditions of the interior mold remediation locations as of 01/21/2025.</p>

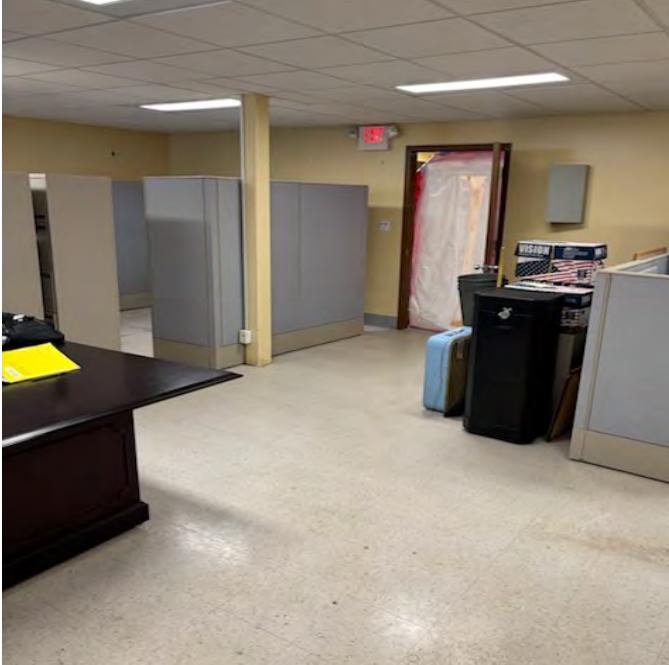
<p><b>Observation:</b></p> <p>Overall existing conditions of the interior mold remediation locations as of 01/21/2025.</p>

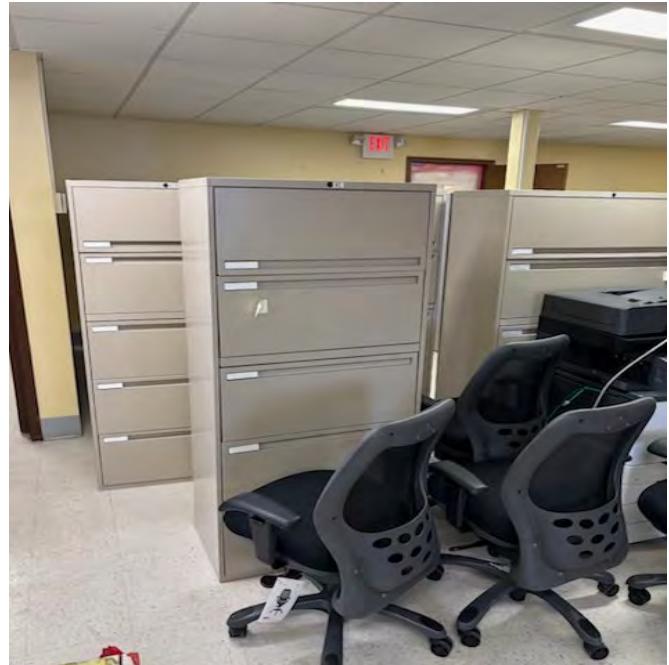
<p><b>Observation:</b></p> <p>Overall existing conditions of the interior mold remediation locations as of 01/21/2025.</p>

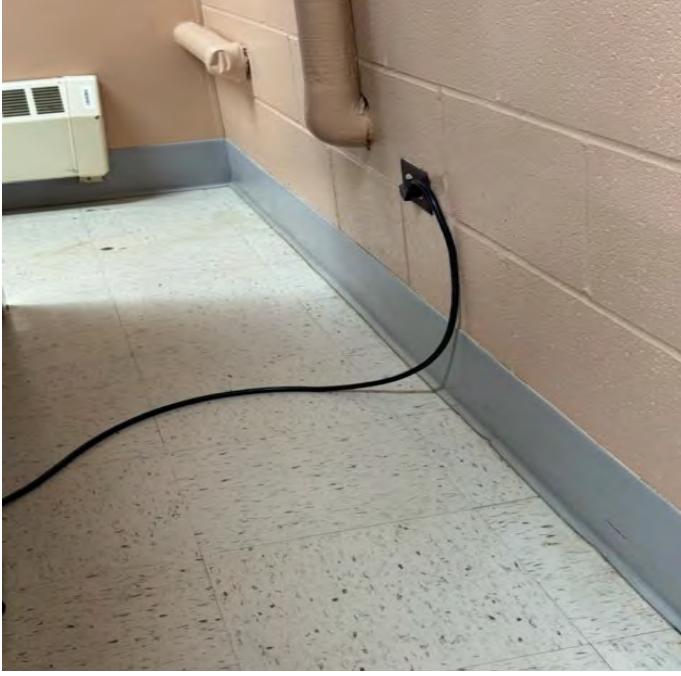
<p><b>Observation:</b></p> <p>Overall existing conditions of the interior mold remediation locations as of 01/21/2025.</p>
