NY067 BLDG1

90129

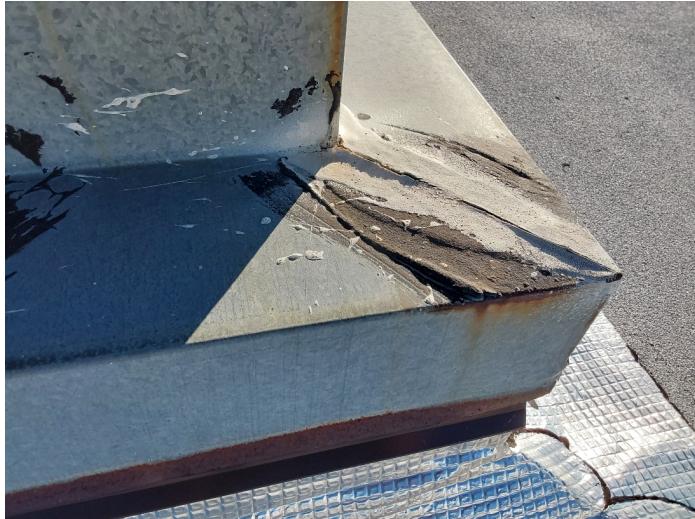
I removed the ceiling tile and found drip lines that led me to the roof , on the roof i found the tar on the seams of the vent stack housing was cracked and exposing the seams i removed the old tar and resealed the seams, then i went back inside and replaced the stained ceiling tile
