CERTIFICATION OF WORK SERVICE CALL

FACID/Building: NY070 Date of Visit: 7/29/24 & 7/30/24

Customer US ARMY WEBSTER RESERVE CENTER (86804)

Description Q SCOPE/INVESTIGATE ONLY ~NO REPAIRS. ROOM 131 UH 3&4, ERV1, ERV2, ERV3 PER QUOTE *SEE NOTES ~CSS96209

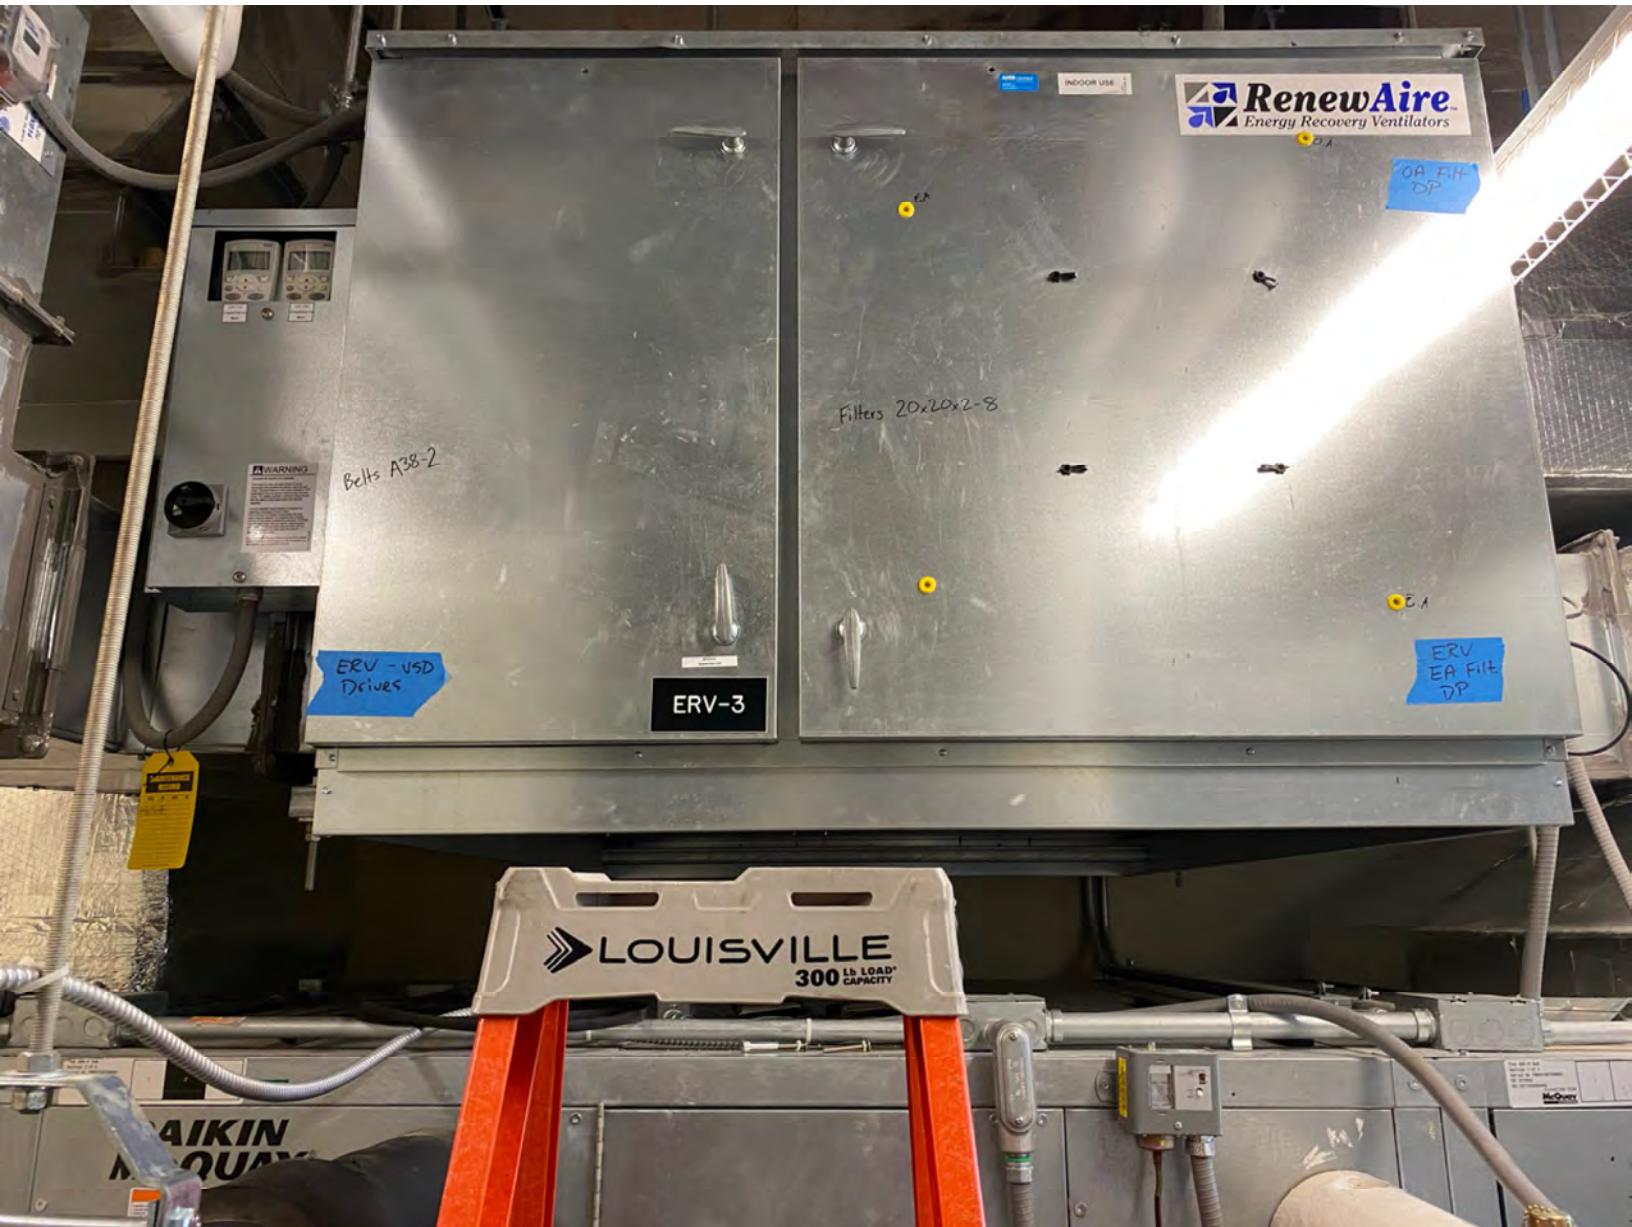
RenewAire®
Energy Recovery Ventilation

7/29/2024 ERV3 - Found unit running with grinding sounds. Shut off unit and lock out power. Open unit and pull belts. Unit needs two new belts (A38 belts). Check top blower and bottom blower. Bearings are OK. Check top motor, and bottom motor. Both motors have very bad bearings and are grinding when I turn them by hand. Both motors need to be replaced. Check dampers, heat recovery cores, and electrical.
 ERV 2 - found unit running and grinding badly. Shut off unit and pull belts off. Needs 2 new belts (A42 and A44 belts). Both motors are grinding badly whe I turn them by hand. Both motors have bad bearings and both motors need to be replaced. Check electrical, controls, dampers, and heat recovery cores.
 ERV 1 - Found unit running and grinding badly. Shut off unit and pull belts. Need 2 new belts (A38 belts). Both motors are grinding badly when turned by hand. Bearings are very bad and motors need to be replaced. Check electrical, dampers, heat recovery cores, and controls.
