Management Report

CMI Management
USARC - AMSA
99 Soldiers Lane, Coraopolis, PA

USARC - AMSA
99 Soldiers Lane
Coraopolis, PA**Site Overview**

Deficiencies

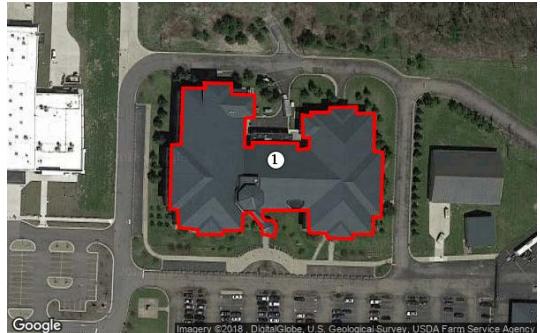
Membrane: A
 Flashings: A
 Sheet Metal: A

Overall: A

Estimated Replacement: 2038

Investigate area around and under expansion joint and make any further repairs that may be found including the deficiencies that were found to be present. Continue to monitor the roof system.
