SERVICE REPORT

KONECRANES®
Lifting Businesses™

Customer	International Support Group LLC / US Army Reserve Center		
Business Location	US Army Reserve Center, Bayside, 200 Duane Rd		
City	Bayside		
Agreement			
Service Request	1-99083770702		
Description	PHI (NY) - SERVICE CALL / REPAIR Provide service technician and scissors lift to perform Service Call on 10 Ton Sisco Crane w/Yale Hoist to determine issue of "Jumped Guide" on Asset #H-1 per Quote# 1-19I63MAA.		
PO Number	Email Approval		
Billing Type	Fixed		
Customer Contact	Michele Dubois 954-900-1095 mdubois@internationalsupportgroup.com	Konecranes Contact	Brett Kenna 6104273521 brett.kenna@konecranes.com

H-1 Single girder EOT - 1 trolley wire rope hoist	Manufacturer SISSCO	Span 70ft		
Serial number A2840-A	Lift 25ft			
Criticality High	Volt/Ph/Hz 460-3-60			
Site Location H-1 / Truck shop				
Capacity/SWL 10 tons				
Model SGTRDM				
Service Products Planned Repairs				
Hoists				
Asset Description	Serial number	Model Type	Manufacturer	Capacity
	CK5835XC	EEW10-23PT19D4	YALE	10 t

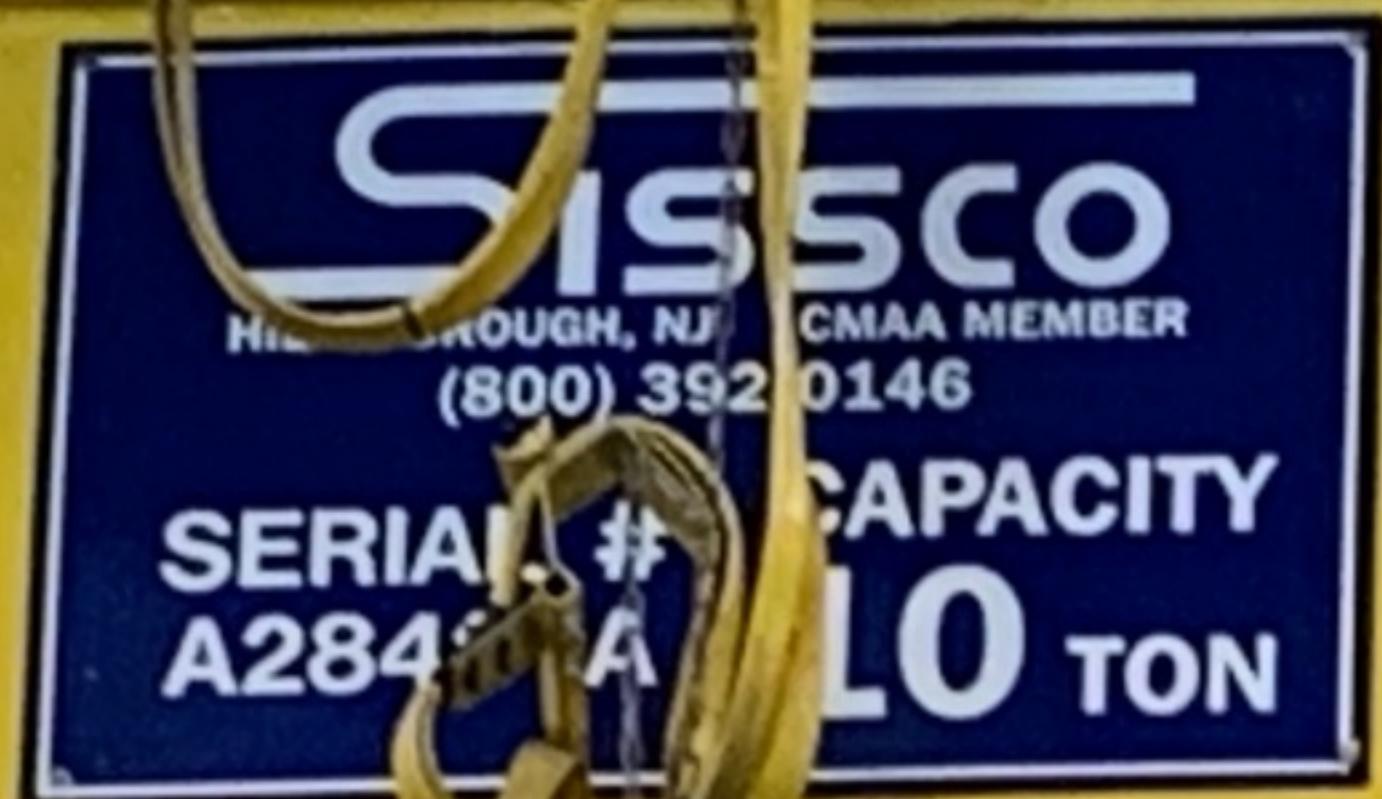
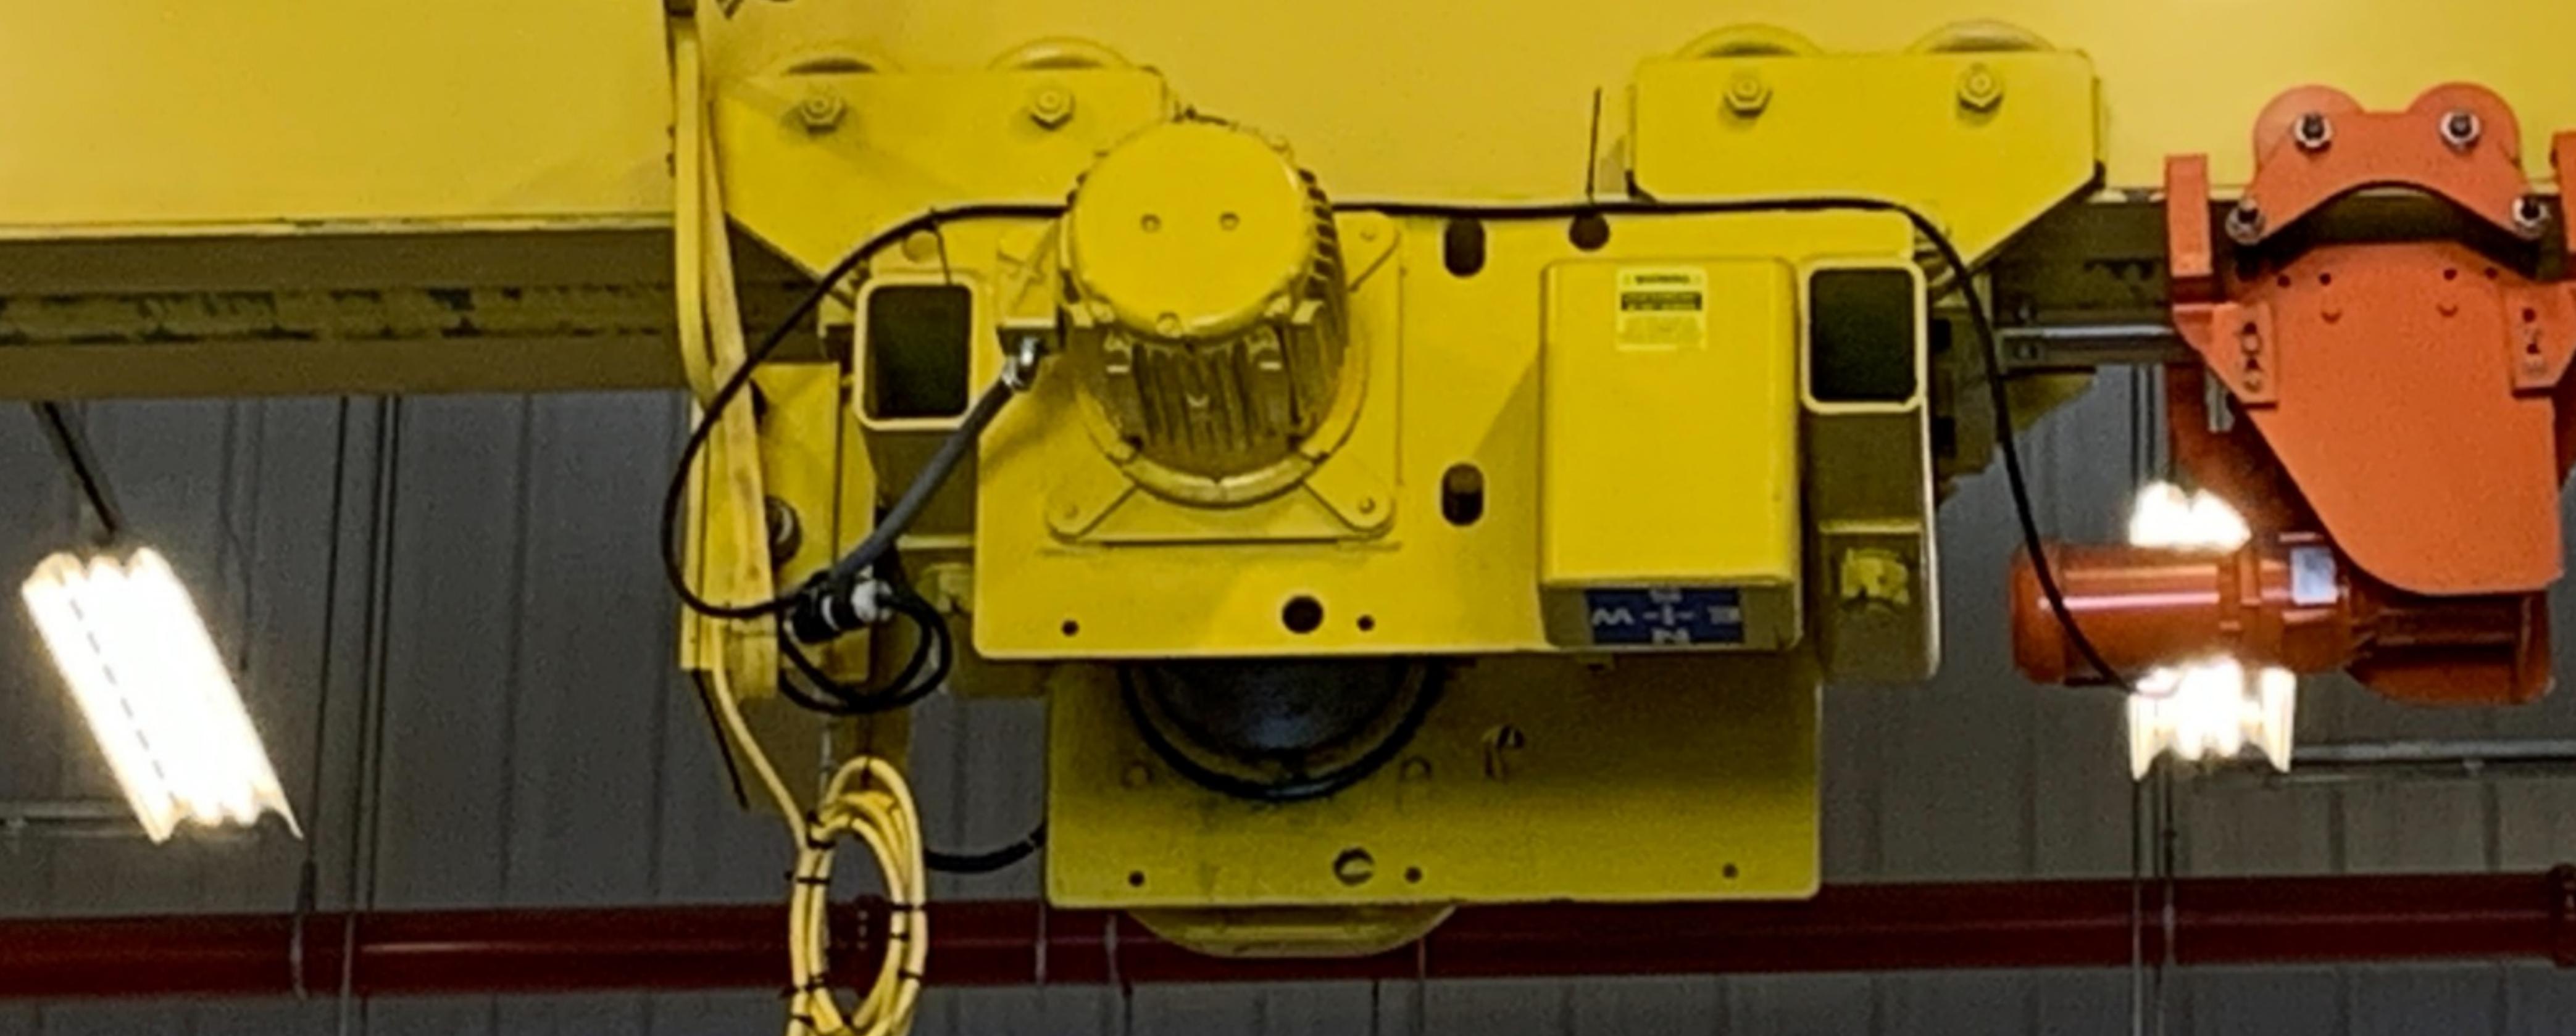
Date Reported Jul 10, 2023
Technician Tony Farquharson
Task Type Operational assessment
Fault Code Cross wrapped on rope drum
Risk **Safety Risk**
Recommendation Replace

Wire rope is wedged and wrapped around the drum a couple time at the motor side. Which causes the rope to jump two upper sheaves and kinked wire rope in multiple sections. I recommend replace wire rope and this crane needs to lockout from any further used for safety reasons.

Replace
