**Mold Inspection Analysis  
&  
Remediation  
Scope of Work**

**8791 Snouffer School Road  
Gaithersburg MD 20879**

99th Army Reserve  
8791 Snouffer School Road  
Gaithersburg MD 20879

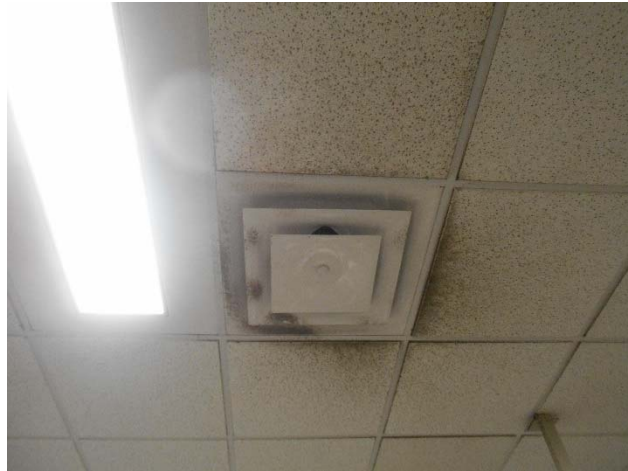
- Visible Mold on Ceiling Tiles, Dirvitors and in the Ductwork in Room 133

**Visible Mold in the Ductwork**

Investigation and development of corrective measures and verification of corrective measure should be conducted regarding moisture in room 133 portions of the building. Assure HVAC unit is serviced by a professional HVAC service provider annually. These actions should be completed immediately following remediation. Remedial actions should strictly follow industry accepted practices and procedures for fungal abatement.

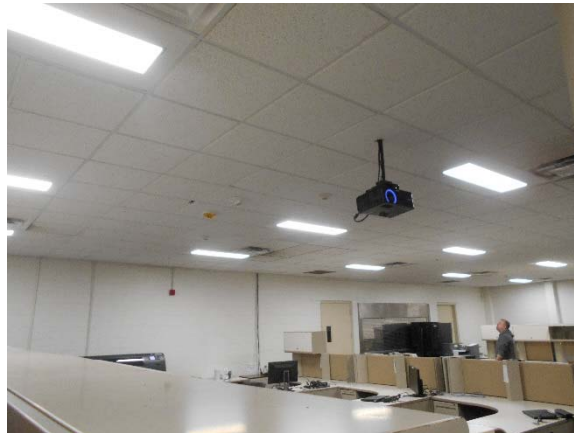
**Portion of Affected Area in Room 133**

1. Set up containment barriers and achieve negative air (-.02 lb) within work areas.
2. Removal and disposal of contaminated materials () according to accepted industry standards.
  - Remove Affected Ceiling Tiles From Room 133 Approx: 250 SFT

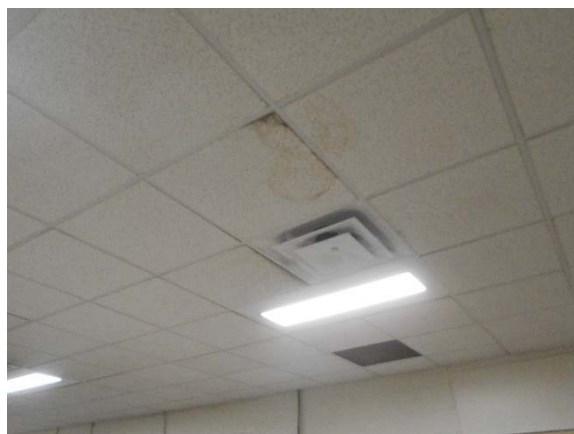
**Visible Mold in the Ductwork**
