CERTIFICATION OF WORK
(To be completed by the Contractor and saved in the Contractor's CMMS)

FACID/Building: MD019

WO# 11717 CSS# 23465 - Replace internal

02/18/2020Tidewater, Inc.
Tidewater, Inc
6625 Selnick Dr.
Suite A
Elkridge MD 21075**INVOICE NO. 74538****Job Name:** 11717
Site: MD019 Greenspring Avenue
Site Address: 12100 Greenspring Avenue
Owings Mills MD 21117**Description****WO#: 11717****CSS Ticket Number: 23465**

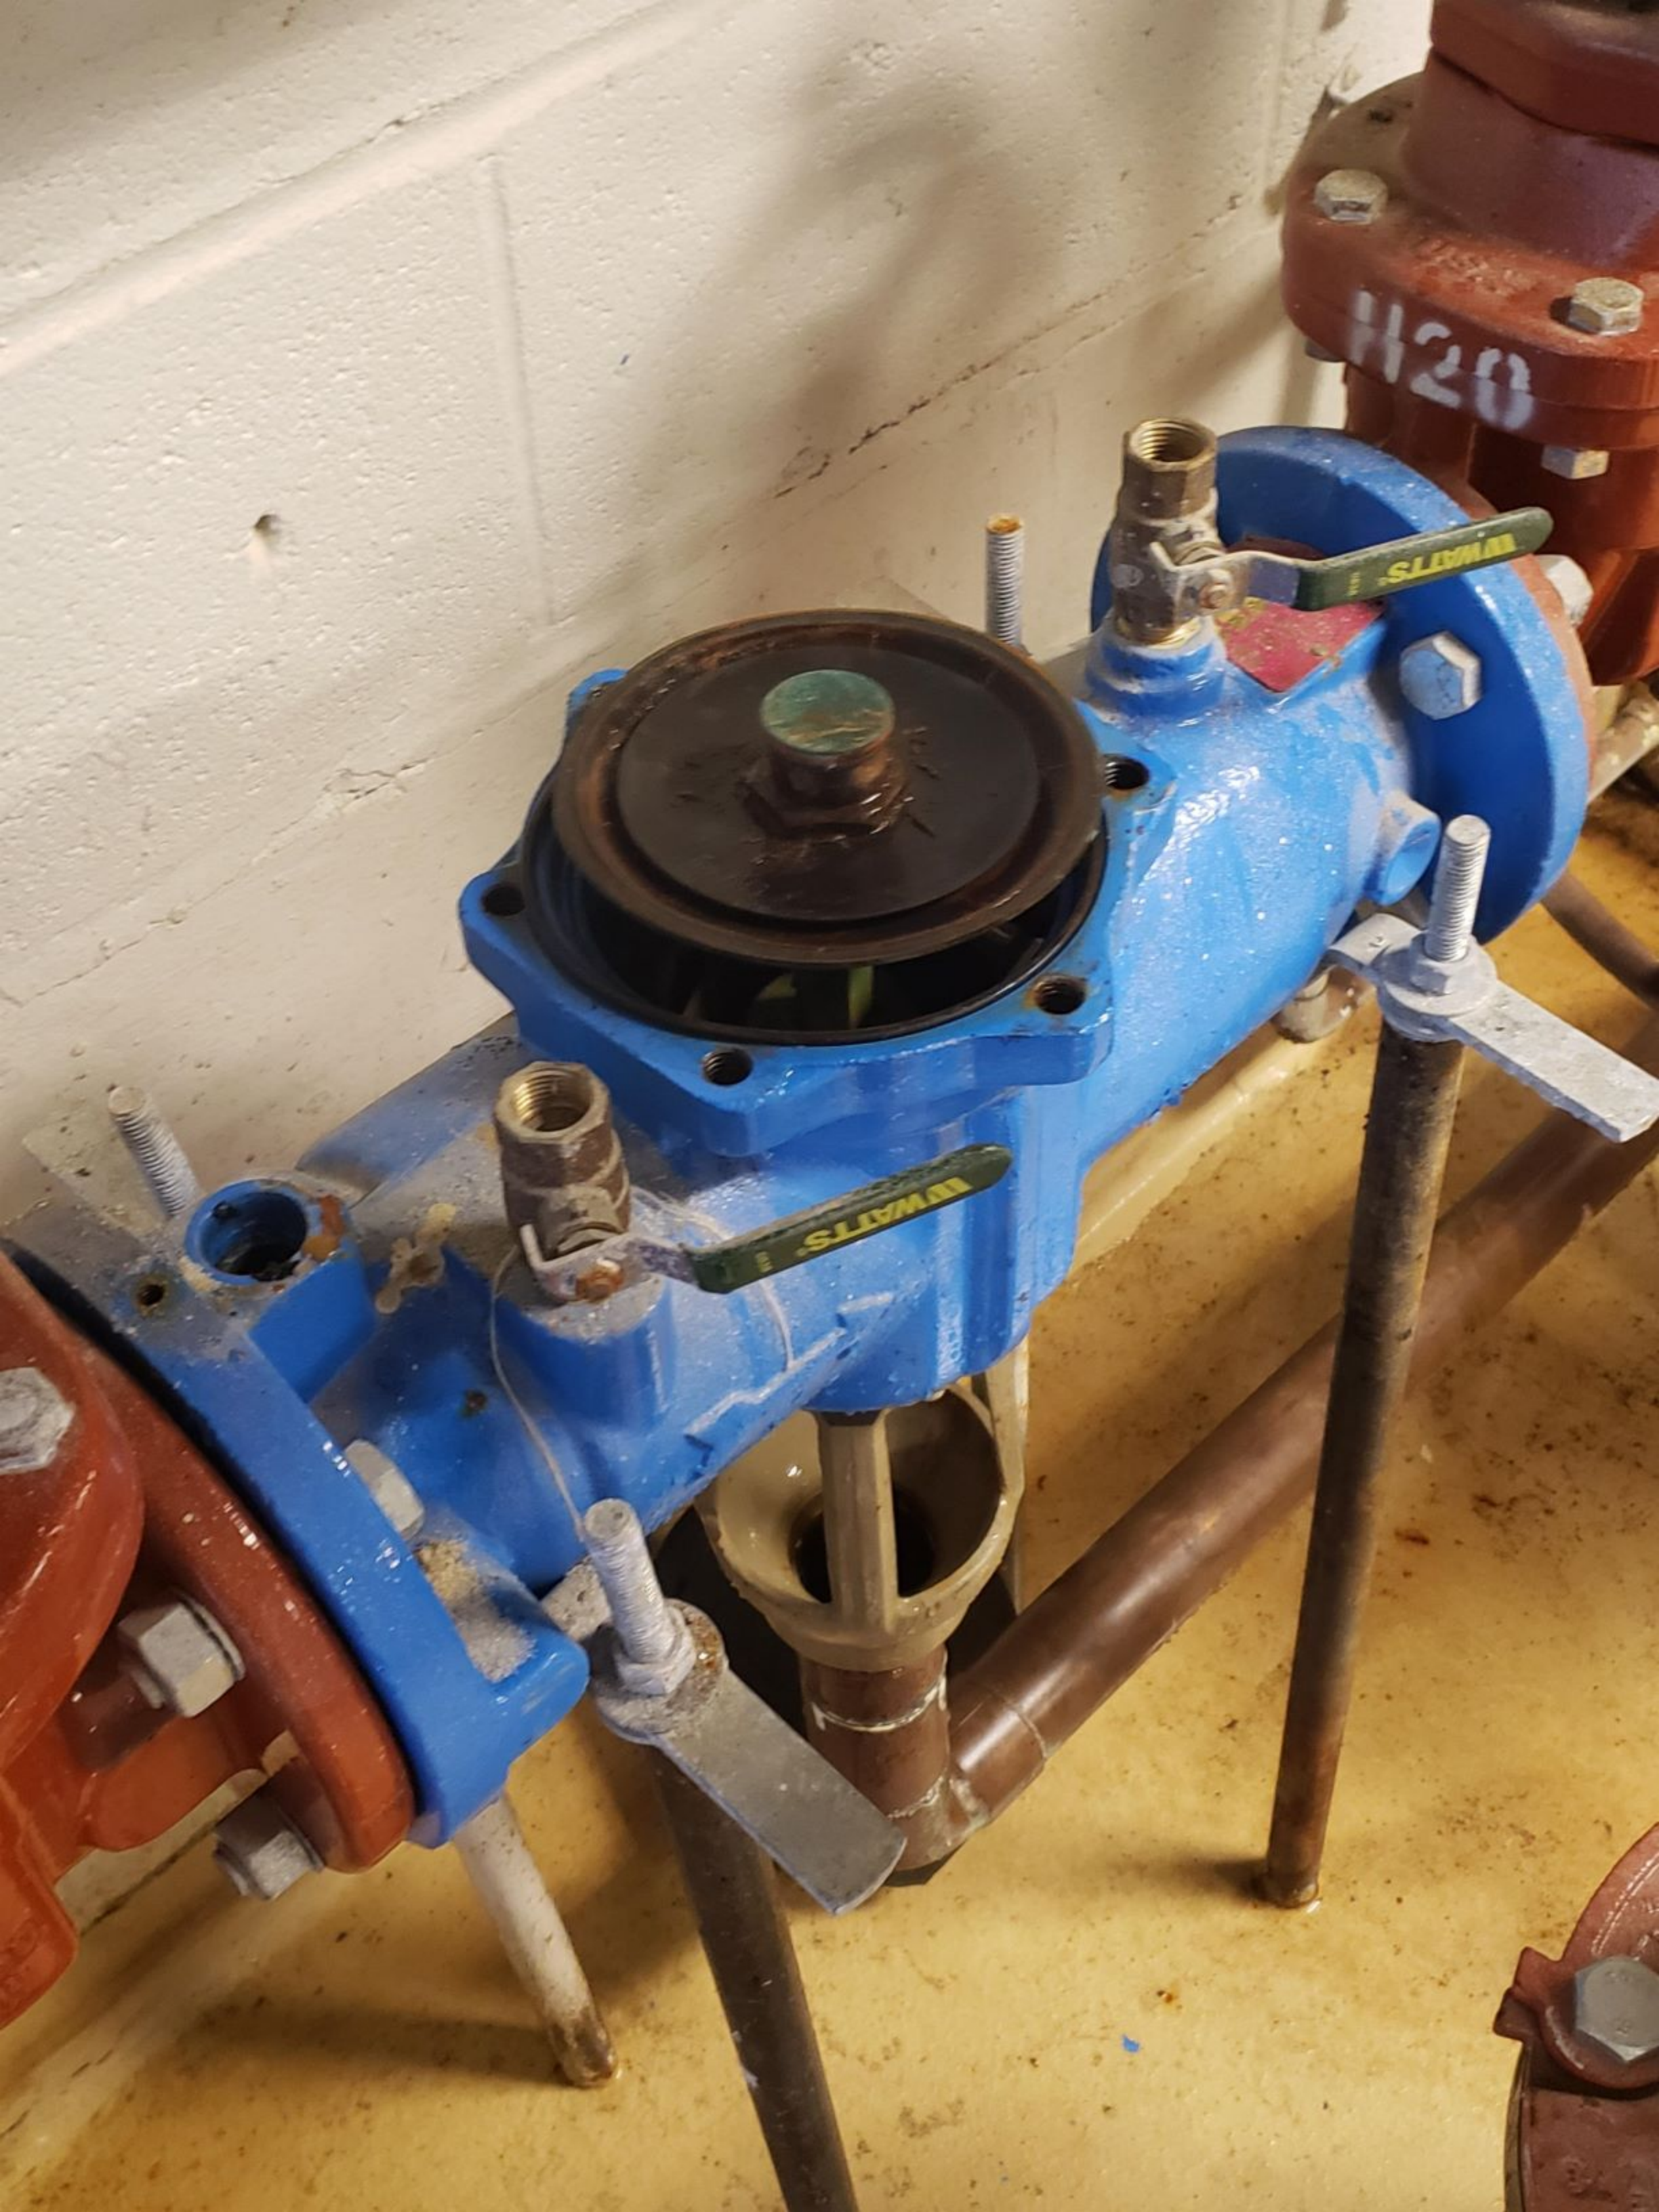
NO. 174A
SIZE 3/4 IN.
SET 75 PSI
BTU/HR. RATING 1,320,000
CANADIAN REGISTRATION NO. OG7543.5C
MFG. & CERT. BY WATTS
www.watts.com

Problem: There was a pressure relief valve that was leaking in the pump house and caused a short in the pull station located directly beneath it. Need to have pressure relief valve repaired and tested to make sure that it doesn't leak anymore. Need to have this done because the pumps have been shut off in order to stop the valve from leaking and possibly burning out the well pump or drying up the well. Once the valve issue is taken care of, need to make sure the pumps are turned back on."

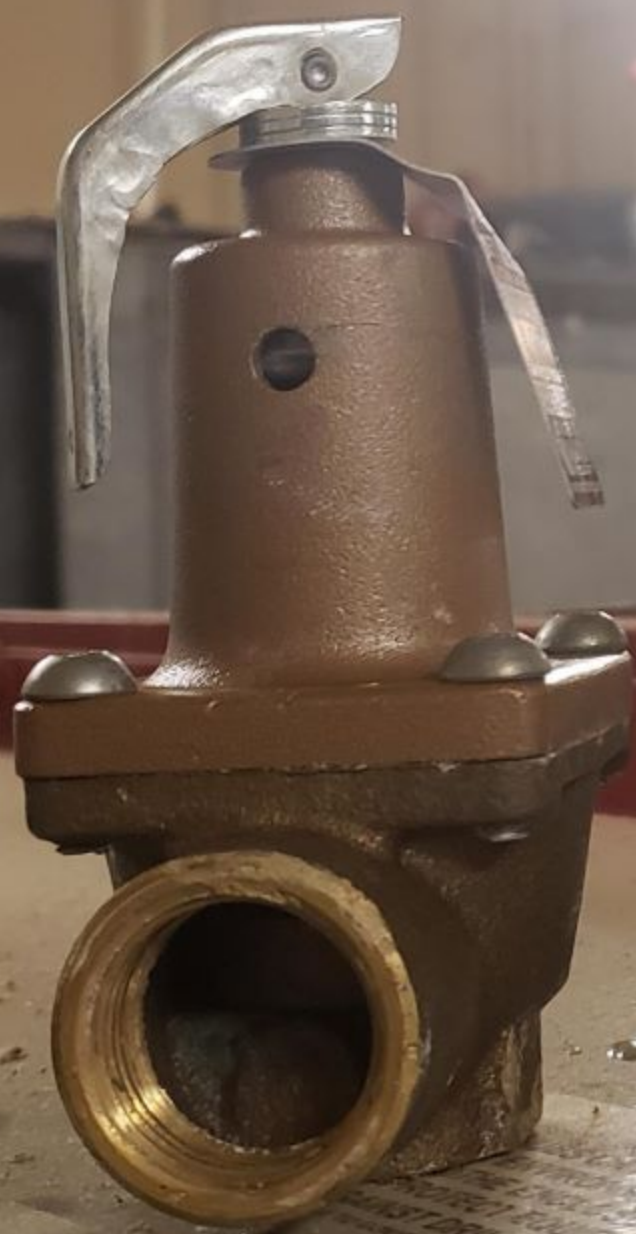
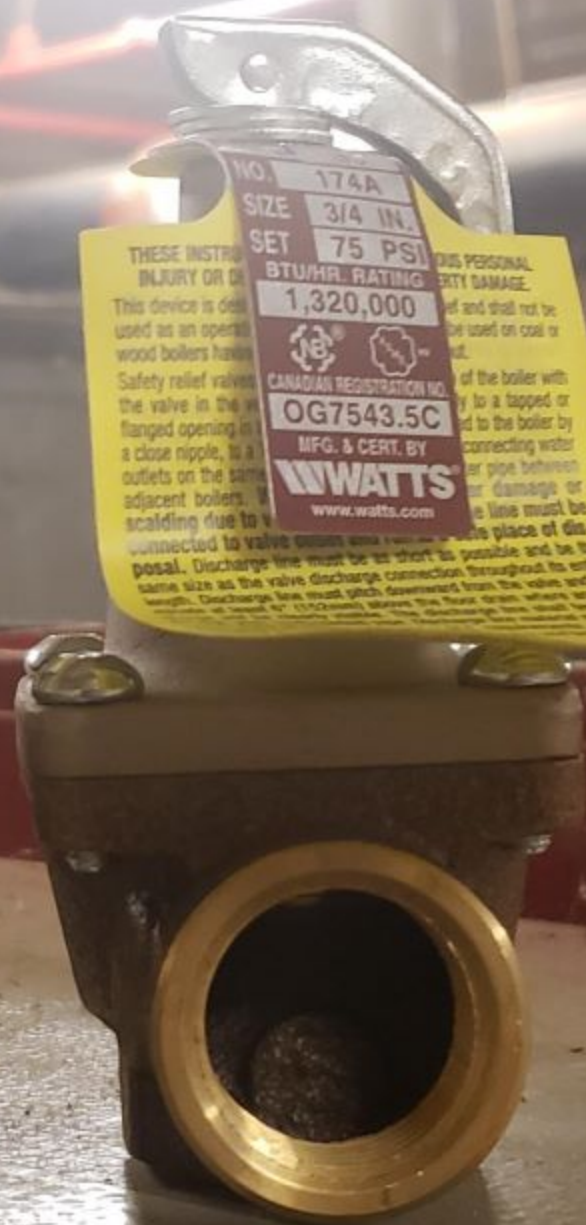
THESE INSTRUCTIONS MUST BE READ AND UNDERSTOOD BY THE OPERATOR OF THE BOILER. THIS DEVICE IS DESIGNED TO RELIEVE EXCESS PRESSURE AND SHALL NOT BE USED ON COAL OR OIL BOILERS. SAFETY RELIEF VALVES ARE TO BE INSTALLED IN THE VALVE IN THE FLANGED OPENING IN A CLOSE NIPPLE, TO A DISCHARGE OUTLET ON THE SAME ADJACENT BOILERS. SCALDING DUE TO VALVE DISCHARGE MUST BE PREVENTED BY THE DISCHARGE LINE BEING AS SHORT AS POSSIBLE AND BEING THE SAME SIZE AS THE VALVE DISCHARGE CONNECTION THROUGHOUT ITS ENTIRE LENGTH. DISCHARGE LINE MUST GLITCH DOWNWARD FROM THE VALVE AND BE AT LEAST 10 FEET ABOVE THE BOILER FROM WHERE ANY DISCHARGE OF STEAM OR HOT WATER COULD OCCUR. THE DISCHARGE LINE MUST BE PROTECTED FROM DAMAGE BY OVERHEATING OR MECHANICAL DAMAGE.

OF THE BOILER WITH A TAPPED OR TO THE BOILER BY CONNECTING WATER PIPE BETWEEN THE PIPE OR LINE MUST BE DISPOSED IN PLACE OF DISPOSAL.
