Region: 5

Location: VA049

CSS #: 23864

Original Description: Leak from ceiling in Mr. Jackson's office, first floor. Steady drip.

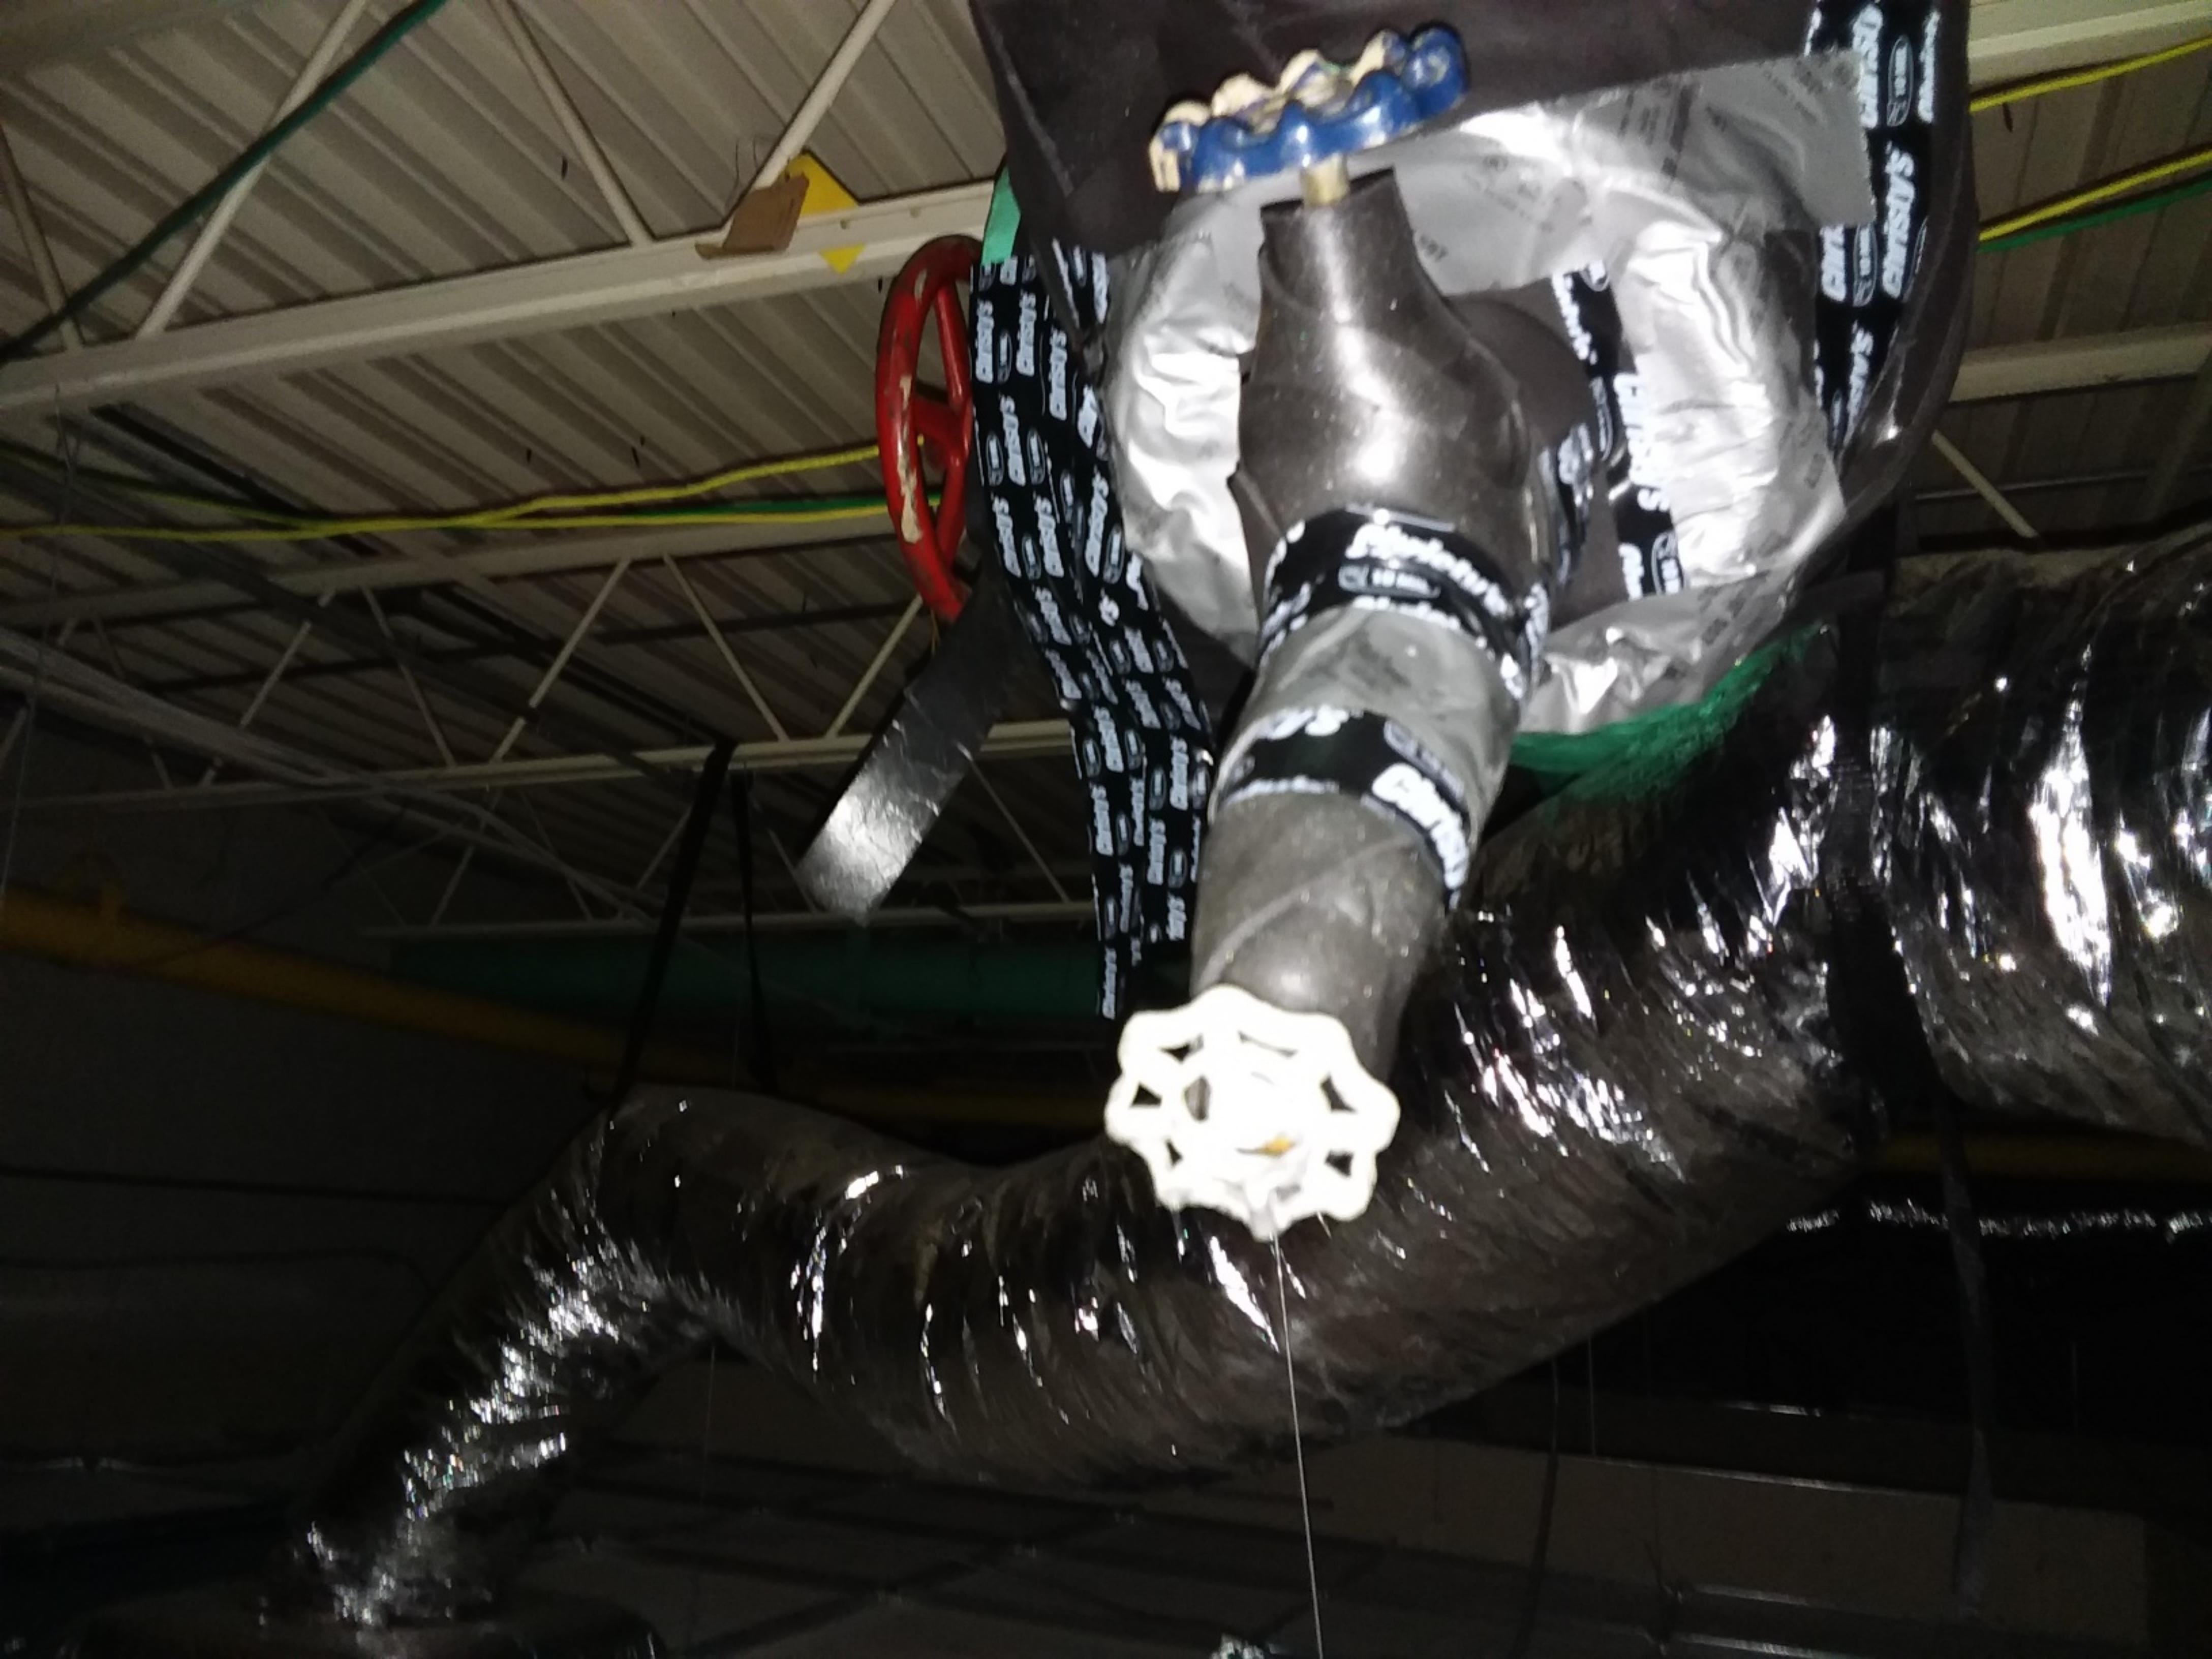
VA049
CSS#23864
close CW supply
valve.

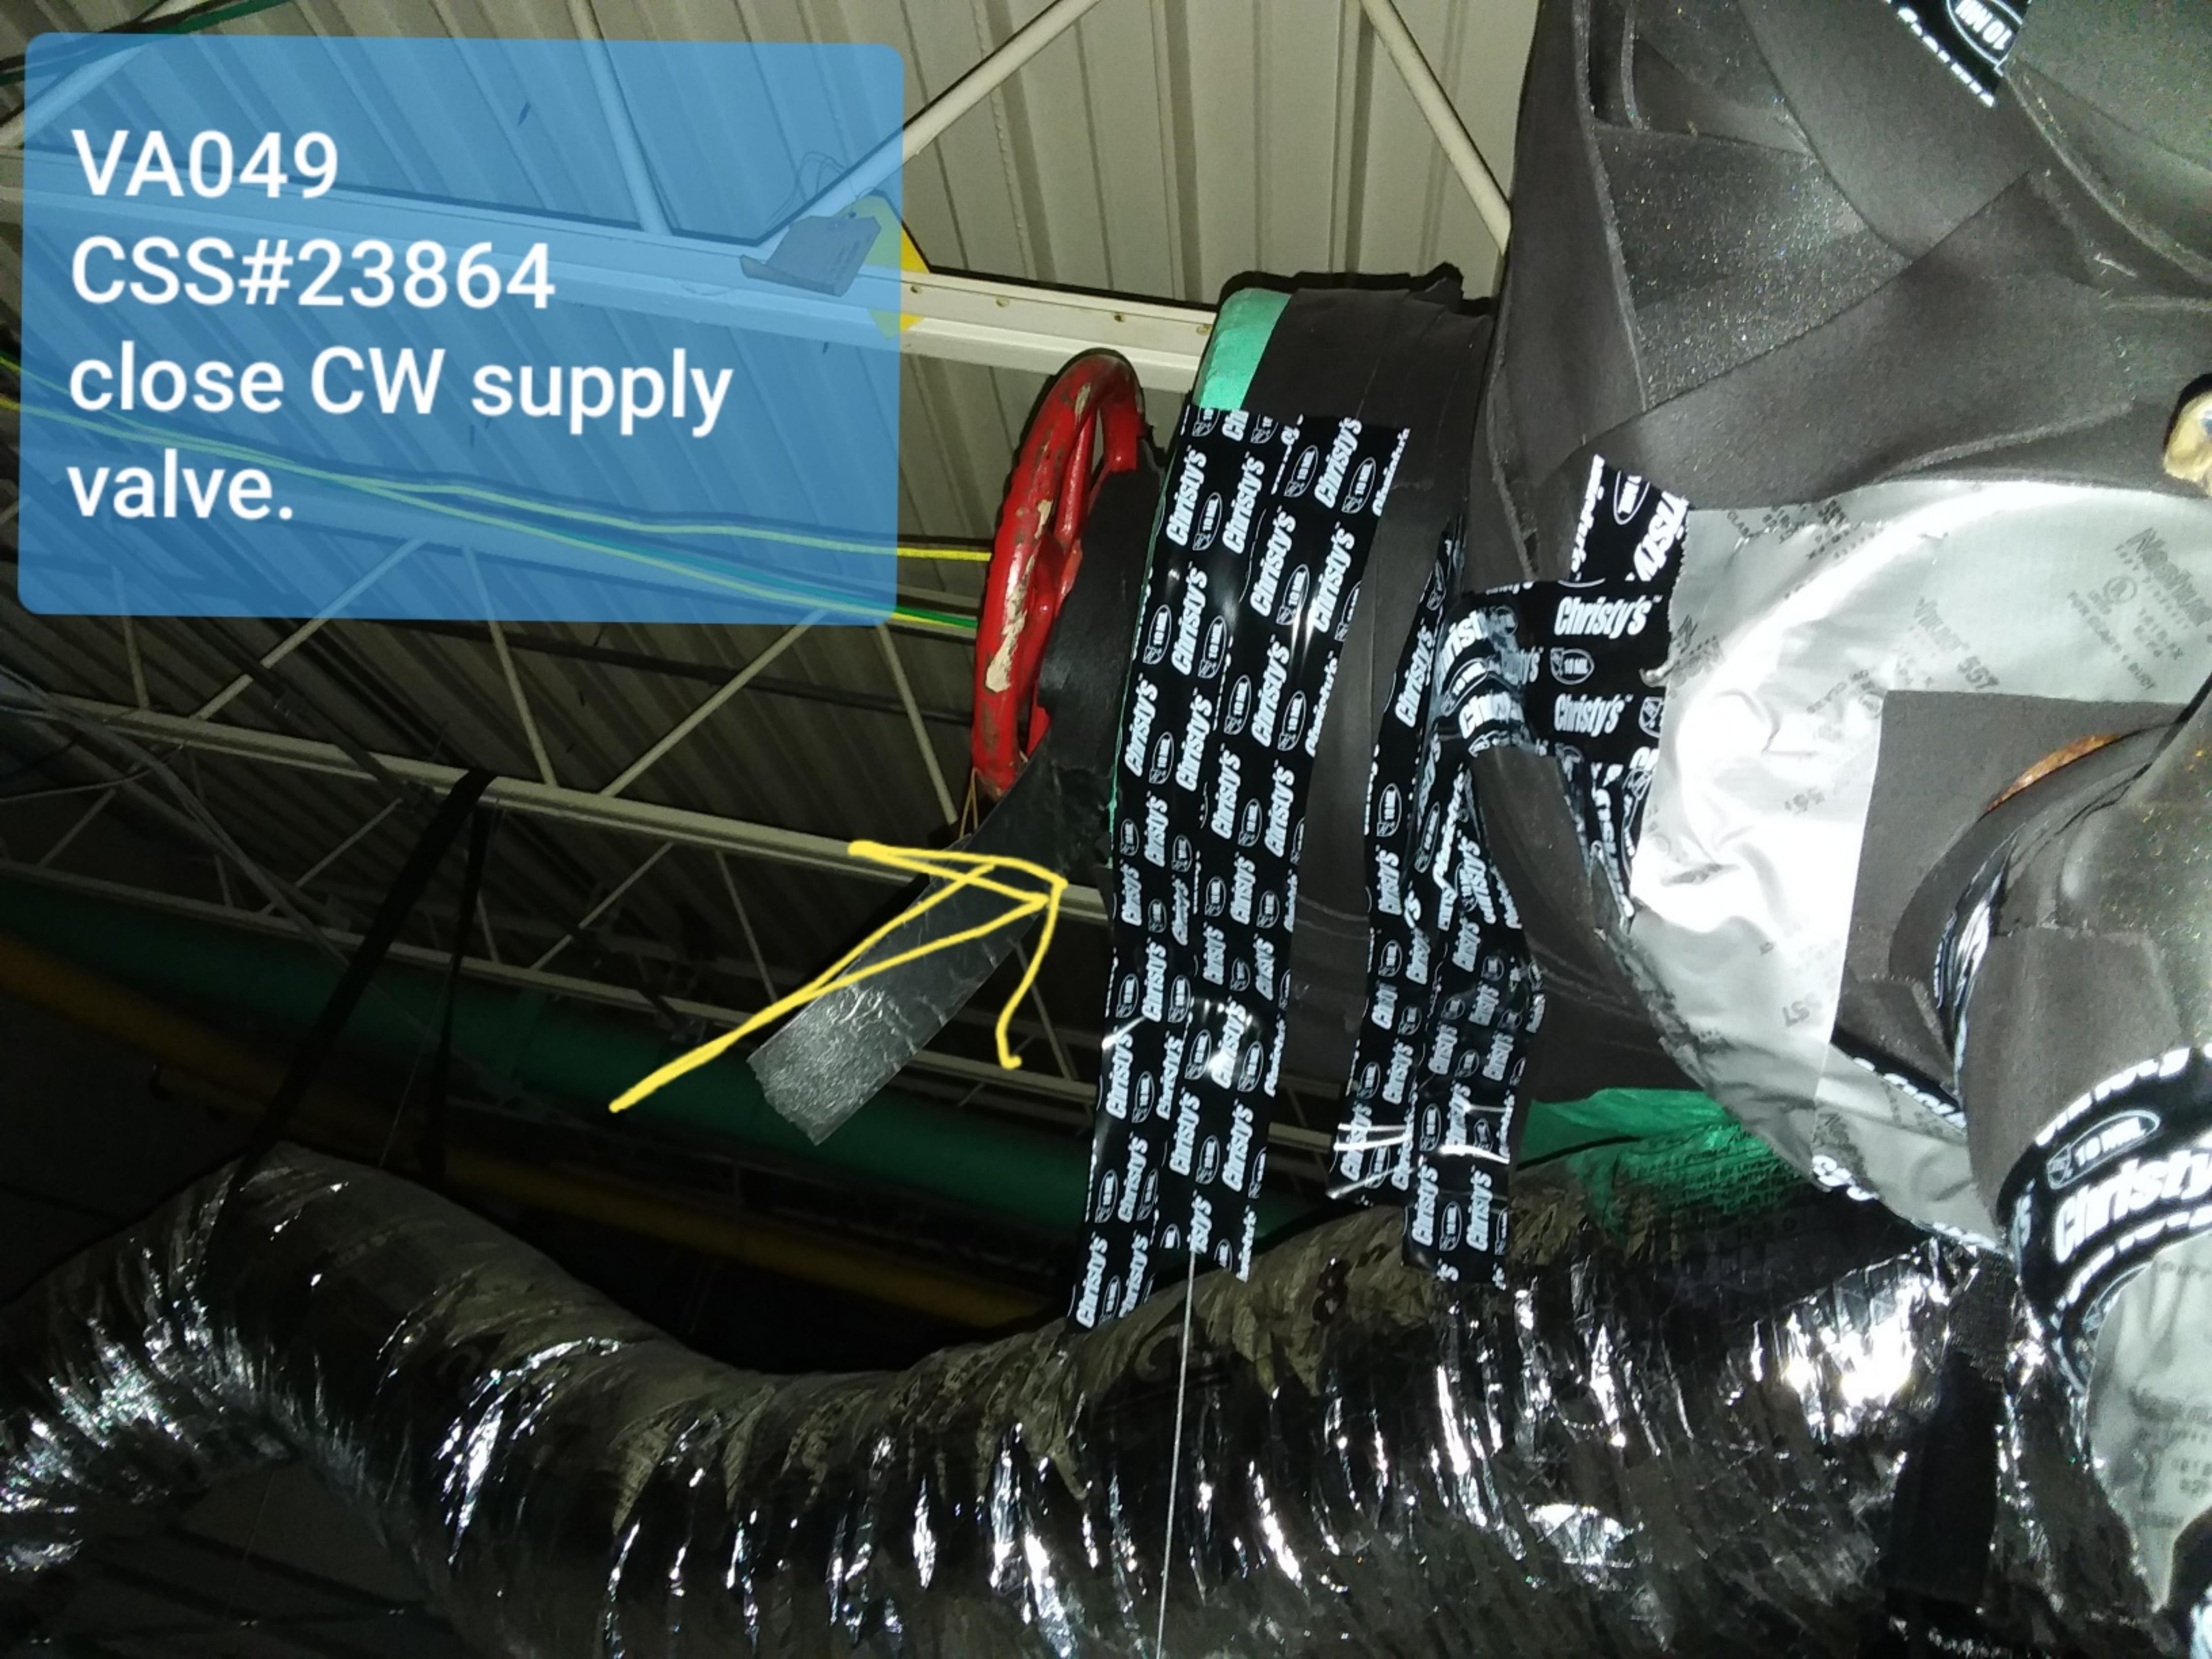
VA049
CSS#23864
Lower CW supply
Gate valve broke

Found: it wrapped
in foam and
metal tape

need to close
valves and drain
system to repair.

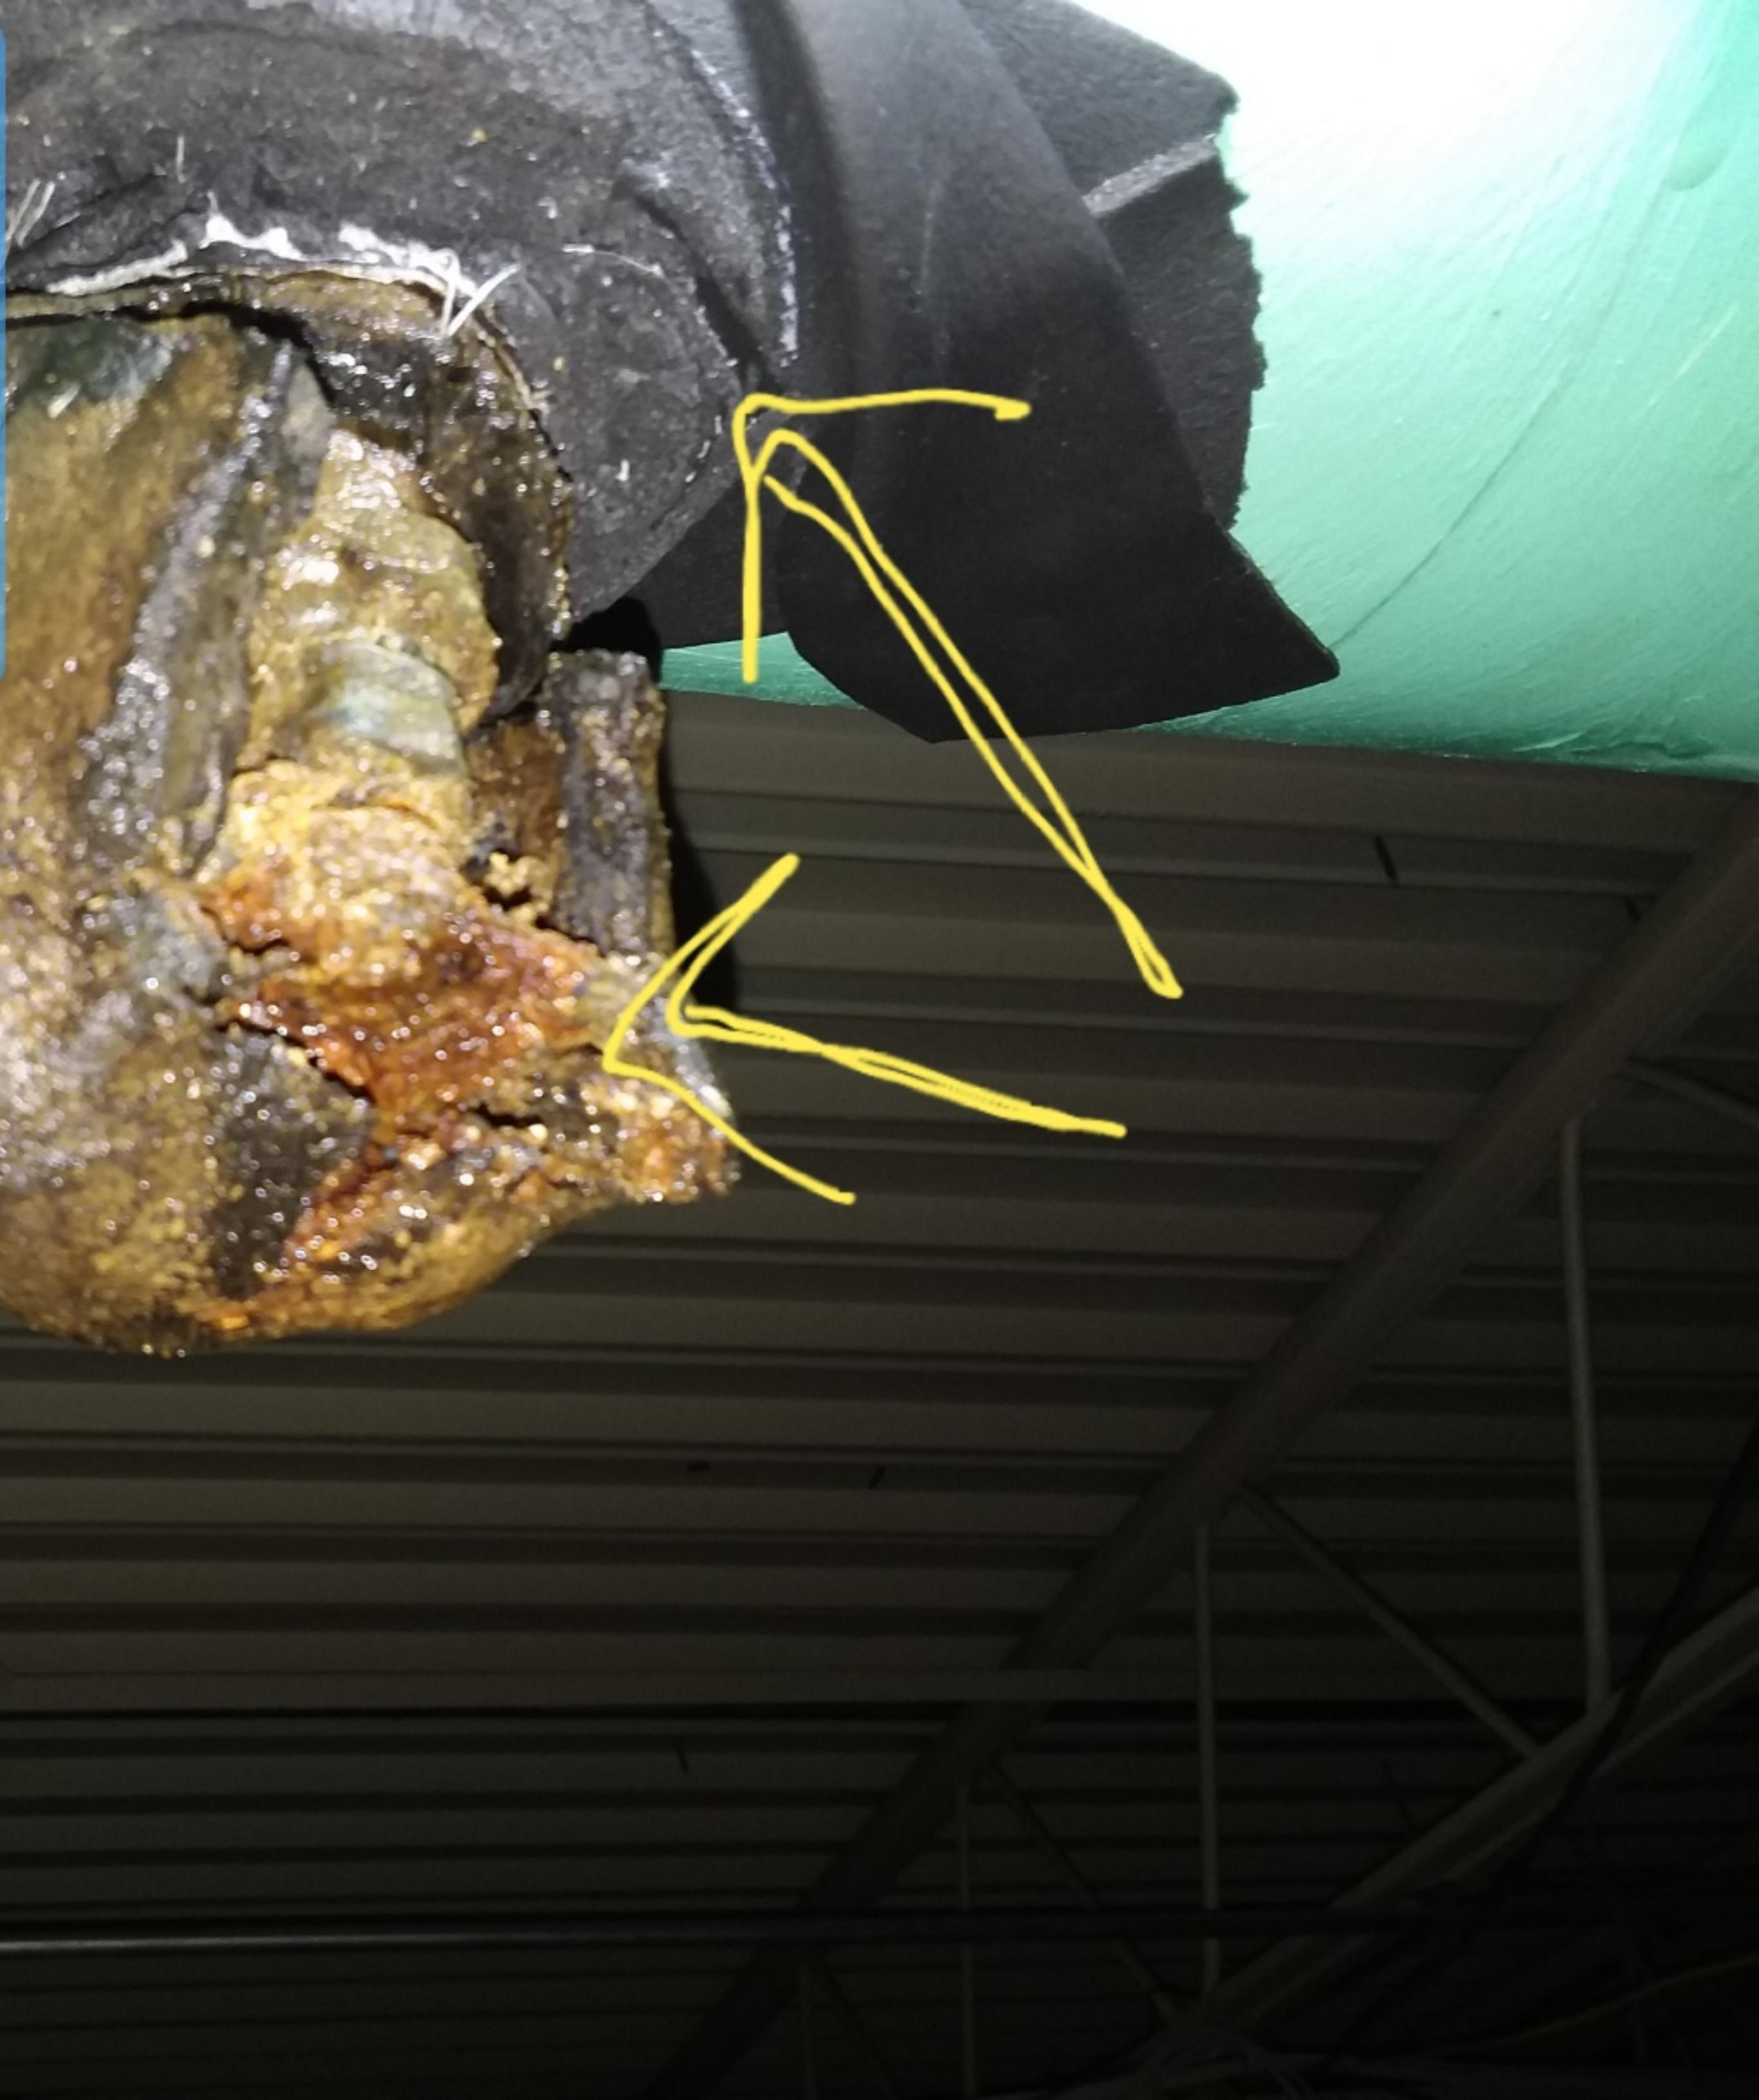
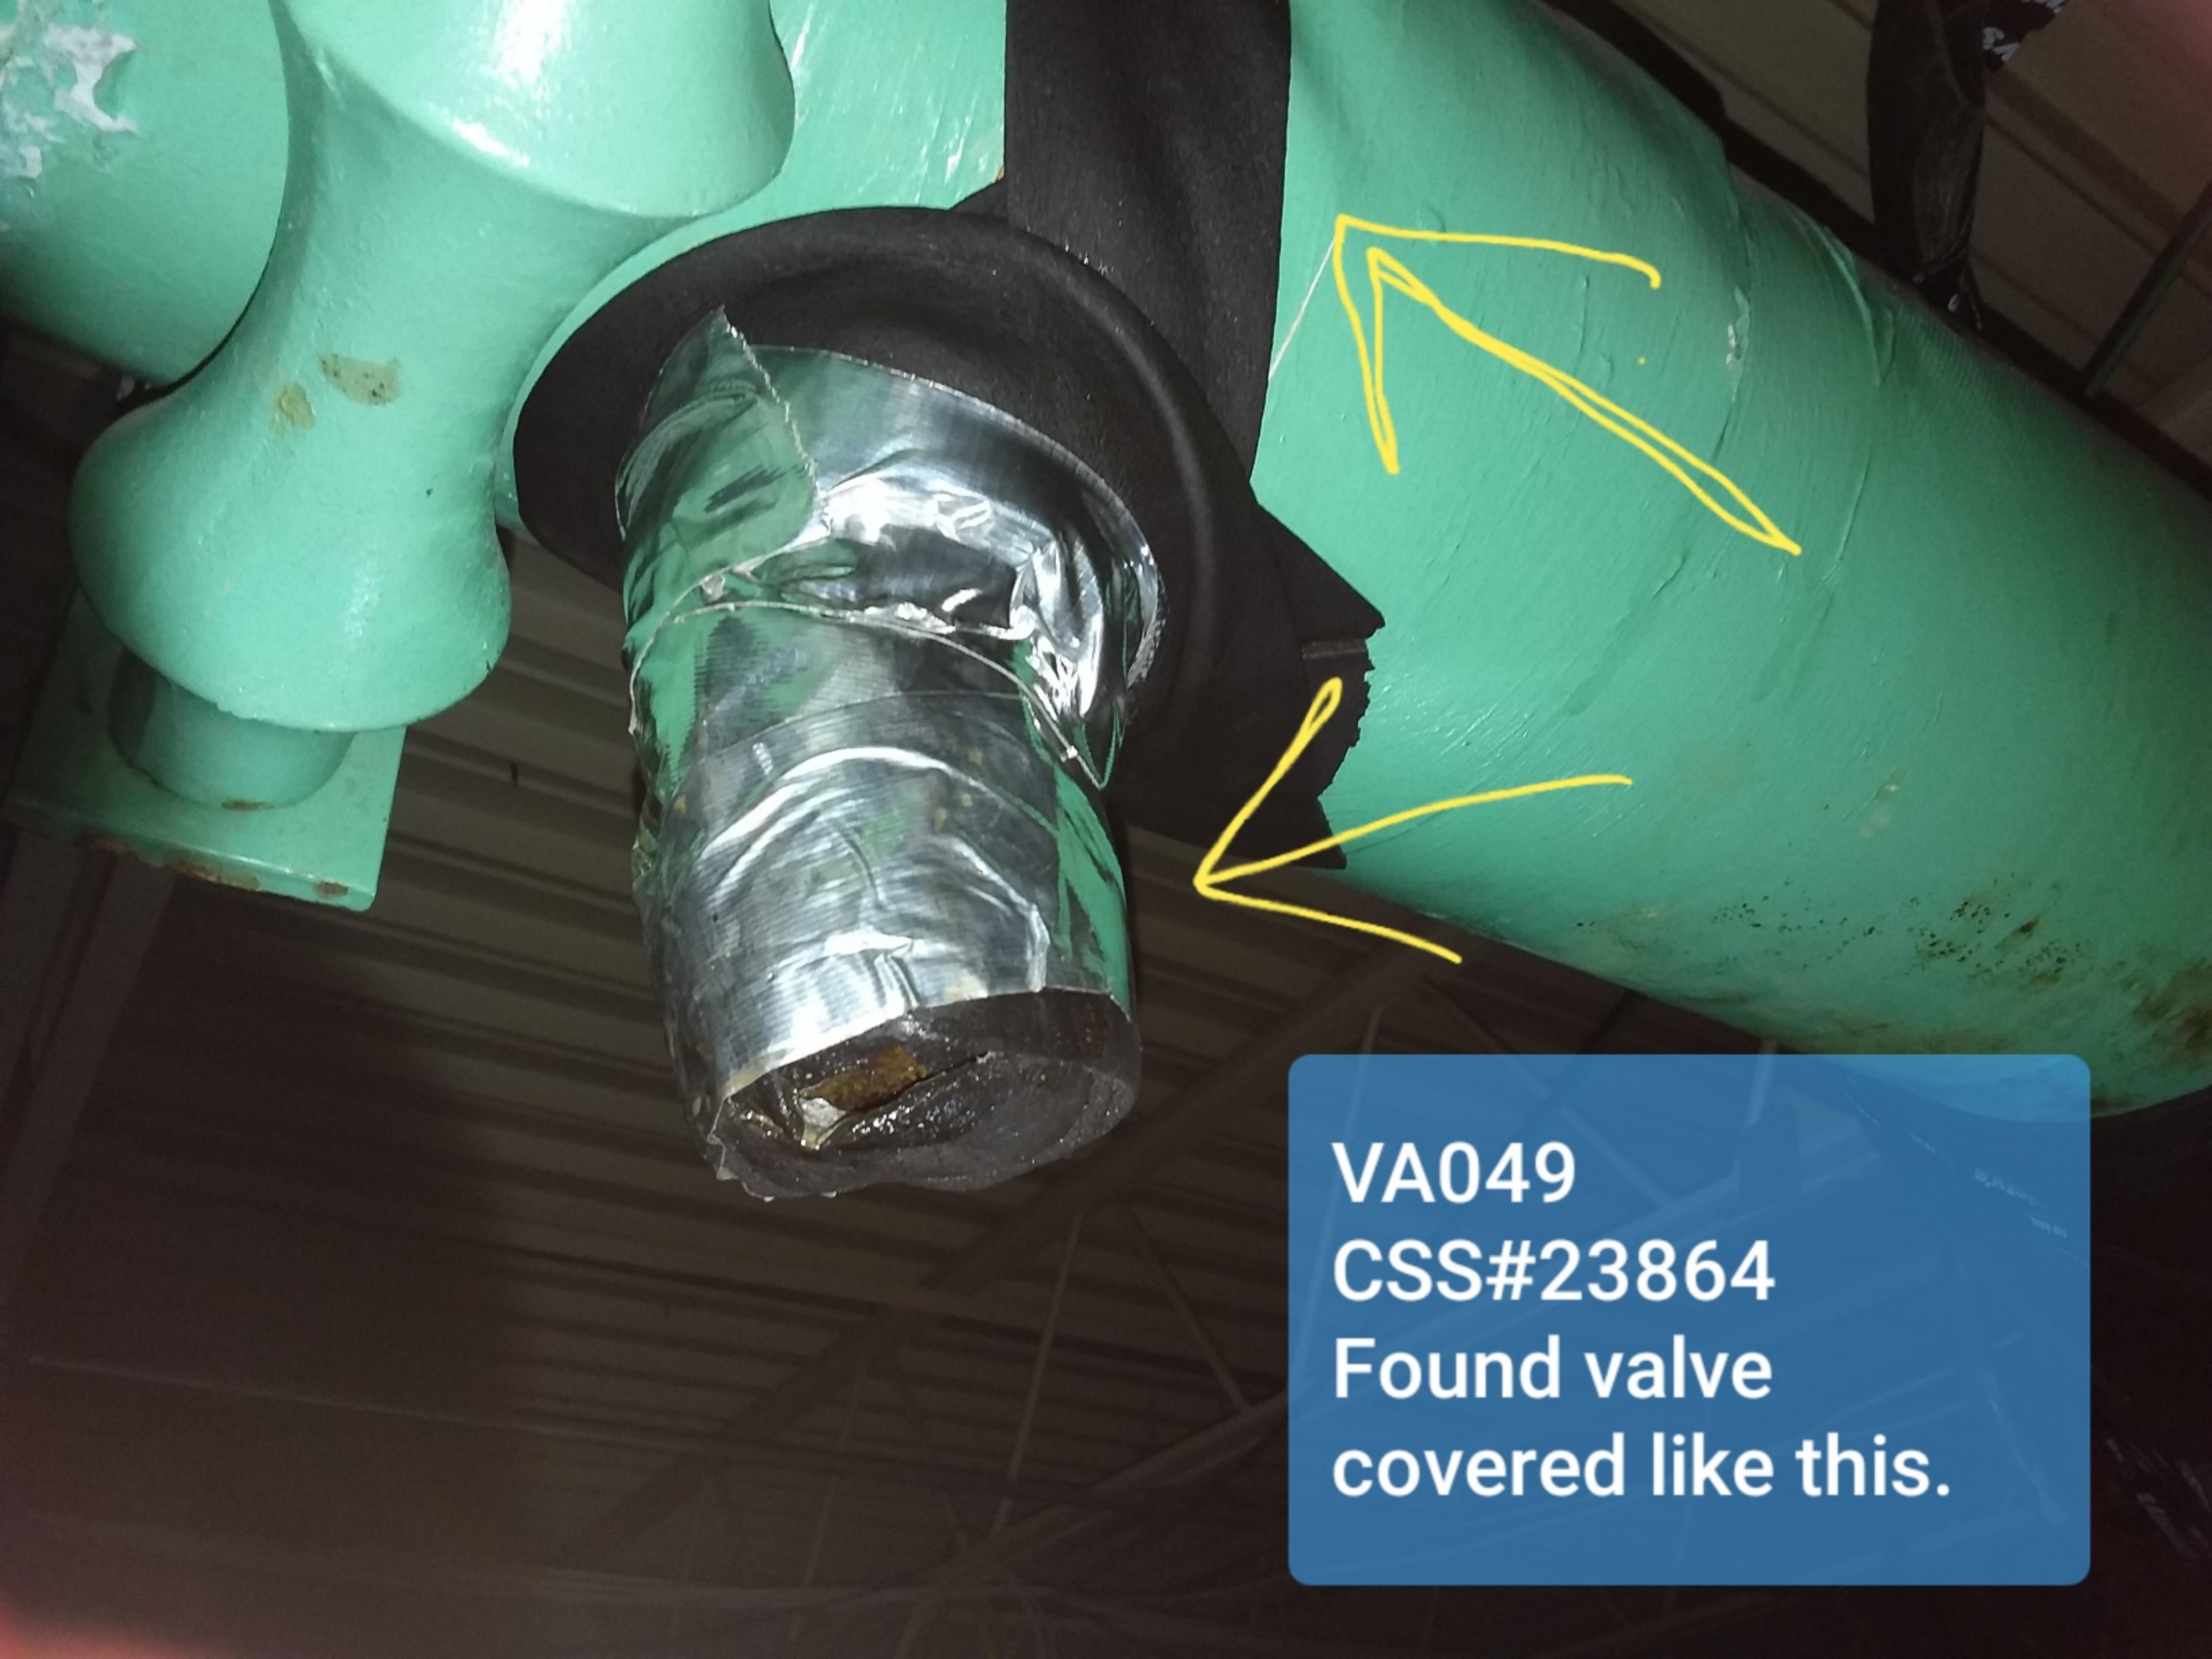
VA049
CSS#23864
Found valve
covered like this.
