**CERTIFICATION OF WORK
SERVICE CALL**

FACID/Building: VA049 Date of Visit: 5/29/20

CSS# 25334 WO# 12331

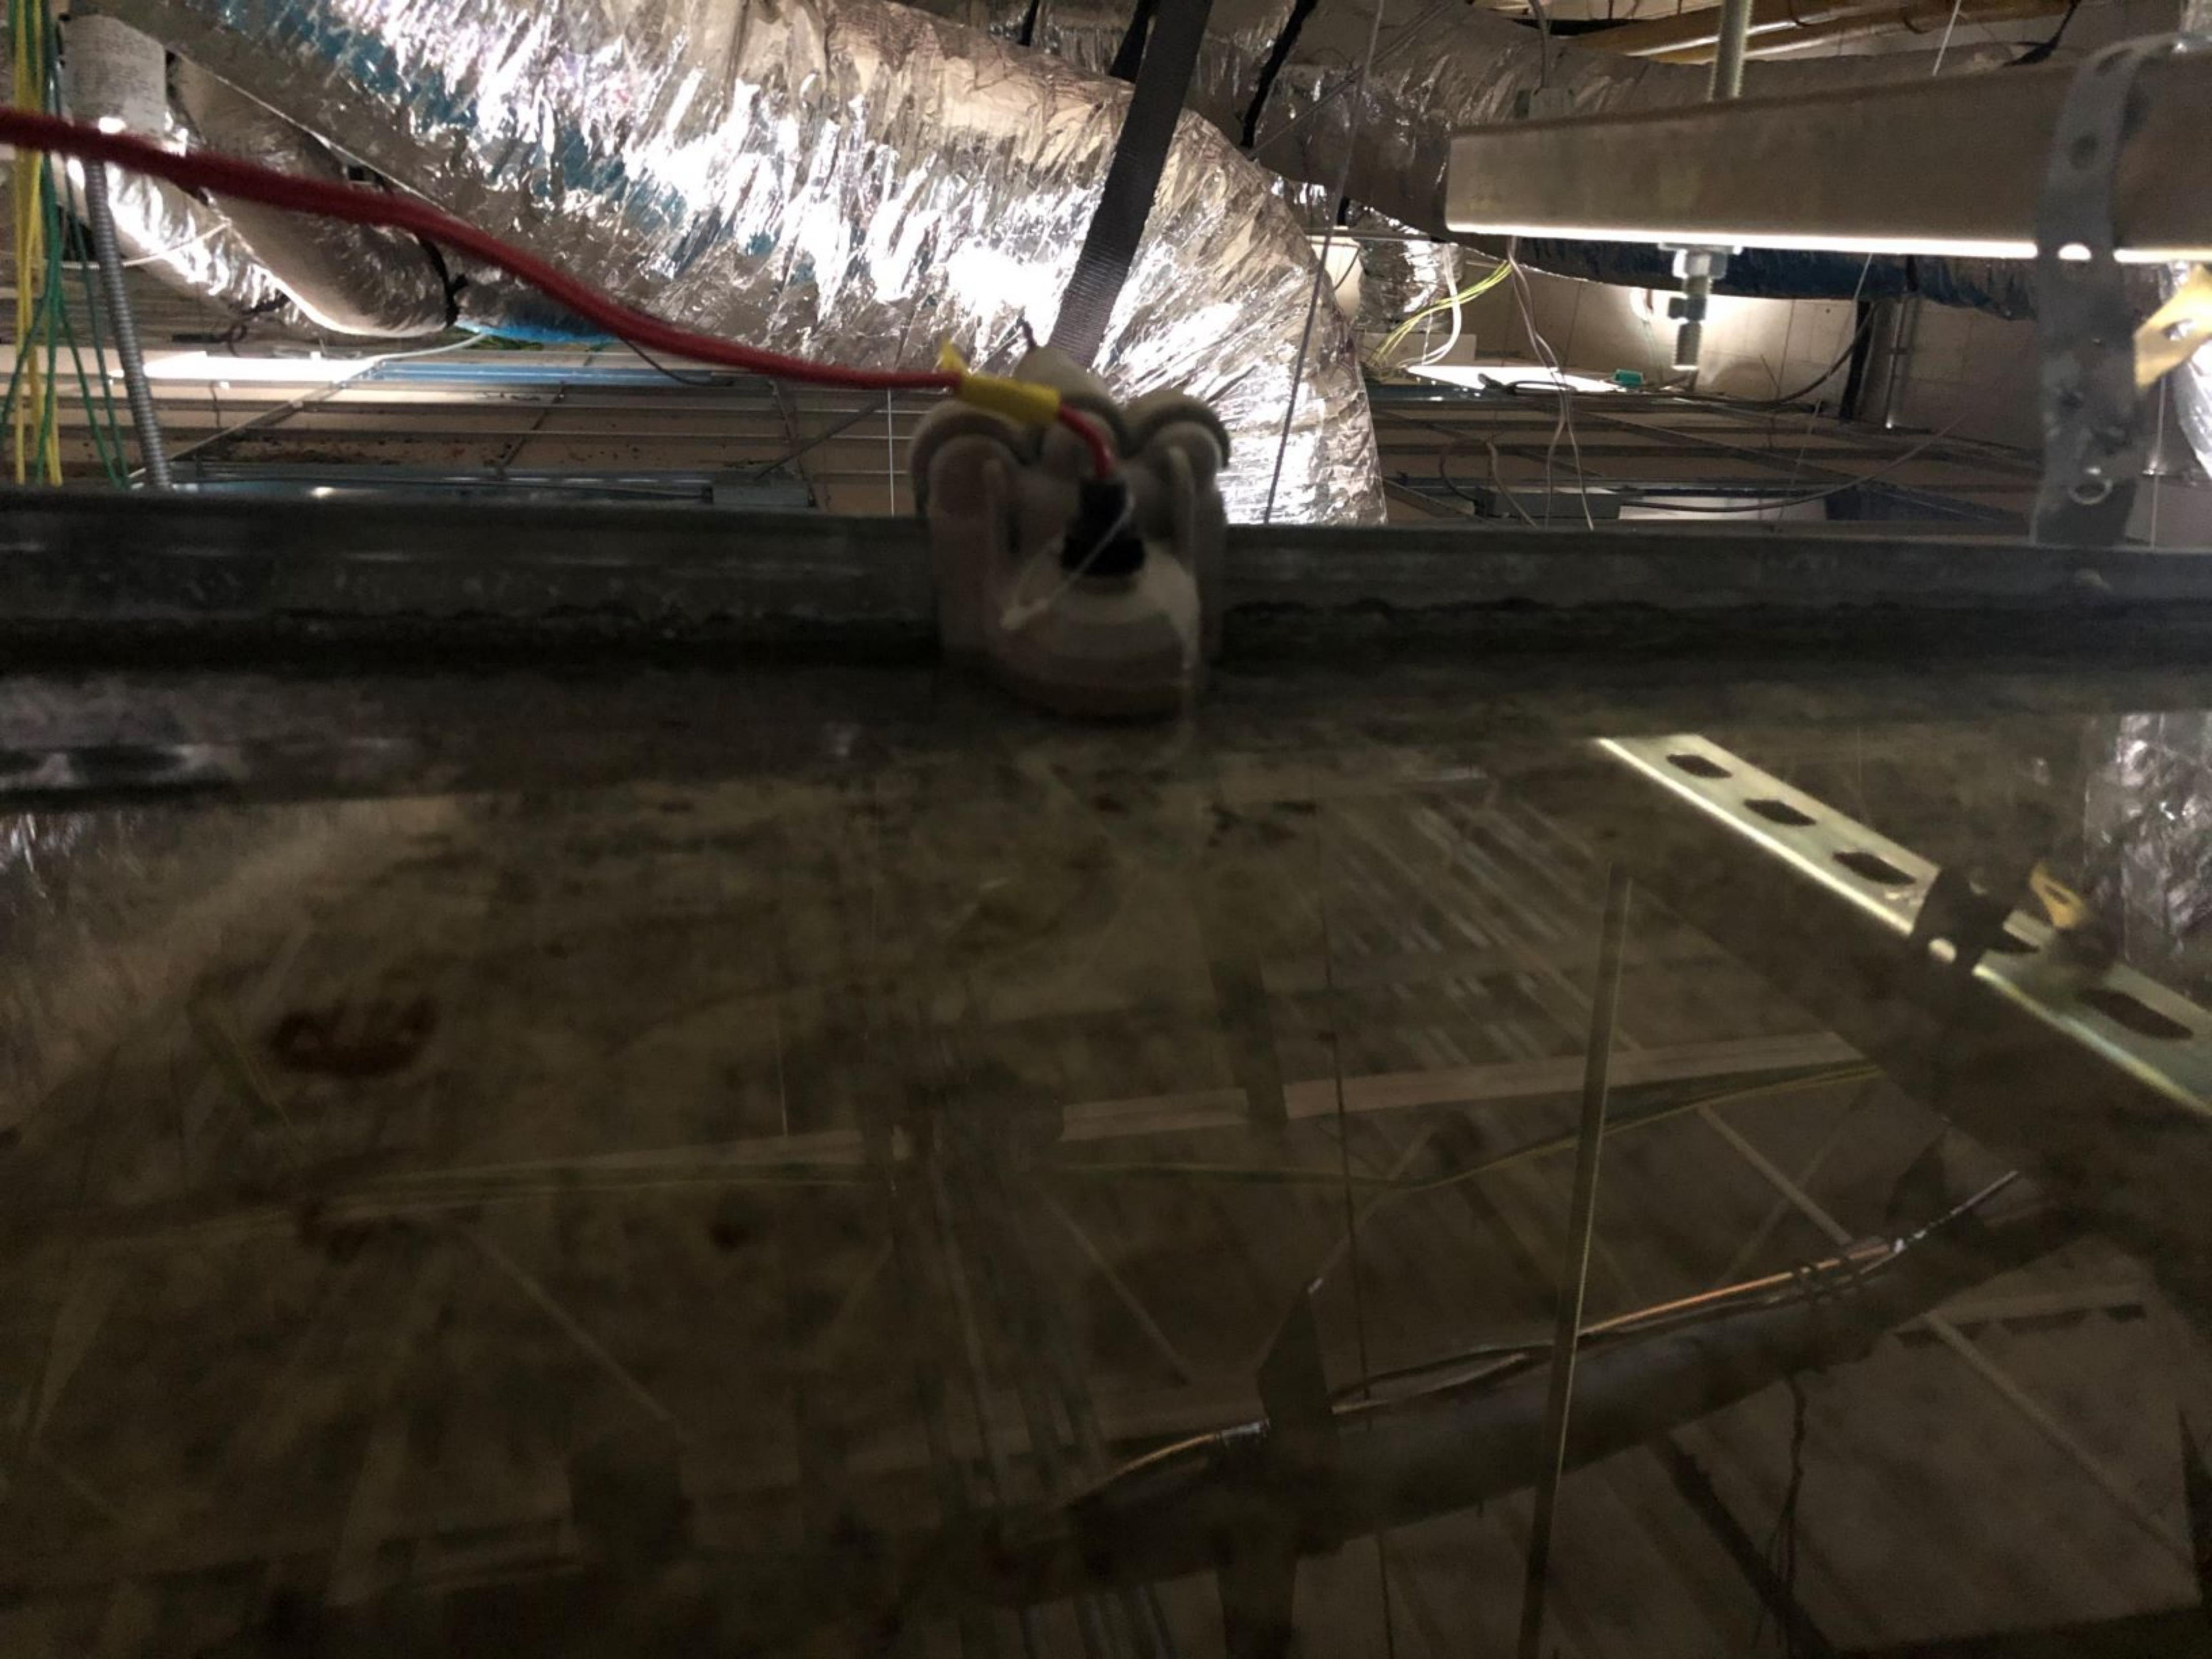
Arrived to site and checked-in. Mark pointed out unit not cooling for offices. Found t-stat blank due to dead batteries. Mark replaced batteries. Found unit off on overflow safety due to clogged drain(see pic). Unclogged drain. When removing water, pan dumped and made a mess. Cleaned-up all water.

Replaced batteries in t-stat and unclogged drain. Cleaned up water.
