1-31-23 Meadville Drill
Hall AHU actuator and
office MA actuator

3-28-23 office hw
actuator and squeaking
inducer on b-2

FACID/Building: PA062 Date of Visit: 12/8/22

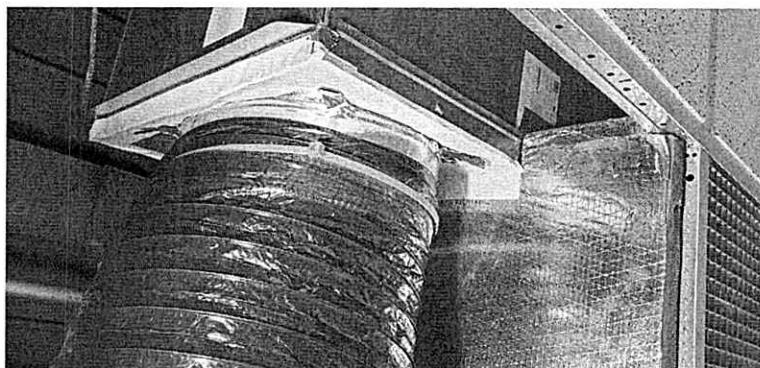
Title	File Name
Duct work put back together	0d74c1d4-7fac-4746-a0f0-bfaf22a3f8da.jpg

Daily Form	Fill out every day, even on PMs, and projects
TECH NAME	Tom Timlin
DATE	1/31/23
TOOLS USED	hand tools
MATERIALS USED	1: Belimo Actuator (ordered)
DESCRIPTION OF WORK PERFORMED	Had to remove the return ductwork to get access to the old actuator. Removed it and installed the new one. Wired it in according to the old one. The actuator had voltage to it but was not moving at this time. I have no access to the controls to see what it should be doing. Reassembled the return duct work and sealed it all up. Still waiting on the hot water actuator. Unit is running good at this time.
HOURS	REGULAR:
	OVERTIME:

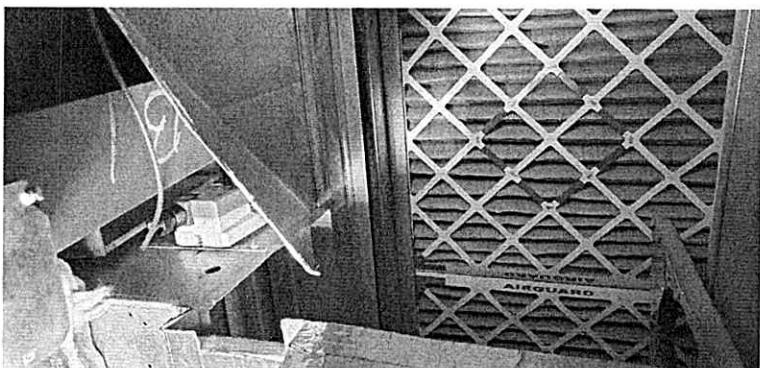
New actuator	80acf60f-1be9-43c8-ae2-9033be49f236.jpg
--------------	---

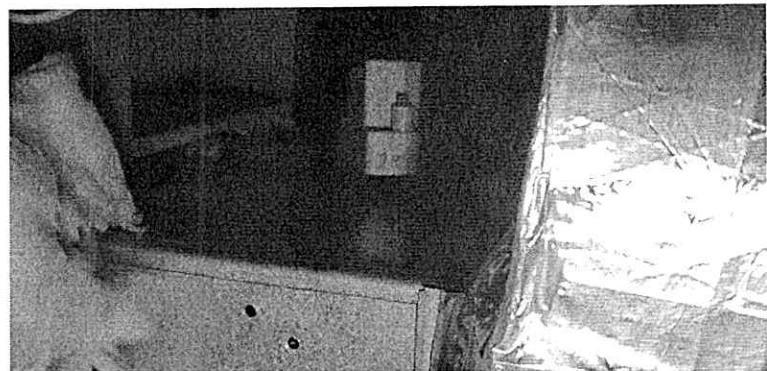
Old Actuator

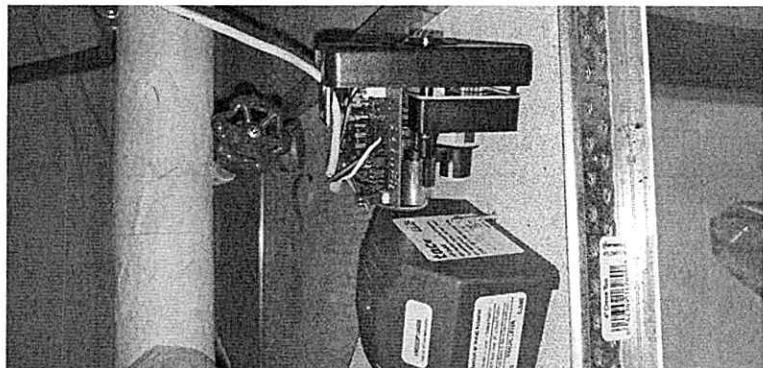
Attachments	
Title	File Name
Before	62d72656-904b-4521-9c07-485eee34b677.jpg

Service Forms	
Daily Form	Fill out every day, even on PMs, and projects
TECH NAME	Tom Timlin
DATE	3/28/23
TOOLS USED	hand tools
MATERIALS USED	1: Erie actuator(ordered)
DESCRIPTION OF WORK PERFORMED	Installed the new actuator and made sure the actuator was cycling properly. I believe there is an issue with the controls moving it the wrong way. Chesapeake Controls is supposed to be out in the next few days to reprogram their system for the drill hall valve with is the same valve as this time installed today on the office AHU.
HOURS	REGULAR:
	OVERTIME:
