RE: WV029, Report of Oil Water Separator Cleaning and Preventative Maintenance Inspection, Morgantown USARC, 228 Comfort Inn Drive, Morgantown, WV 26505

Attachment: Photographs of the Service

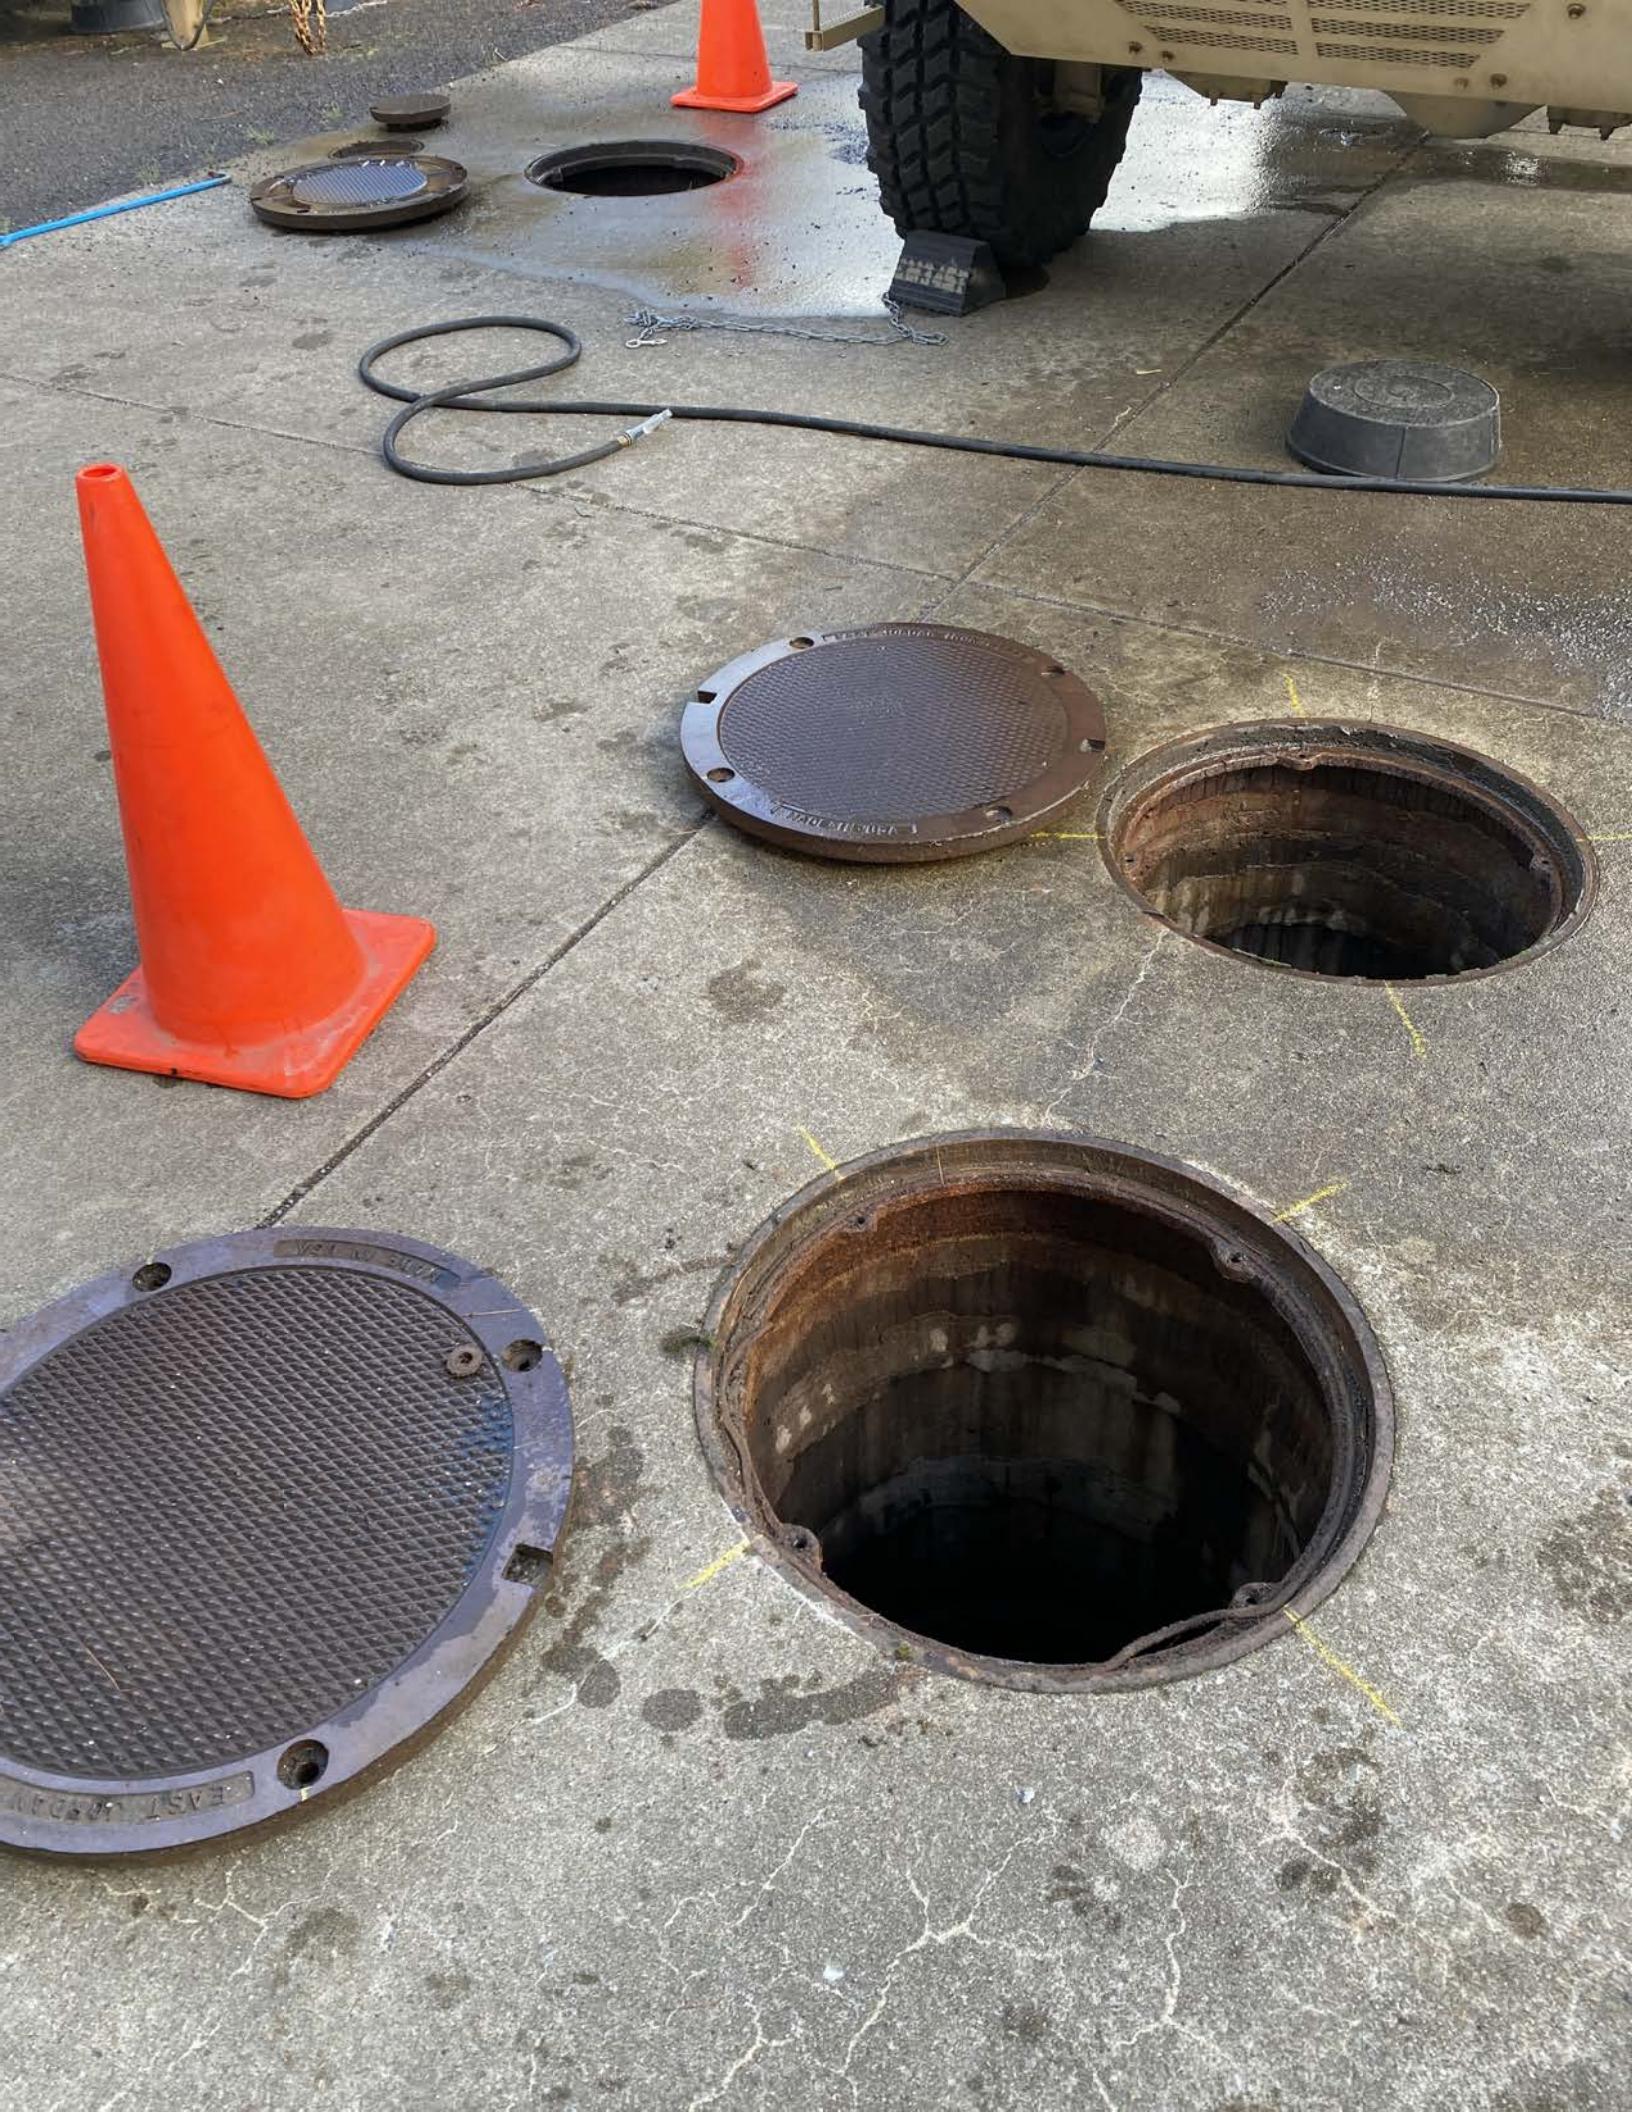
Site Service Performed: We mobilized to the facility on the morning of Wednesday, May 14, 2025. The three chambers of the system were accessed by the removal of three manhole covers.

3	OWS Area Prework
4	OWS Covers Removed
5	Primary Chamber Prework
6	Secondary Chamber Prework
7	Tertiary Chamber Prework
8	Primary Chamber After Cleaning
9	Secondary Chamber After Cleaning
10	Tertiary Chamber After Cleaning

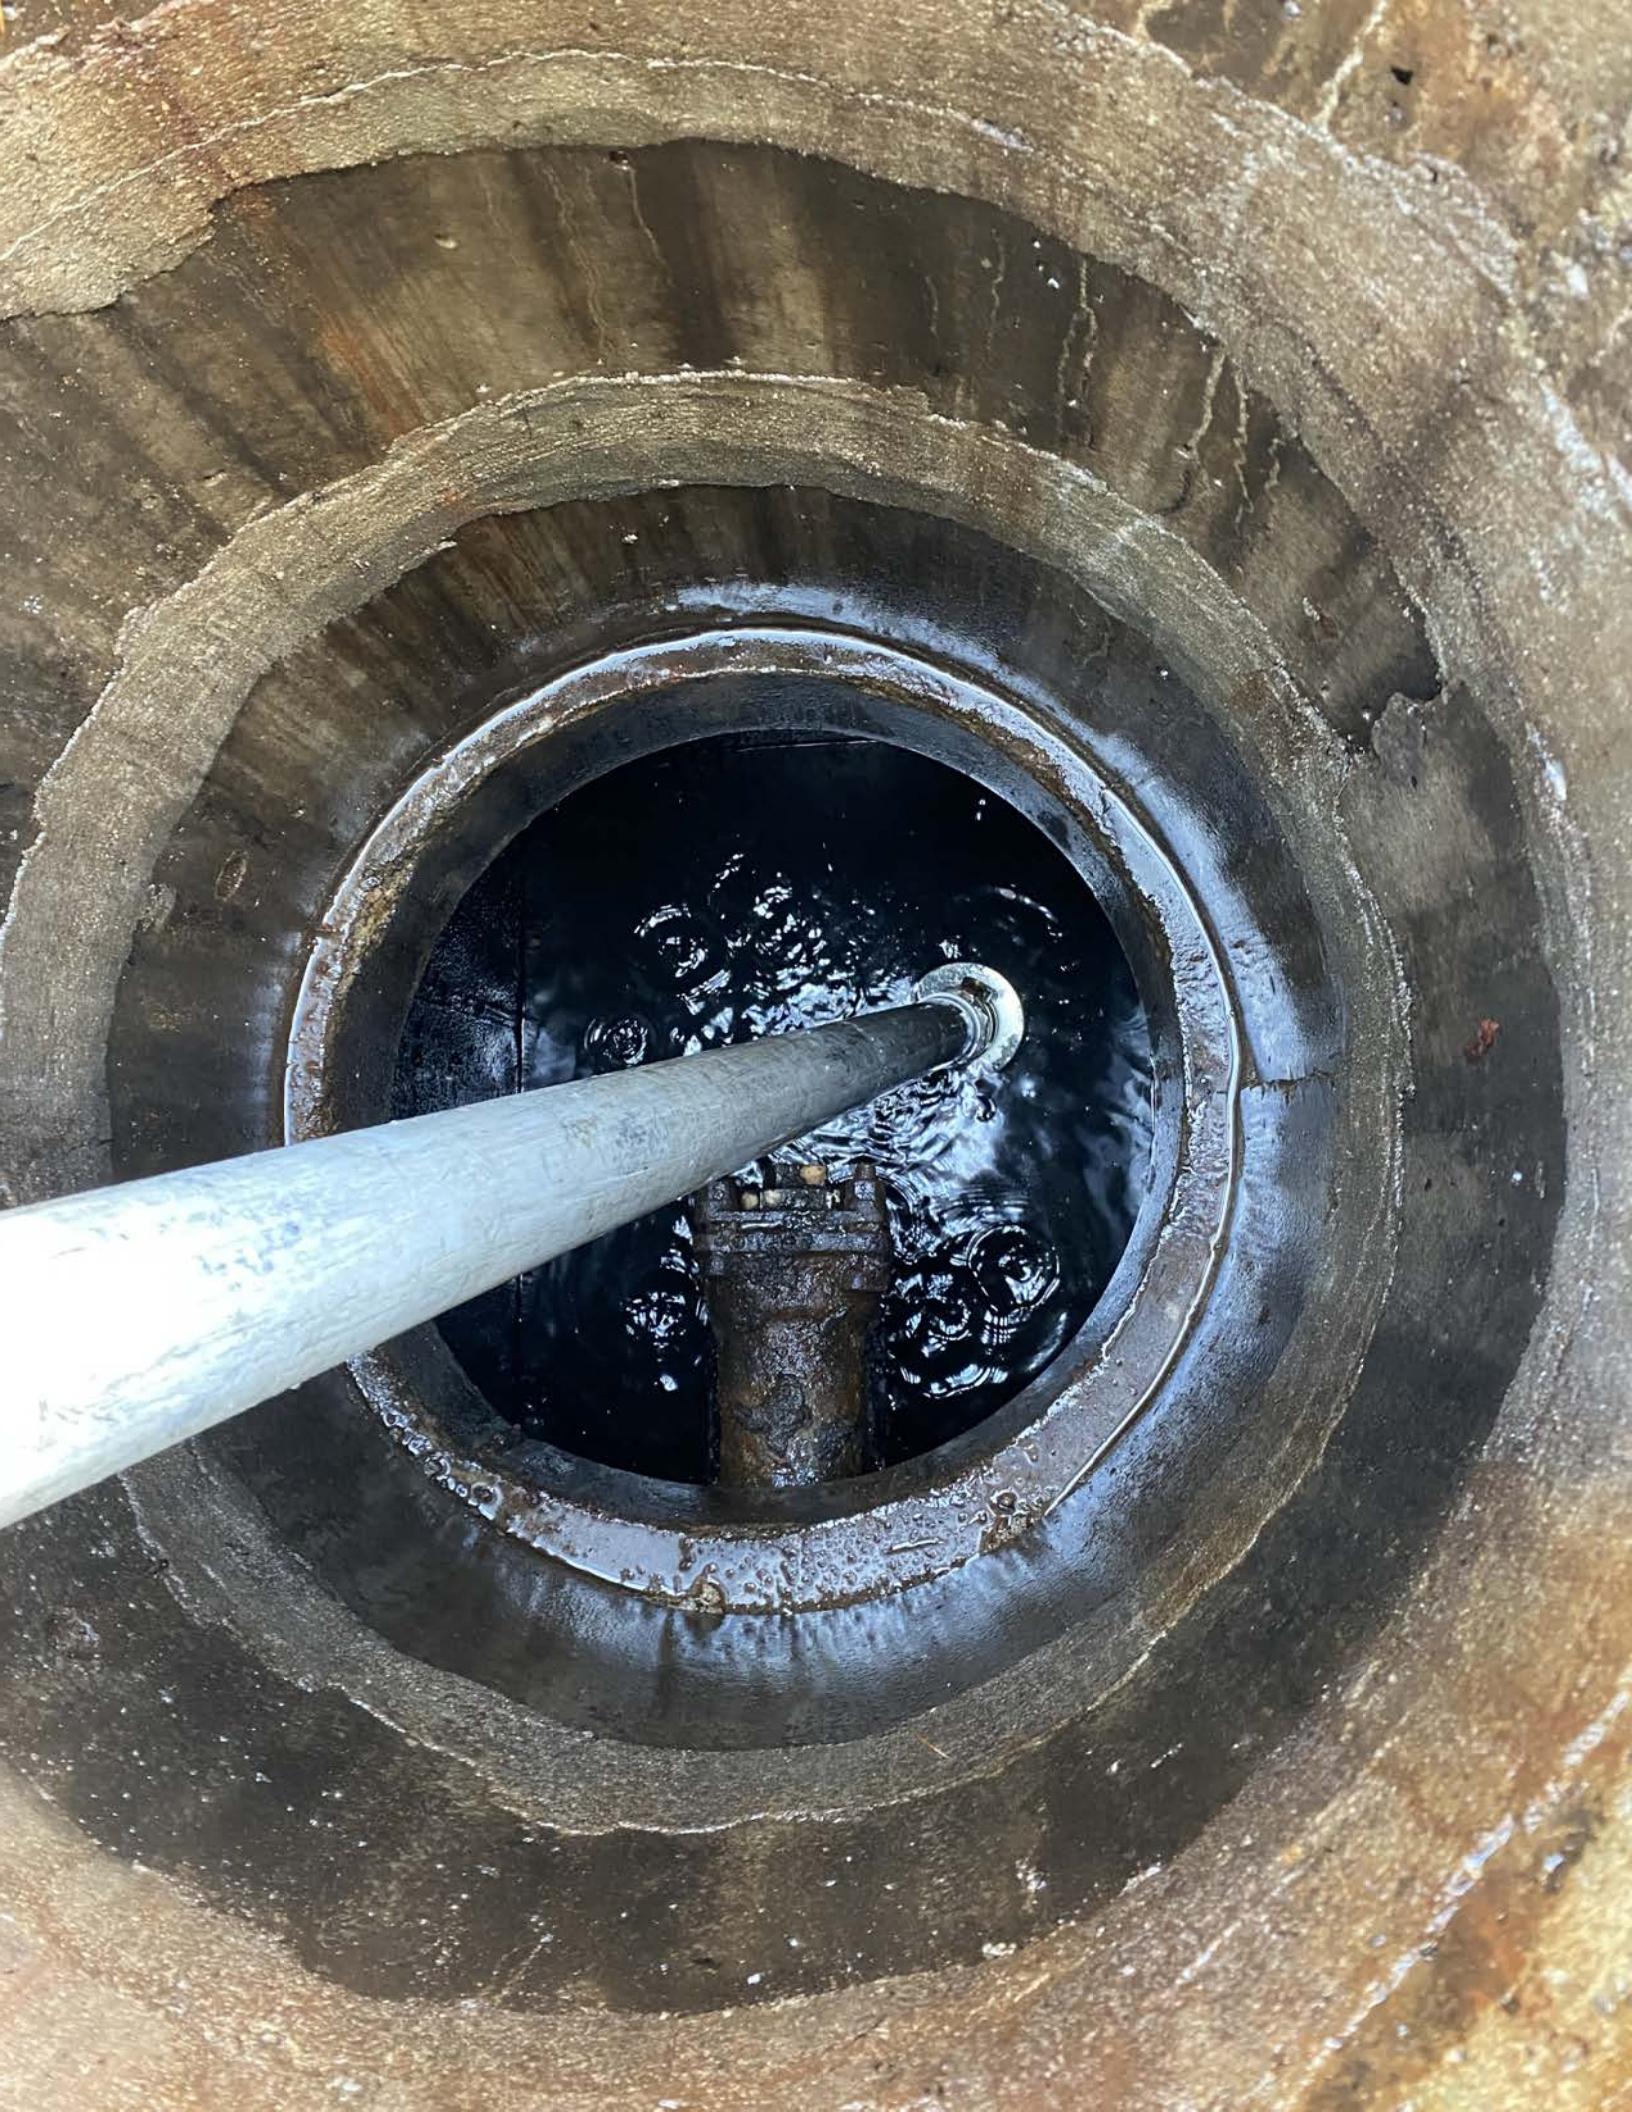
Free floating oil was removed from the chambers and the water phase was filtered and processed through the system until the bottom of each chamber was visible. No measurable sludge was encountered in any of the three chambers during the dewatering operation.
