## Additional Funding Request

<b>Site: NY058</b>	<b>WO# 21786 CSS #93084</b>
Description of Repairs	Remove and rehang the Telecom rack in Rm 204. The existing rack is not fastened properly to any studs to support the weight. Will remove the rack and reinstall it with backer boards for support and properly secure with screws and construction adhesive.
Diagnosis: Initial Work Order	Repair and re hang telecoms rack building 206 rm 204.
Explanation of Additional Costs for Repairs	
Additional Labor Cost to Perform Repairs	1200.00
Additional Material Cost to Perform Repairs	50.00
Total Cost of Repair	\$1250.00

ESTIMATE 041423 CSS93084 WO21786

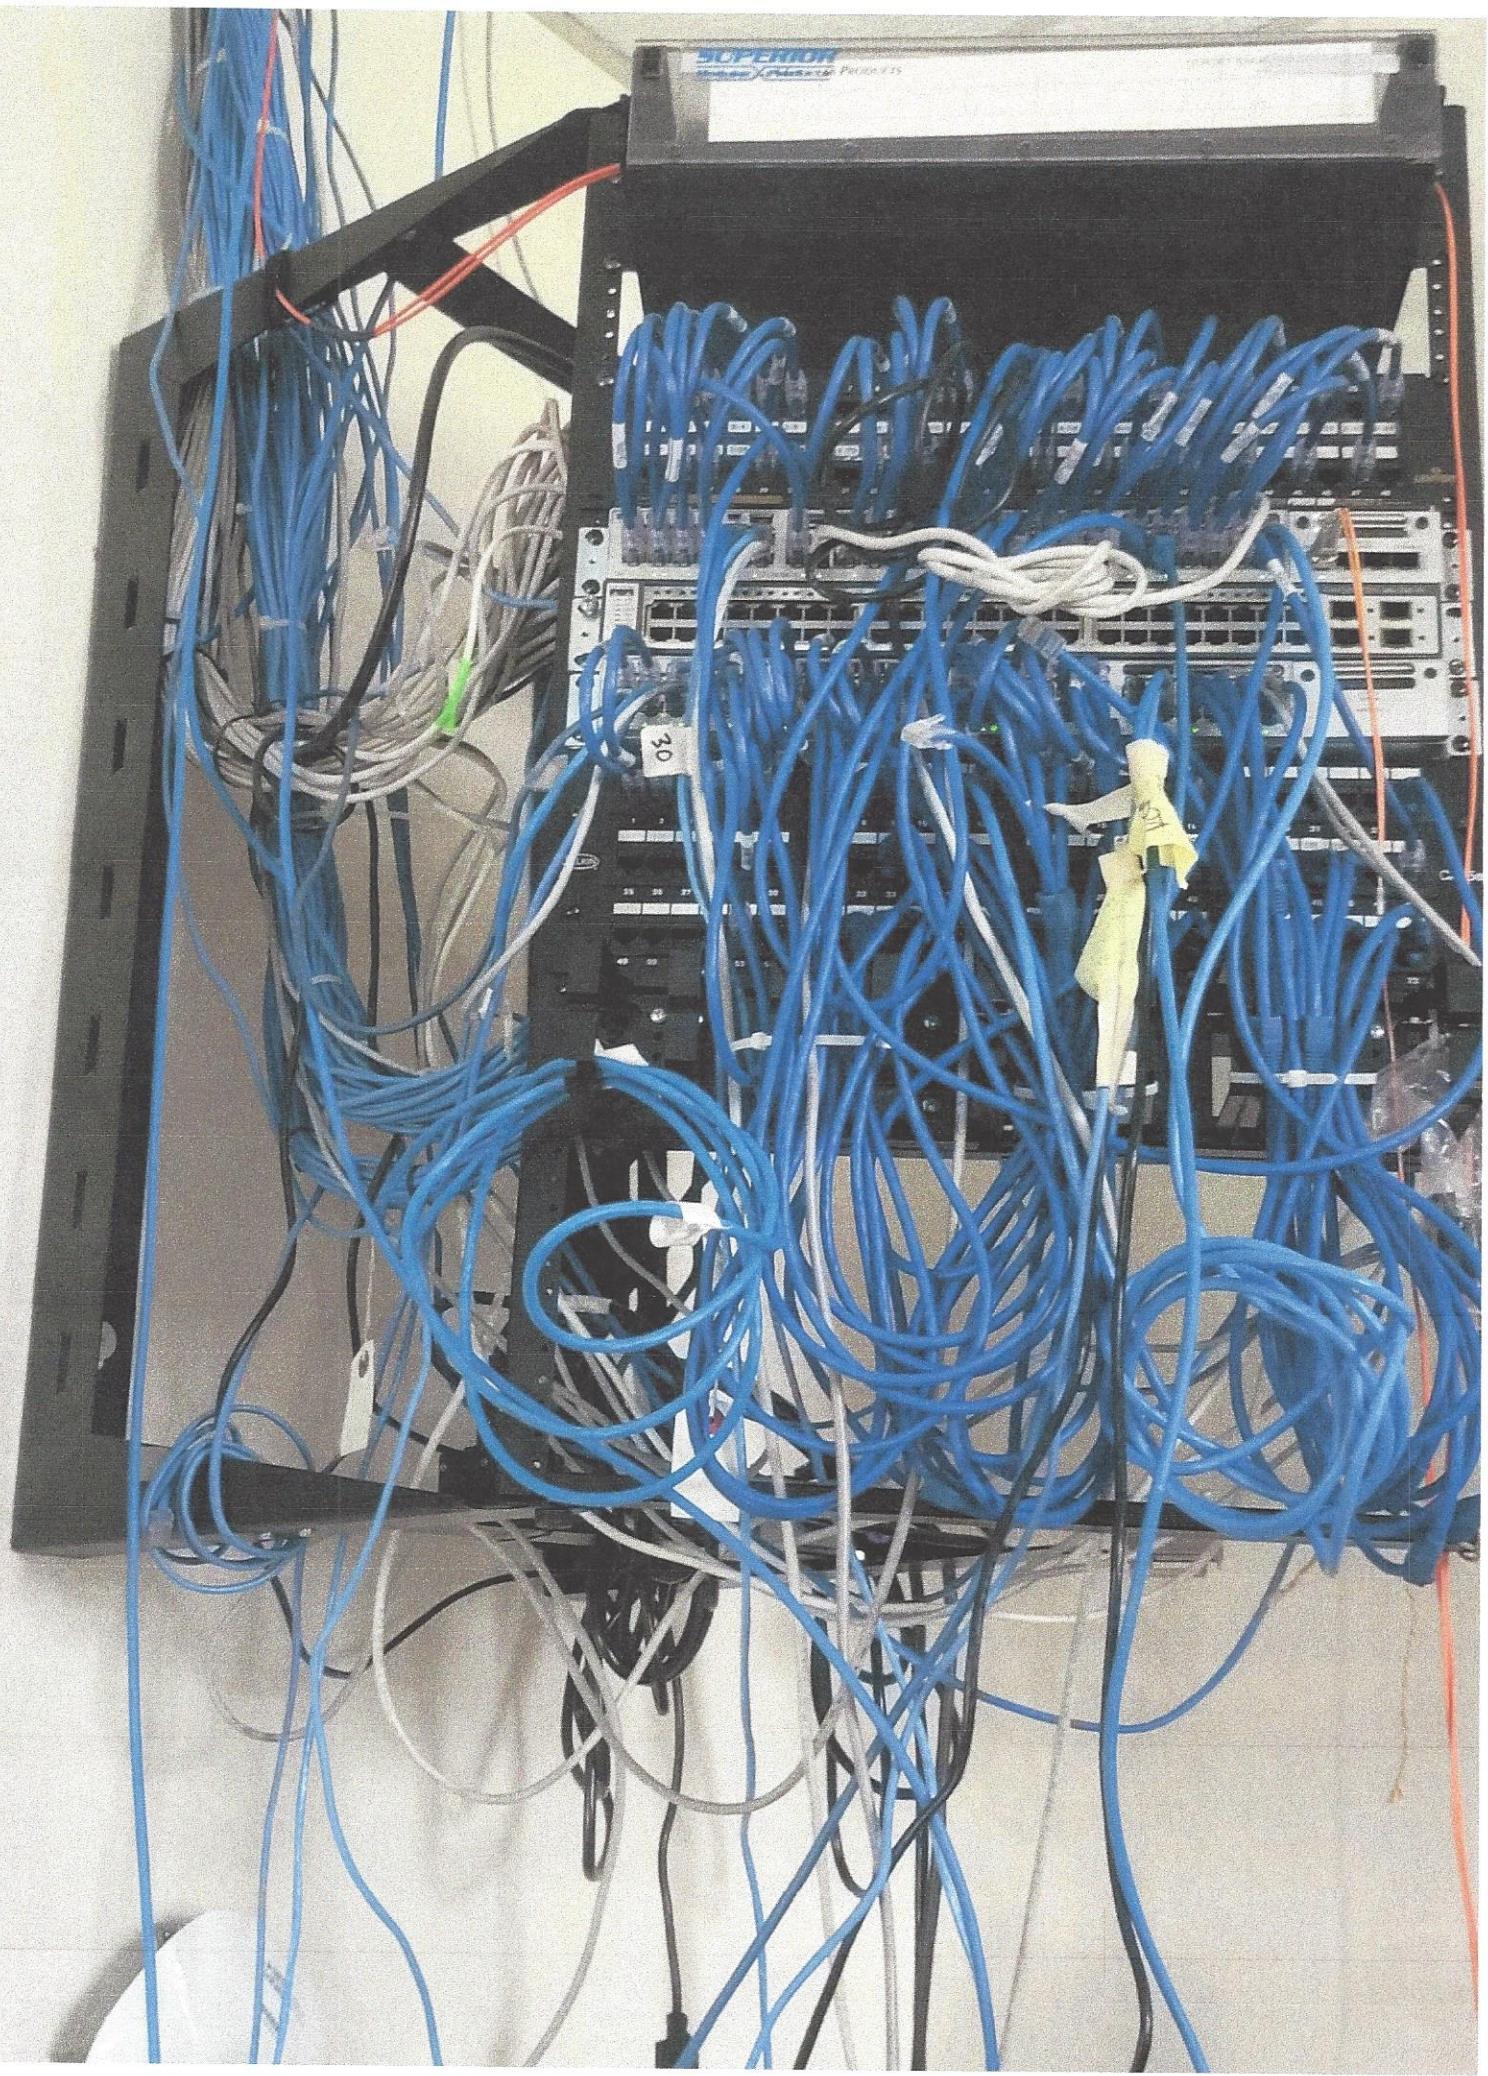
Qty.	Item#	Description	Unit Price	Line Total
		<p><b>NY23 (BLDG 206) RM 204</b></p> <p><b>REHANG TELECOM RACK IN RM 204</b></p> <p><b>THE RACK WAS NOT INSTALLED PROPERLY, WHO EVER SECURED THE RACK TO THE WALL (SHEET ROCK) DID NOT FASTEN THE FRAME TO ANY STUDS BEHIND THE SHEETROCK</b></p> <p><b>TWO MEN WILL BE REQUIRED TO REMOVE THE RACK AND TEMPORALLY SUPPORT IT WHILE BACKER BOARDS COULD BE CUT TO SIZE AND THEN</b></p>

Qty.	Item#	Description	Unit Price	Line Total
		<b>PROPERLY SECURED WITH SCREWS AND CONSTRUCTION ADHESIVE. THIS HAD TO BE ACCOMPLISHED WITH COORDINATION WITH THE IT PERSONNEL</b>		
		<b><u>MATERIAL</u></b>		
		<b>2X8X8 BOARD</b>		<b>\$50.00</b>
		<b>CONSTRUCTION ADHESIVE</b>		
		<b><u>LABOR</u></b>		
		<b>6 HRS @ 200.00 PER HR</b>		<b>\$1200.00</b>
		<b>(2 MEN 3HRS EA)</b>		
		<b>TOTAL</b>		<b>\$1250.00</b>
				<b>TOTAL \$1250.00</b>
