PREVENTATIVE MAINTENANCE PROGRAM CHECKLIST
OUTDOOR CONDENSING UNIT

SITE AND BLDG #: NY058-104

LOCATION/RM #: Outside Around B.104

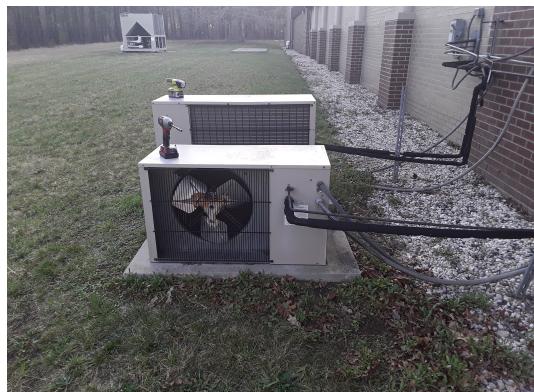
*CM - Asset # 10239 outdoor fan motor is seized and needs to be replaced.

- Units must be checked again for low charge
when outside temp. increases, (Thermostat Locked)
