WORK ORDER ESTIMATE

FACID/Building: NY058-104

Service Calls – PO/CSS# 23195

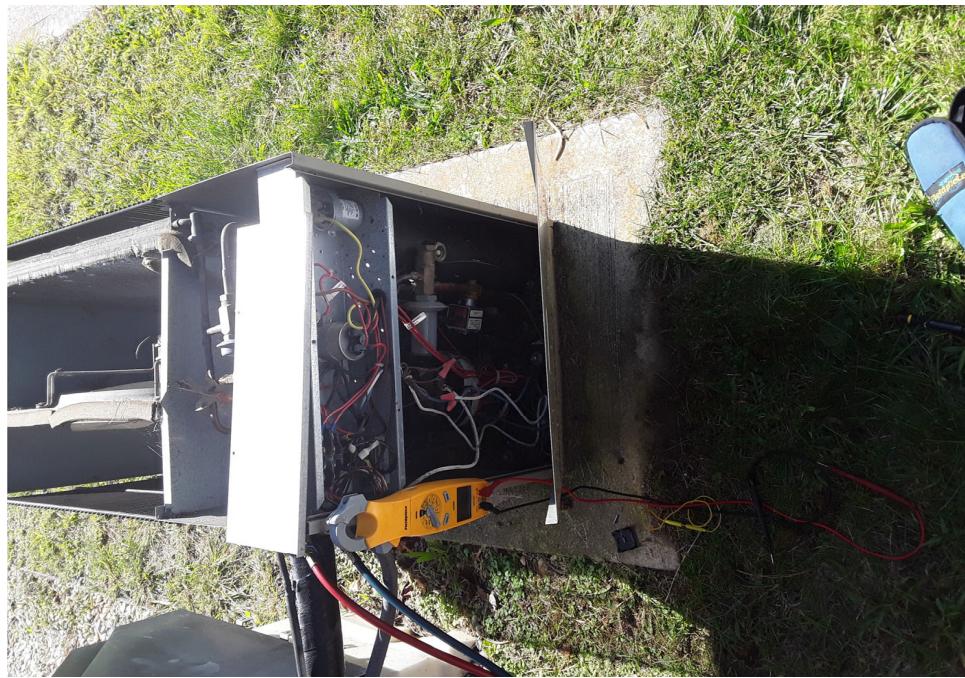
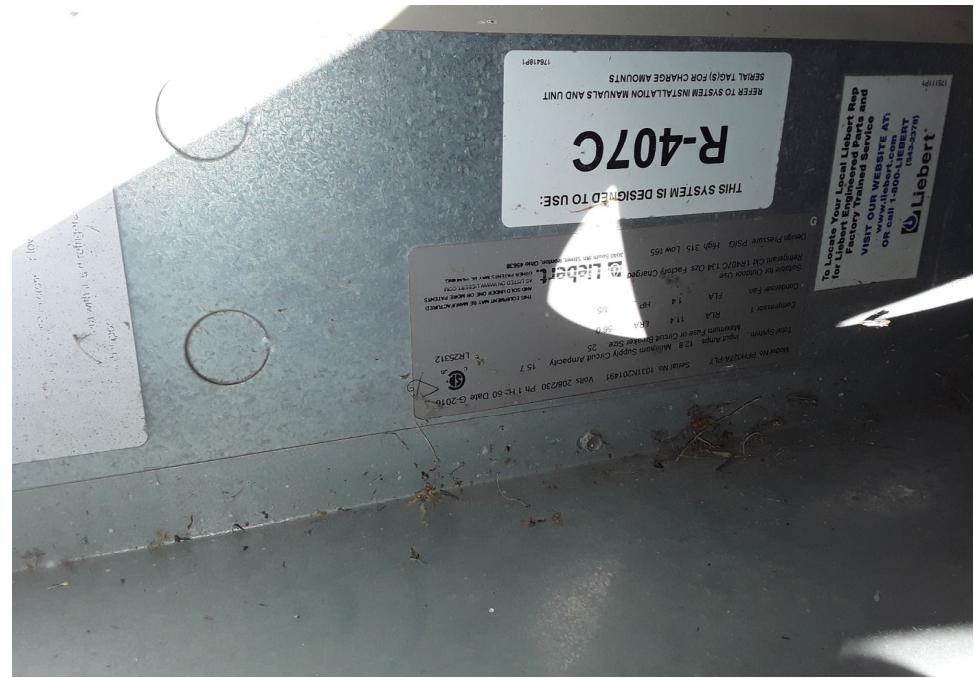
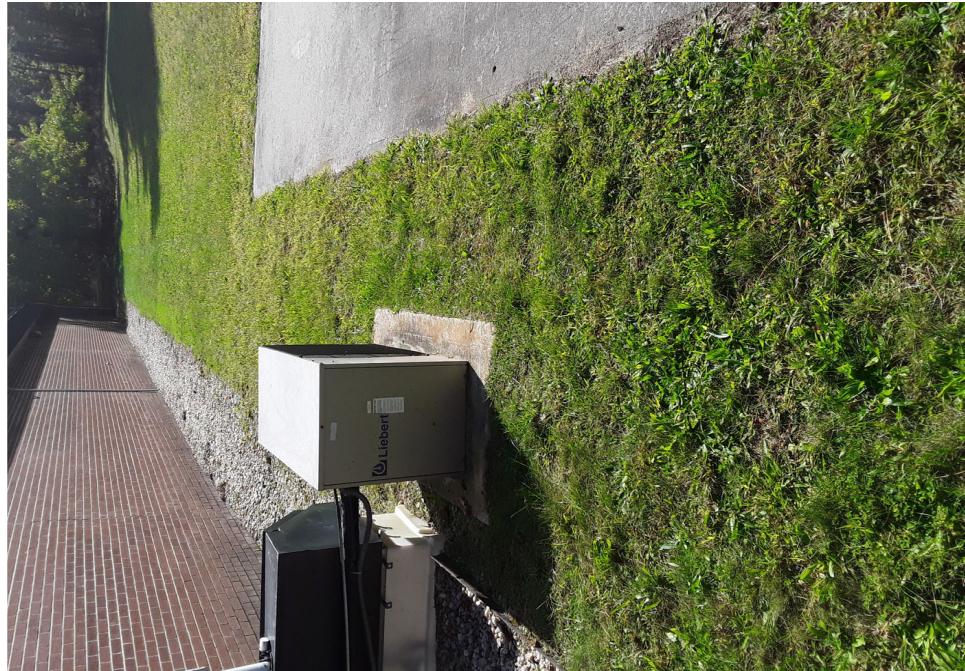
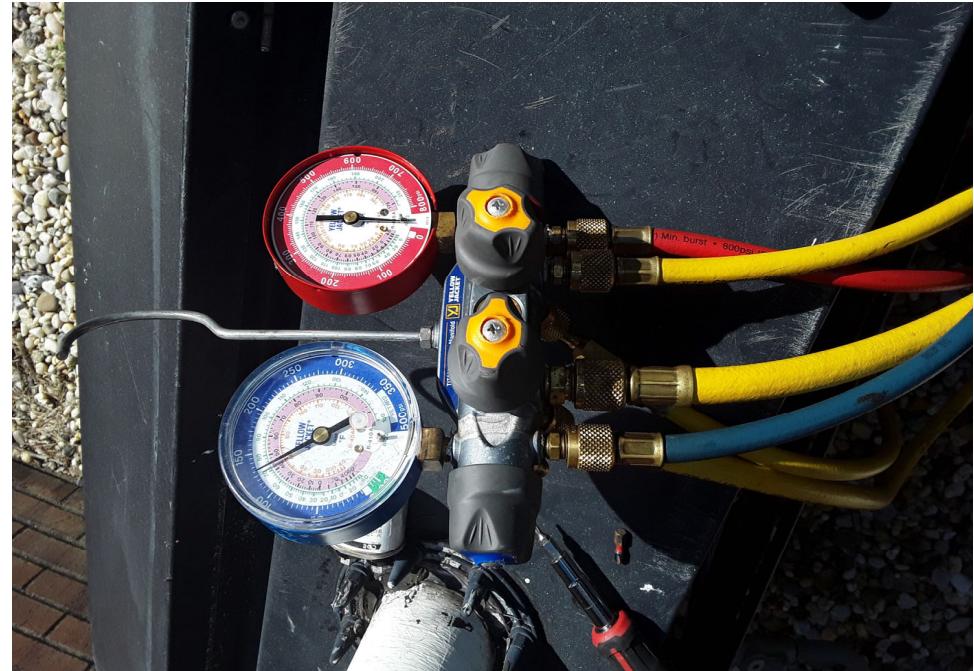
This unit has no motor and has loose wires appears as if was in process of being replaced and never completed. Motor Provided by the govt. ISG technician, leak tested , pulled vaccum and charged unit with R407C. ISG performed work will do for issued amount of 724.00

Work Performed: g Leak tested with Nitrogen and leak detector, Pilled Vacuum, And Charged w/ 8.4 lbs of R407C. / Fan Motor Was Already Repaired.
