CERTIFICATION OF WORK SERVICE CALL

Ref: Remediation/Sanitization Report for Amhurst USARC - Buffalo, NY

Remediation / Sanitization Report for Amhurst USARC – Buffalo, NY

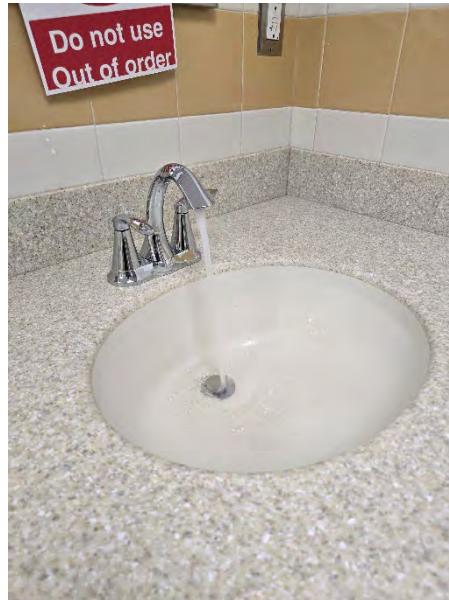
Water after Treatment

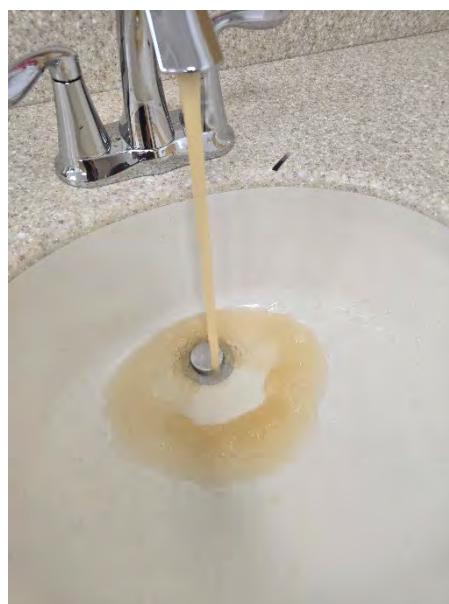
Water during Treatment
